SELF HEALING OF CRACKS IN CONCRETE: FROM A MODEL MATERIAL TO USUAL CONCRETES

Sébastien Granger⁽¹⁾, Ahmed Loukili⁽¹⁾, Gilles Pijaudier-Cabot⁽¹⁾ and Mouloud Behloul⁽²⁾

(1) ERT R&DO, GeM – Ecole Centrale de Nantes, France

Abstract

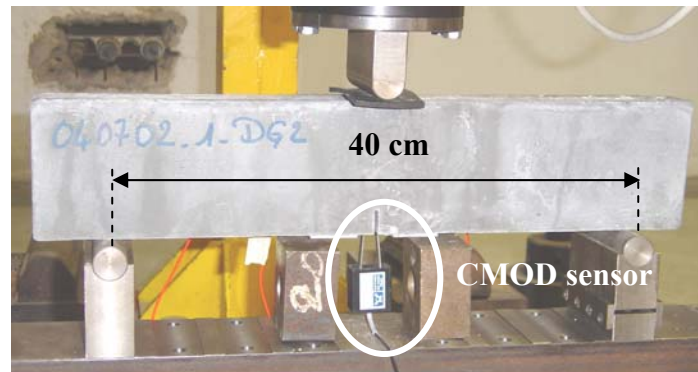
During the first phase of the mechanical program, specimens are loaded under three points bending (figure 1). The tests are notch opening controlled with a constant rate of 0.05 µm/s. The aim of this first step is to get a controlled cracking of the specimen. Pre-cracking is performed in the post peak regime: after having reached the peak (comprised between 3 and 4 kN), unloading is performed when the applied load reaches 2 kN, which represents approximately 60% of the peak load. Thus, a single residual crack width of 10 µm, which permits to get a fast self healing, is aimed. This unloading is also notch opening controlled with the same rate as loading. Pre-cracking phases are quite reproducible and residual crack widths for specimens after unloading range between 8 µm and 15 µm.

Figure 1: Mechanical test configuration

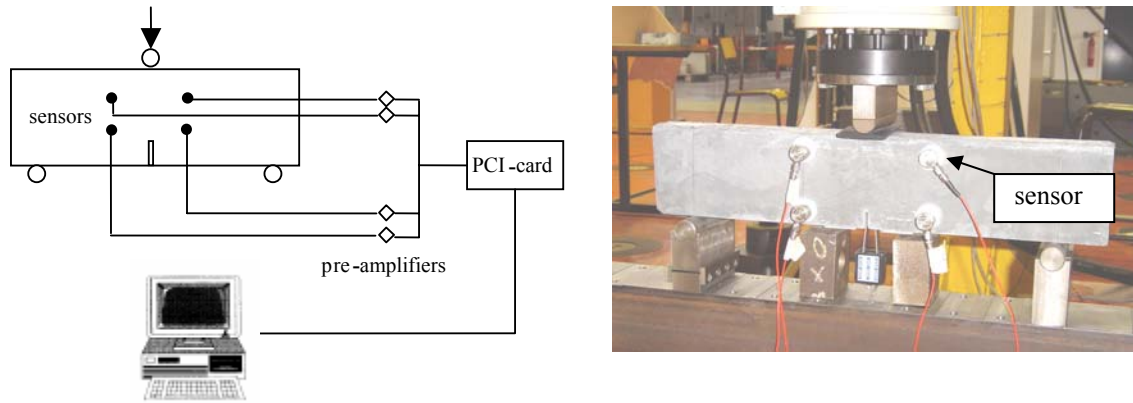
In order to follow and to characterize the cracking processes, all the specimens are instrumented with an Acoustic Emission (AE) system, during the pre-cracking and reloading phases. The aim is to locate the microcracks (called AE events) which appear during the tests. The instrumentation consists of a MISTRAS system, a general-purpose interface bus (for extraction of AE parameters, such as amplitude, energy, duration...) and a PC for data storage analysis. Four piezoelectric transducers (with a resonance frequency of 150 kHz) are placed in a rectangular array just above the notch of the specimens, in order to cover the expected zone of crack path, and to minimize errors in the AE event location algorithms. The dimensions of the rectangular array are 140x65 mm² (figure 2). The transducers are placed on one side of the specimen, and coupled to the material with a silicon glue. The detection value (in amplitude) is set to 35 dB, in order to overcome the background noise, and the detected signals are amplified with 40 dB gain amplifiers. The frequency range of acquisition is set from 20 kHz to 400 kHz.

A planar location algorithm is used for AE location. It is based on the triangulation of the differences between detection times by each transducer. Three transducers are enough, but the accuracy is improved with an additional one. For the UHPC used in this research work, the accuracy of location, checked with Hsu Nielsen simulations, is ± 3 mm, which is correct in comparison with the diameter of the transducers (15 mm). We do not take into account the thickness of the beam, and all the events detected within the thickness of the specimen are projected onto the same place in the 2D maps.

Figure 2: Acoustic emission instrumentation – Rectangular array of 140x65 mm²

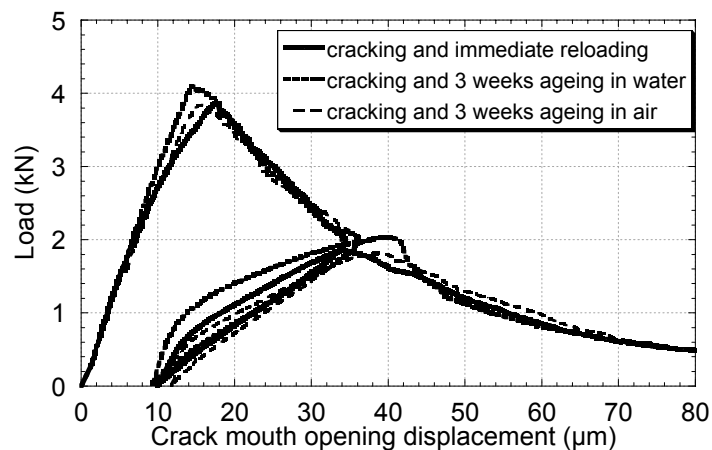
Three kinds of mechanical results are presented on figure 3. These are curves for a specimen pre-cracked and then reloaded immediately, and for specimens cracked and aged during three weeks (before reloading) in water and in air. The objective of this figure is to show the effect of storage in water, and to compare with the storage in air and with the immediate reloading of the specimen. The curves display the applied load versus the crack mouth opening displacement (CMOD). Each curve presents two parts: the pre-cracking phase, consisting in loading and unloading when the applied load reaches 2 kN in the post peak regime, and the reloading phase, immediate or after ageing.

Figure 3: : Mechanical behaviour of a specimen cracked and immediately reloaded, of a specimen cracked and aged 3 weeks in water before reloading, and of a specimen cracked and aged 3 weeks in air before reloading – Pre-cracking and reloading phases

The reproducibility of the pre-cracking phase of the tests can be seen on this figure. It also shows that the cracked specimen immediately reloaded and the specimen aged in air, have the same mechanical behaviour while reloading, which is the typical reloading after cracking. On the contrary, there is a difference with the mechanical behaviour for the specimen stored in water, especially on the reloading stiffness and the reloading peak load.

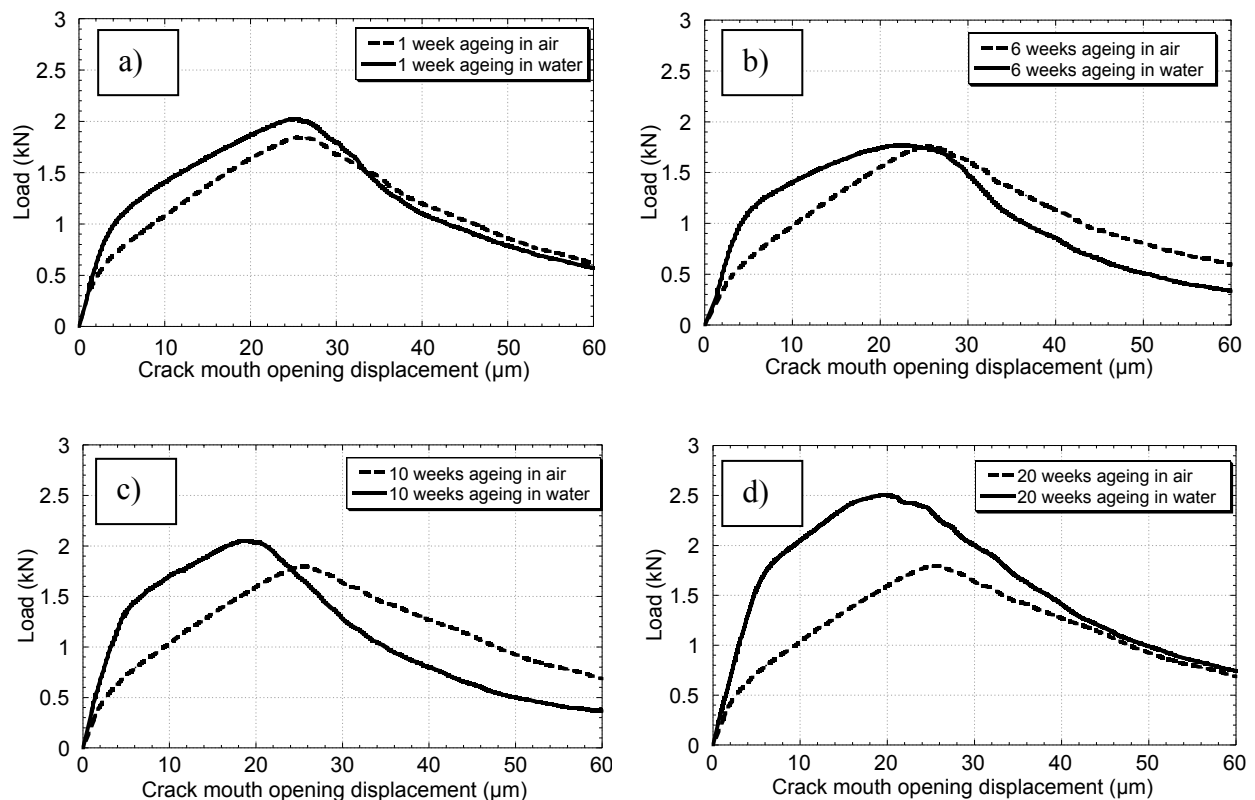
If we consider the influence of the ageing time, which is, of course, an important parameter, figure 4 presents the average reloading curves for specimens stored in air and in water (reloading curves for 3 specimens), and for 4 different periods of ageing: 1, 6, 10 and 20 weeks. For the sake of clarity, only the reloading parts of the total curves are presented. The CMOD at the beginning of the tests is shifted to 0, in order to have the same initial state, but in reality we should have the value of the residual CMOD at the end of the pre-cracking phase.

Figure 4: Mechanical reloading behaviour of aged specimens for different ageing times – Comparison ageing in water and ageing in air - Average curves: (a) 1 week, (b) 6 weeks, (c) 10 weeks, and (d) 20 weeks

We can notice that specimens stored in air exhibit very similar mechanical behaviour for the different periods of ageing. It means that air has no influence on the mechanical properties of cracked specimens, even for a long period of ageing. The reloading part corresponds to the re-opening of the existing crack until the reloading peak load, followed by the continuation of the crack propagation. On the contrary, there is a clear evolution of the mechanical behaviour

of specimens stored in water with the time of ageing. The initial reloading stiffness is not the same as for specimens aged in air, and it increases. There is also a slight improvement of flexural strength and a change in stiffness in the pre-peak phase which evolves with time.

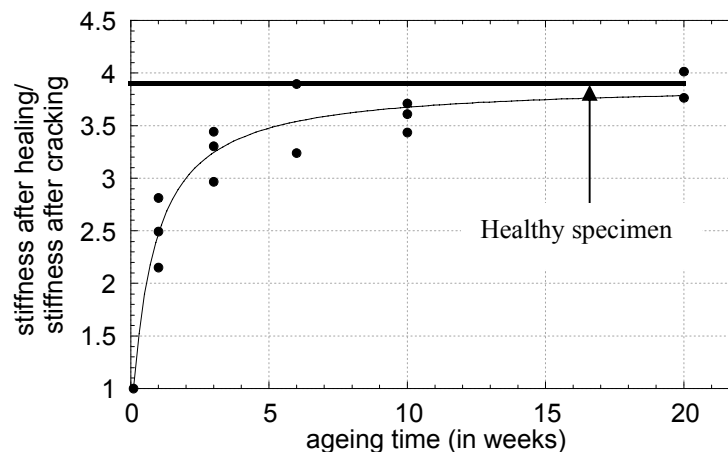
Figure 5 shows the evolution of the ratio between the reloading stiffness with healing, and the reloading stiffness without healing, as a function of the ageing time. It is noticeable that there is a fast recovery by self healing, and this stiffness tends to those of healthy specimen, which is represented by the straight line on the graph. These results can be explained by the fact that products are formed in the crack, especially, if we consider the low W/C ratio, new C-S-H. These crystals make a bridge between the two faces of the crack and progressively fill it, making the specimen recover its initial stiffness.

Figure 5: Evolution of the ratio between the reloading stiffness with healing and the reloading stiffness without healing, as a function of time of ageing – Comparison with the average stiffness of healthy specimens

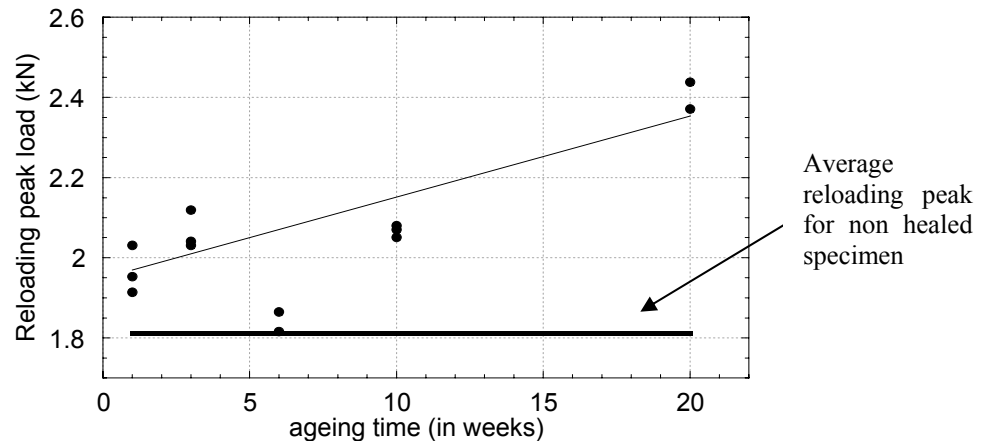
Concerning the flexural resistance, figure 6 represents the evolution (with the ageing time) of the peak load upon reloading for healed specimens. It shows that self healing provides a slight improvement of strength, compared with the strength of non healed specimens. Nevertheless, the initial flexural strength is not reached, and a kind of explanation will be provided according to SEM observations, later in the contribution.

Figure 6: Evolution of the reloading peak for healed specimens (storage in water) with the time of ageing – Comparison with the average reloading peak of non healed specimen

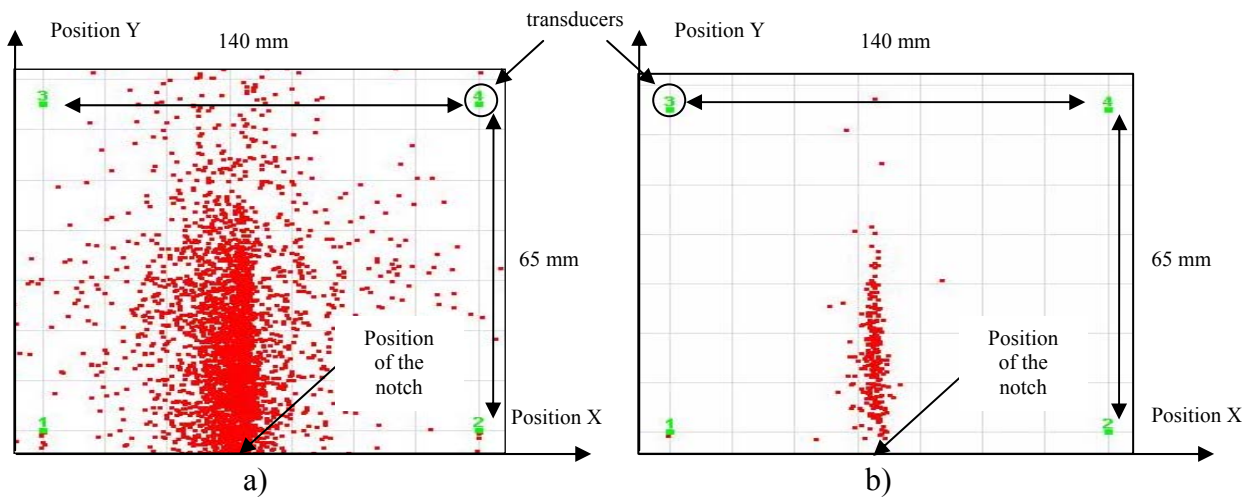
The mechanical tests have shown the contribution of the self healing phenomenon on the mechanical properties of initially cracked specimens. The main aim of the acoustic tests performed during the mechanical tests is thus to highlight that this contribution is related to the precipitation of new crystals in the crack. The principle is to analyse micro-cracking during the reloading phase of the mechanical tests. So, location maps of micro-cracks are performed during the two steps of the mechanical tests, pre-cracking and reloading after ageing. The first kind of maps illustrates the initial micro-cracking processes and serves as a reference for the second one. The typical maps exhibit a very dense area of micro-cracks in the zone of crack path. In order to have an accurate location of the acoustic events in the macro-crack, we need to filter the detected signals. Otsuka [11] have shown that 95% of the dissipated acoustic energy is located in the fracture process zone, and that the less energetic micro-cracks are not associated with the fracture process of concrete. After having selected the events with the most important energy, we have decided to eliminate those with an energy inferior to 2% of this maximal energy. The filtering energy is thus set to 1000 atto-Joule (aJ). The cumulative energy of these eliminated events is of course non negligible, but with this technique, we can keep only the micro-cracks of interest. Figure 7 presents a typical micro-cracking map of a specimen, just after the pre-cracking phase without filtering, and with filtering. The four points in the corners represent the transducers which form the rectangular array, and the other points are the micro-cracks detected. On the map with filtering, we can clearly see, at the end of the pre-cracking phase, where the macro-crack is located, and we are able to make the link with the results during the reloading phase.

Figure 7: Micro-cracking map of a specimen after the pre-cracking phase; a) Result without filtering, b) Result with filtering in energy: events with an energy higher than 1000 aJ

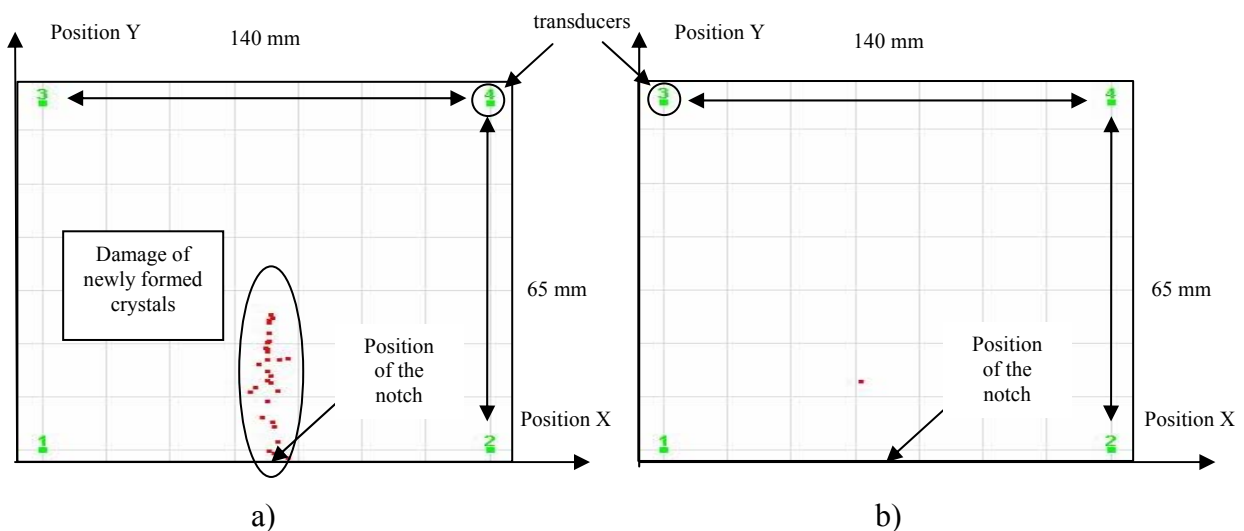
According to the same filtering criterion, new maps are obtained for aged specimens in order to locate the newly formed crystals micro-cracking. In a first analysis, they are performed during the reloading phase (in the pre-peak regime) until $18 \mu\text{m}$ crack mouth opening. Figure 8 presents the maps for a specimen aged in water and for a specimen aged in air, both during 10 weeks. It is noticeable that micro-cracks appear for the healed specimen in the region of the initial crack, while nearly no micro-cracks are detected for a non healed specimen. In one case, there is damage of crystals in the crack, and in the other case, there is only the re-opening of the existing crack, without any damage but with eventually some detected frictions. These results confirm that crystals have precipitated in the crack during storage in water, and they start being damaged in the pre-peak phase of reloading. The sudden decrease of the stiffness in the pre-peak regime is the consequence of this damage process.

Figure 8: Micro-cracking maps, during the reloading phase (until $18 \mu\text{m}$ – pre-peak regime) of specimens aged for 10 weeks; (a) ageing in water, (b) ageing in air

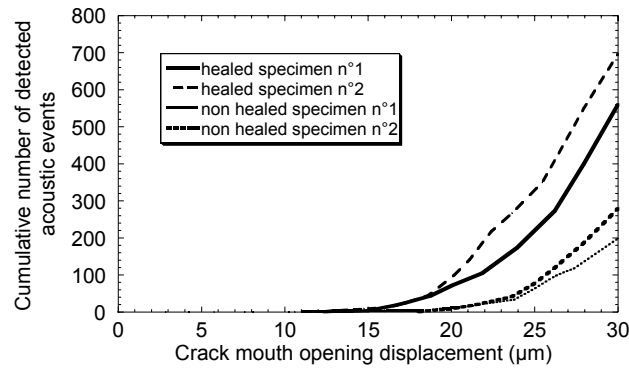
This result is confirmed by the analysis of the total number of detected acoustic events. The appearance of acoustic emission while fracturing is linked to the development of damage [12]. Figure 9 presents the cumulative number of detected acoustic events as a function of the crack mouth opening displacement, for the reloading of two healed specimens and two non healed specimens (specimens aged during 10 weeks).

Figure 9: Evolution of the cumulative number of detected acoustic events for healed specimens and non healed specimens, during reloading phase

So, we can see that in the case of healing, the development of damage appears sooner than for non healed specimens, which confirms the fact that new crystals are damaged in a first time during the reloading phase.

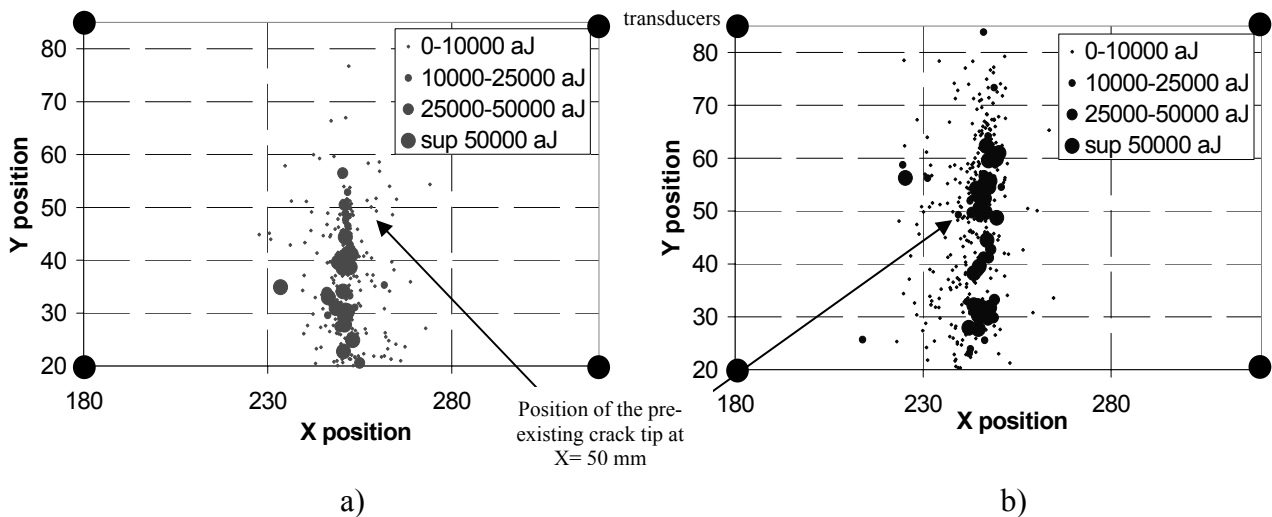
We can now consider, in a second analysis, a comparison during the reloading phase, not at the same CMOD, but at the same load level. Results at 90% of the peak load, in the post peak regime are analysed. Figure 10 represents the location maps in terms of energy. Points representing the micro-cracks are plotted according to their acoustic energy: the bigger the point, the more important the energy.

Figure 10: Energy location maps at 90% of the peak load in the post peak regime; a) healed specimen, b) non healed specimen

If we sum these energies for events located below and above the pre-existing crack tip (which is for height of 50 mm from the bottom face of the specimen), we can notice that nearly 100% of the acoustic energy dissipated until 90% of the peak load is located in the pre-existing crack, for the specimen which has been stored in water, although it is 50 % for a non healed specimen (acoustic events due to frictions or re-opening of micro-cracks). This result highlights the two regimes of damage for healed specimens: first we have damage of the newly formed crystals, and then continuation of the crack propagation. If we consider now the total energy dissipated, it is 50% less in the case of a healed specimen. This energy corresponds to the micro-cracking of the new crystals in the case of healing, and corresponds to the micro-cracking of healthy concrete in the case of non healing. We can thus consider that the mechanical properties of the new crystals should be less than those of healthy concrete.

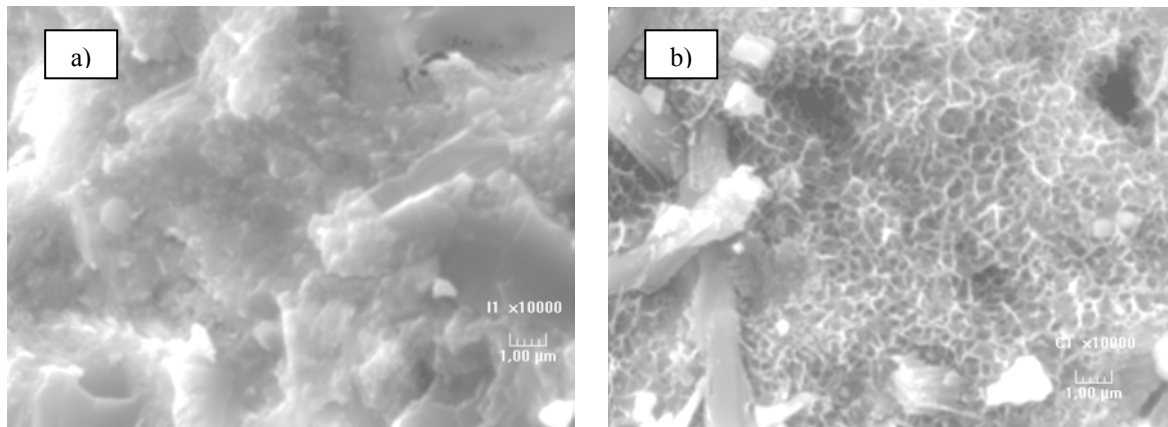
In order to complete our mechanical and acoustic results, and to explain what really happens in the crack, SEM observations are performed. The essential aim is to determinate the nature of the new crystals that have precipitated in the crack. The observations are performed on the crack surfaces after the reloading phase, and are completed by some qualitative analysis by energy dispersive spectrometry (EDS) technique. Figure 11 presents the typical observations for a non healed crack surface, and for a healed one, with an enlargement of 10000.

Figure 11: SEM observations on the crack surfaces of the studied concrete; a) crack without healing, b) crack with healing – Enlargement of 10000

The typical crack surface without healing shows a very dense microstructure, made of C-S-H gel. On the contrary, the observations carried out on the healed surface are totally different. We can thus see a particular structure formed by alveolar crystals. EDS tests are carried out on several places in these crystals and give the typical result which can be seen on figure 12.

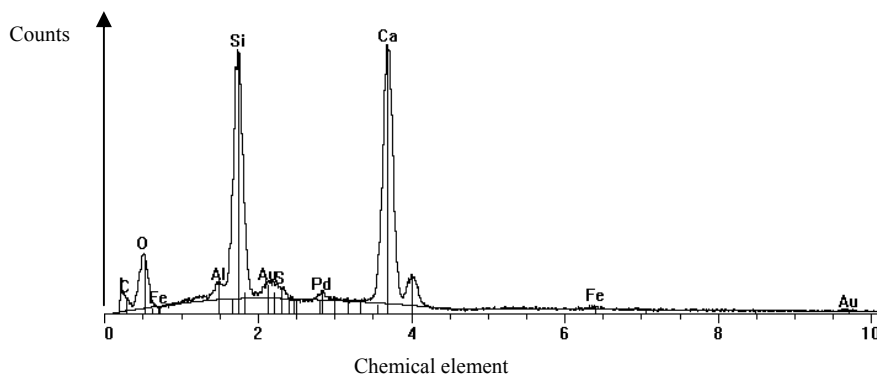
Figure 12: Result of the energy dispersive spectrometry analysis on the alveolar crystals on the healed crack surfaces

This analysis reveals the typical composition of alveolar C-S-H. We can thus give some new explanations about the mechanical behaviour of healed specimens. Indeed, the fact that C-S-H have clearly precipitated in the crack explains the recovery of stiffness. Nevertheless, the special structure of these new C-S-H, in comparison with the very dense structure of hardened concrete, can not permit to recover the specimen strength. It is in fact difficult to build in the crack, the complex structure, which gives its strength to concrete, and especially all the links between C-S-H.

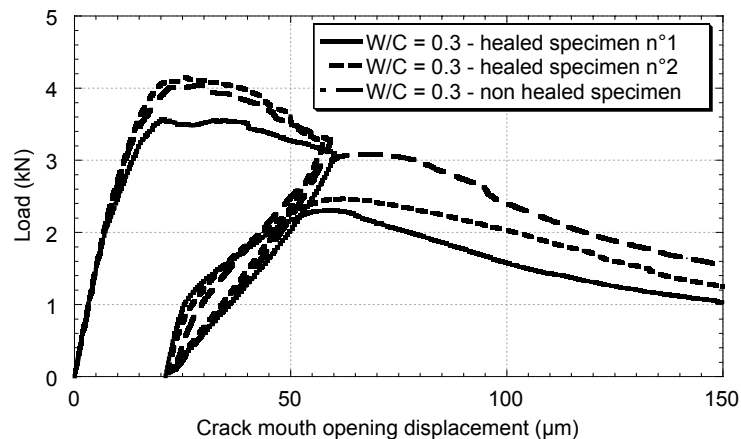
After casting, the prismatic specimens (dimensions 50x100x500 mm³) have been cured in water for 120 days. Young modulus (followed by the measurement of resonance frequency) and compressive strength are stable at the end of this curing time. They are then stored in a climate chamber at 20°C and 50% relative humidity, but are not thermally treated. The specimens are then pre-cracked under 3 points bending. The four concretes are less brittle than the ultra high performance one. So it is difficult to aim a residual crack width of 10 µm with a significant damage. It was so decided to aim a residual crack width in the order of 20 µm. The specimens are then totally immersed in water at 20°C and their mechanical behaviour is characterized after 10 weeks of ageing. The mechanical behaviour of non aged specimens is also characterized in comparison: specimens are pre-cracked and then immediately reloaded. Figure 13 presents the typical results obtained for specimens of concrete 1, pre-cracked at 20 µm and aged for 10 weeks, compared with the mechanical behaviour of a non healed specimen.

Figure 13: Mechanical behaviour of healed specimens (10 weeks) compared with mechanical behaviour of a non healed specimen, for concrete with W/C = 0.3

We could have represented the same result for the three other concretes. Qualitatively, we have exactly the same result: there is a very slight recovery of initial stiffness for healed specimens, and a very significant loss of flexural resistance, in comparison with non healed specimens. If we consider only the healed specimens, Figure 14 shows the average reloading curves (only the reloading part) for the four concretes, after 10 weeks of ageing. The curves display the ratio load applied on load at the unloading point of the pre-cracking phase, in order to be able to make comparisons.

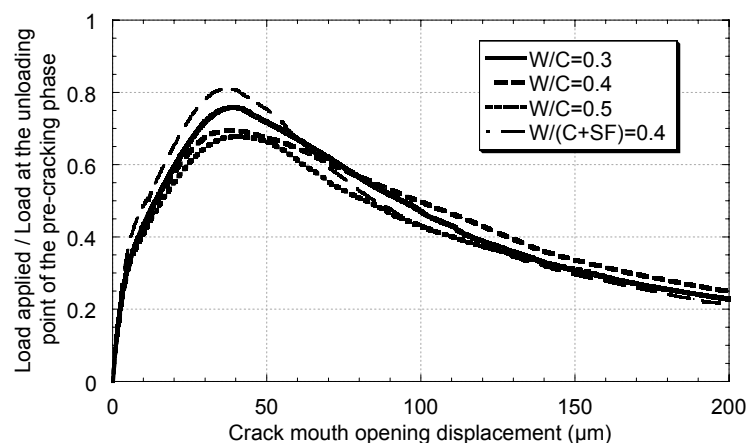
Figure 14: Average mechanical behaviour of specimens from different concrete compositions during the reloading phase

We can thus notice that the influence of composition of concrete on the phenomenon of self healing is quite limited for our tests. It appears that the highlighted deterioration of strength is less important for concrete with low W/C ratio, and for concrete which includes silica fume. But, this loss of strength is quite surprising. And we certainly need more information to be able to explain this result. Nevertheless, a first explanation based on the structure of the hardened cement paste could be advanced. Indeed, for the ultra high performance concrete, anhydrous cement grain present in the microstructure can be fractured in their whole volume, so that cement is directly in contact with water and can react. On the contrary, for usual concretes, the crack is preferentially located in the interface between cement paste and aggregates, and the intrusion of water can deteriorate this zone (increase of porosity) and thus degrade the strength. We can also wonder if the residual crack widths are not just too big to have the formed crystals bridging the gap between the two faces of the crack. As a conclusion, this investigation of the self healing on usual concretes indicates that the role of self healing on the mechanical properties of such concrete is limited. Further investigations, with, for instance, ageing conditions in air with high relative humidity and longer ageing times, could complete this part of the research work.
