Mechanism of Fatigue Crack Growth in Carbon Black Filled Natural Rubber

ABSTRACT: The present paper deals with the fatigue crack growth in a carbon black filled *cis*-1,4-polyisoprene rubber under relaxing loading conditions. The study focuses on the determination of the scenario of crack growth. For this purpose, an original "microcutting" method is employed to observe microscopic phenomena involved in the growth of the crack with a SEM. It reveals that the cavitation induced by the decohesion between zinc oxides and rubber matrix is the major fatigue damage and that the crack tip is composed of stretched elliptical areas surrounded by highly stretched and crystallized ligaments. Finally, the observations are considered to establish the fatigue crack growth mechanism.

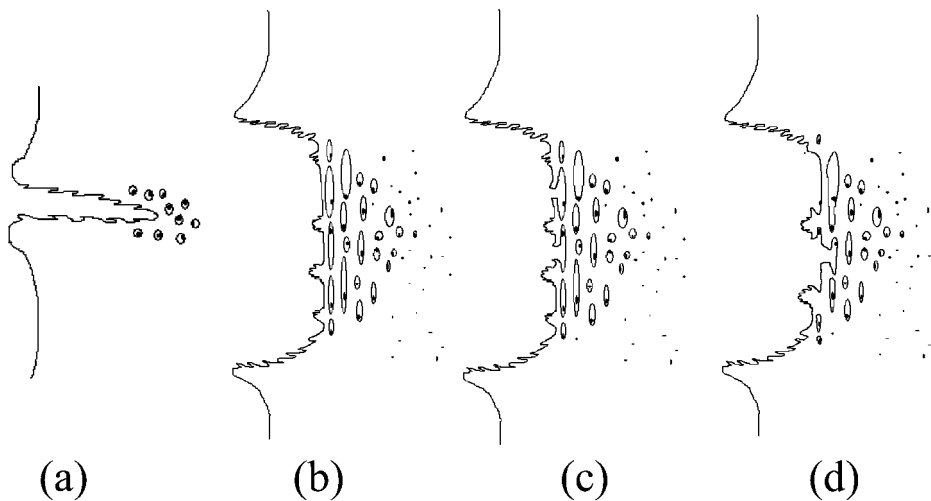
Figure 8. Crack growth mechanism: side view.

3.3. Crack Growth Mechanism. Using the previous observations, the scenario of fatigue crack growth is proposed in this section. It will be described thanks to two chronological sketches which correspond to two views of the phenomenon. Figures 8 and 9 present respectively the side and front views of crack growth. These two views will be used to accurately describe the three-dimensional nature of the phenomenon. It is to note that the chronology of the two figures are different; i.e., the stage of Figure 8a does not correspond to the one of Figure 9a.

The crack growth phenomenon can be seen as the succession of elementary sequences from initiation to final failure. Before examining this elementary sequence, let us recall that both fatigue loading and the stress state in the neighborhood of the crack tip generate cavitation due to the decohesion between oxides and rubber matrix as shown in Figure 8a. The elementary sequence is composed of three steps:

(i) As the crack tip is stretched, elliptical areas take place with ligaments on both sides and wrenchings at the top and bottom. Cavities are situated behind these areas, and their shape is ellipsoidal (see Figure 9a). As shown in Figure 8b, the wall that separates the crack tip and cavities is thin, such that it can be considered as a membrane.

(ii) This membrane tears and reveals most of the cavities situated behind it (see Figure 8c). The corresponding microcracks propagate perpendicularly to the crack growth direction (see Figure 9b).
