Real-scale investigation of the kinematic response of a rockfall protection embankment

Abstract. This paper addresses the response of rockfall protection embankments when exposed to a rock impact. For this purpose, real-scale impact experiments were conducted with impact energies ranging from 200 to 2200 kJ. The structure was composed of a 4 m high cellular wall leaned against a levee. The wall was a double-layer sandwich made from gabion cages filled with either stones or a sand–shredded-tyre mixture. For the first time, sensors were placed in different locations within the structure to measure real-time accelerations and displacements. The test conditions, measurement methods and results are presented in detail. The structure's response is discussed in a descriptive and phenomenological approach and compared with previous real-scale experiments on other types of embankments.

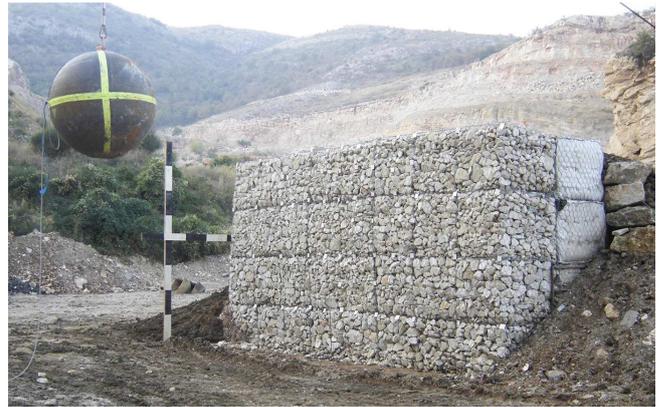
Figure 1. View of the tested embankment, showing the sandwich wall leaned against the levee and the hanging projectile.

The tested structure consists of a two-layered cellular sandwich wall leaned against a ground-compacted levee (Fig. 1). The wall is 4 m high, 8 m long and 2 m thick. The geocells consist of gabion cages made up of a hexagonal wire mesh with an 80×120 mm mesh, and a 2.7 mm diameter wire. Gabion cages are parallelepiped in shape, 3 m or 2 m long, subdivided into three or two 1 m^3 cubic parts, respectively.

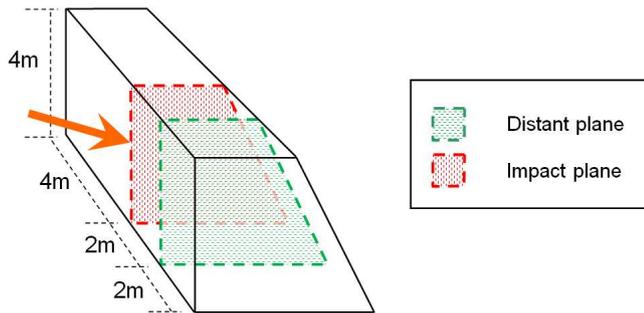
Figure 2. Sensors within the structure were placed in two vertical planes: in the impact direction and 2 m aside.

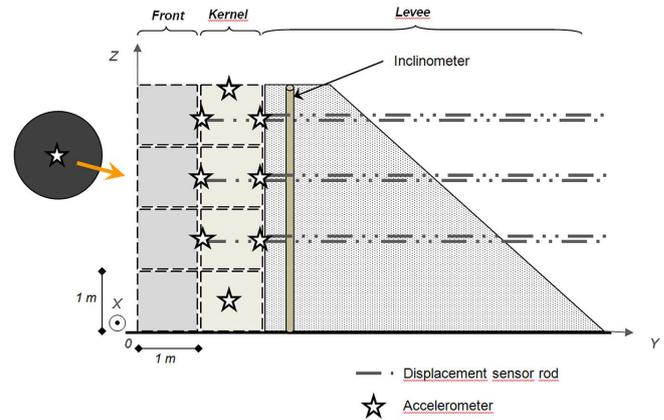
Figure 3. Cross section of the tested structure in the impact plane and measuring devices.

The structure is instrumented with the aim of evaluating (i) the displacements, (ii) the energy transfer and (iii) the damage to the structure. Stress measurements were not possible given the coarse nature of the fill materials. As shown in Fig. 2, the measurement devices were placed in two vertical planes normal to the front facing: the first in the impact direction and the second one 2 m distant, respectively referred to as the “impact plane” and the “distant plane” in the following. In the impact plane, displacements are assumed to occur in this plane for symmetry reasons only, contrary to the distant plane where normal-to-the-plane displacements are expected. The position of the sensors in the impact plane is depicted in Fig. 3.

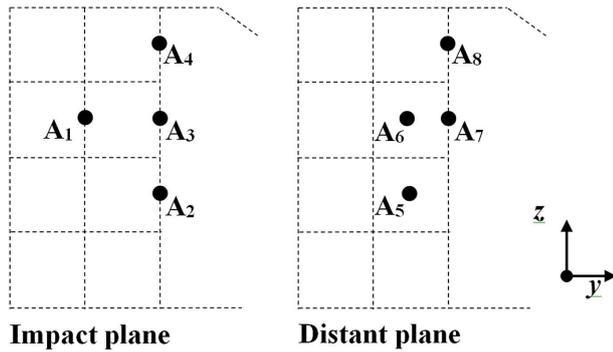
Figure 4. Accelerometers considered in this study.

Accelerometers placed within and on the structure allow monitoring of the compression wave propagation and soil particle displacement. The piezo-resistive technology was preferred to other accelerometer technologies based on previous impact experiments involving smaller impact energies on a smaller structure (Haza-Rozier et al., 2010; Heymann et al., 2010). In the impact plane, eight different points within the structure are equipped: six accelerometers at the same locations as the displacement sensor extremities and two others in the middle of the kernel, 0.5 and 4 m above the ground. In the distant plane, accelerometers are positioned at five different points, in the middle of the kernel and at the kernel–levee interface. Depending on the expected displacement of the point considered, acceleration is measured in one, two or three directions. A total of eleven acceleration measurements concern the impact plane and nine concern the distant plane. For this purpose, a uni-axial accelerometer (measuring range ± 200 g, bandwidth 0–1.5 kHz) and a tri-axial accelerometer (measuring range ± 100 g, bandwidth 0–1 kHz) are used. Accelerometers are placed on PVC supports and protected from impact by a cap. The supports are fixed to the gabion mesh. The locations of the accelerometers considered in this study are shown in Fig. 4. Data is referred to using the accelerometer number (nos. 1–4 and nos. 5–8 in the impact plane and distant plane, respectively) and the measurement direction with respect to the global system of axes shown in Fig. 4.

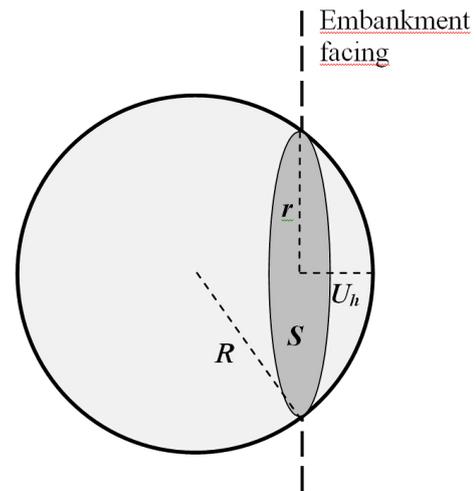
Figure 5. Definition of the contact surface between the projectile and the embankment.

The so-called impact force is derived from the projectile deceleration using Newton’s second law. In order to compute a stress from this force, the surface considered is the interception between the embankment facing plane and the projectile (Fig. 5). The area of this surface is given by

$$S(t) = \pi \cdot r^2 \quad \text{with} \quad r = \sqrt{2 \cdot R \cdot U_h(t) - U_h(t)^2}, \tag{2}$$

with R the radius of the projectile and $U_h(t)$ its penetration in the embankment. This area represents the projection of the real facing–projectile contact surface on the surface normal to the penetration direction. It is thought to be the most relevant for computing a stress value based on the force acting on the projectile (i.e. the impact force).

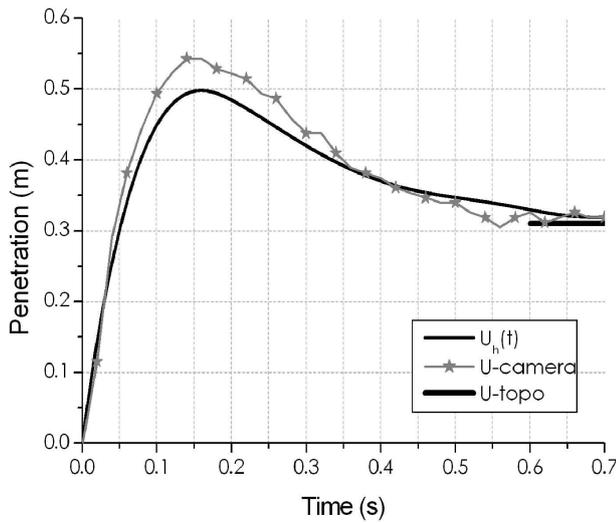
Figure 6. Comparison of the different penetration estimates (210 kJ impact test).

The penetration derived from acceleration measurements fitted rather well with measurements from other methods (Fig. 6). A rather good agreement with displacement derived

from the high-speed camera images was observed during impact ($U_h(t)$ vs. U -camera), as well as with the final indentation measured with topographical survey ($U_h(t)$ vs. U -topo). The accelerometer tended to slightly overestimate the acceleration, because penetration derived from this measurement was less than with the camera. The agreement concerning the maximum penetration values was considered good because the difference was about 10 %.

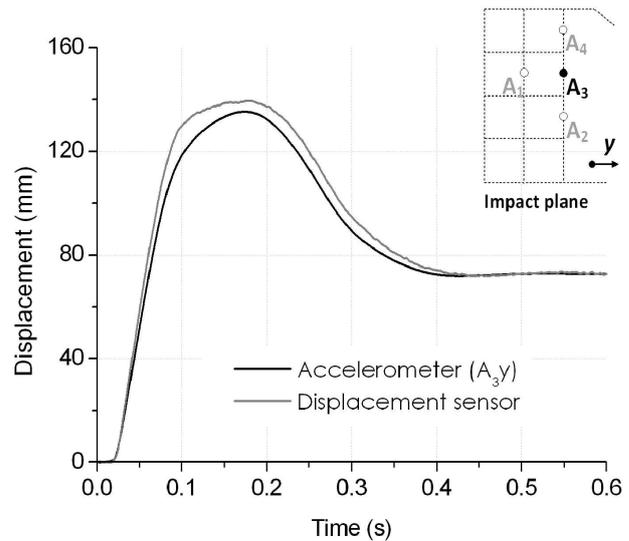
Figure 7. Comparison of the horizontal displacement 3.5 m from the ground at the kernel–levee interface, based on accelerometer and displacement sensor data (2200 kJ impact test).

In a similar way, displacements within the embankment derived from accelerometer measurements were in rather good agreement with data from displacement sensors (e.g. Fig. 7). The difference was most often less than 10 %.

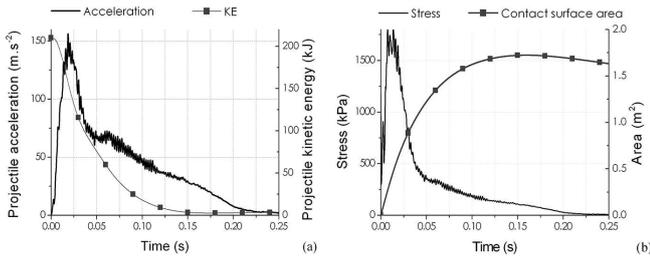
Figure 8. (a) Acceleration and kinetic energy of the projectile and (b) projectile/embankment contact surface and stress at the structure's front face during the 210 kJ impact test.

The impact of the projectile on the structure facing was characterised by a triangular and non-symmetrical projectile acceleration, with a peak value of 150 m s^{-2} (Fig. 8a). This maximum was reached 20 ms after the impact beginning and corresponds to an impact force of about 1000 kN. The total impact duration was about 200 ms. The projectile kinetic energy rapidly decreased: it was less than half its initial value 40 ms after the impact beginning. Comparison with displacements depicted in Fig. 6 shows that the penetration at the acceleration peak time was 0.15 m and that the maximum penetration was reached long after this acceleration peak (150 ms vs. 20 ms respectively).

The contact surface between the projectile and the structure facing increased with the projectile penetration (Fig. 8b) and the stress curve exhibited differences with the projectile acceleration curve: a steeper increase (7 ms), a well-marked quasi plateau for almost 8 ms followed by a sharp decrease until 40 ms. The maximum stress reached exceeded 1500 kPa, enough to generate stone crushing as locally observed after the test.

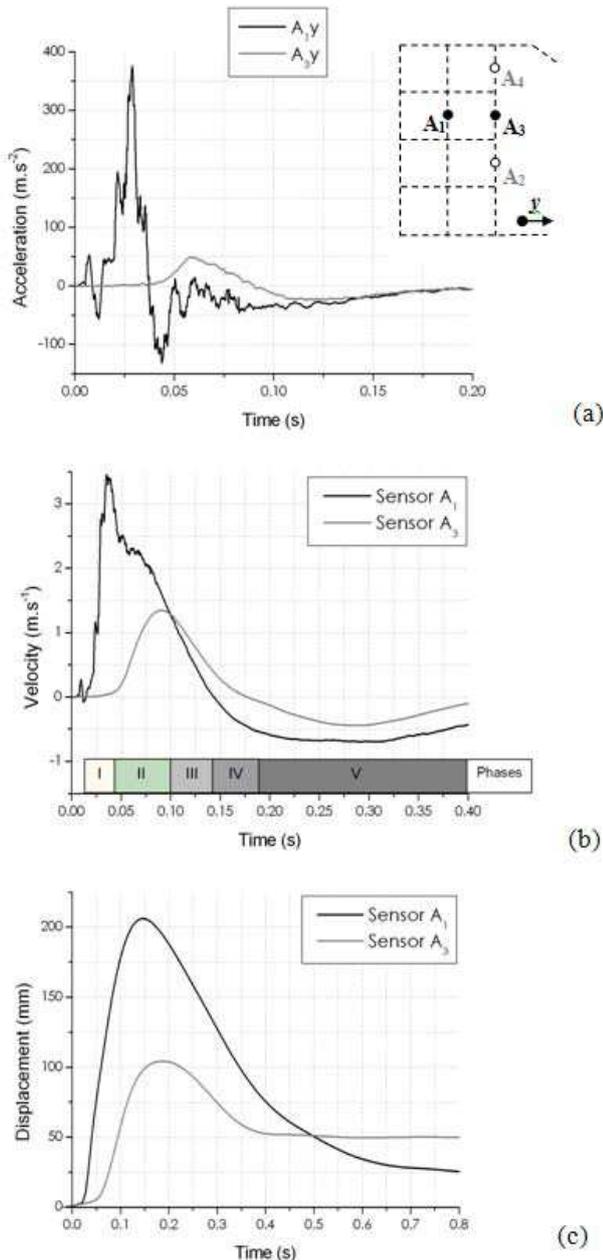
Figure 9. Time evolution of acceleration, velocity and displacement along the y axis direction at the front–kernel interface (A_5) and at the kernel–levee interface (A_6) in the impact plane.

The structure's response to this loading is investigated in detail by using measurements from sensors within the embankment. Figure 9 shows acceleration, velocity and displacement along the y axis direction of two points close to the impact axis direction, namely A_1 and A_3 located 2.5 m from the ground at the front–kernel and kernel–levee interfaces, respectively. Between the two acceleration peaks, a time lag of about 30 ms was observed together with an amplitude reduction by a factor of 8.

Five different phases can be distinguished considering the three graphs plotted in Fig. 9. Phase I corresponds to a compression phase of the kernel. It lasts from 20 to 40 ms and follows the stress plateau observed in Fig. 8. During this phase, the first interface (i.e. A_1) experiences a rapid acceleration, contrary to the second interface (i.e. A_3). This difference in acceleration results in a difference in velocity and displacement (Fig. 9b, c). Phase II starts from the time the second interface begins moving (40 ms). From this time, the kernel is shifted progressively in the impact direction. Compression still develops due to the difference in velocity between the two interfaces. The maximal kernel thickness reduction is 120 mm, reached at the end of this phase (100 ms). During the next phase (III, 100–145 ms), both velocities decrease but the kernel progressively expands due to the difference in interface velocity. This expansion lasts until the end of the impact. During phase IV (145–175 ms), the two interfaces move in opposite directions. Finally, in the last phase (V) both velocities are negative, revealing a global kernel displacement in the direction opposite the impact direction (Fig. 9c).

At the end of the impact, the kernel almost returns to its initial position with a thickness increased by about 25 mm. By contrast, comparison of the projectile's penetration curve with the displacement curve of sensor A_1 reveals that the

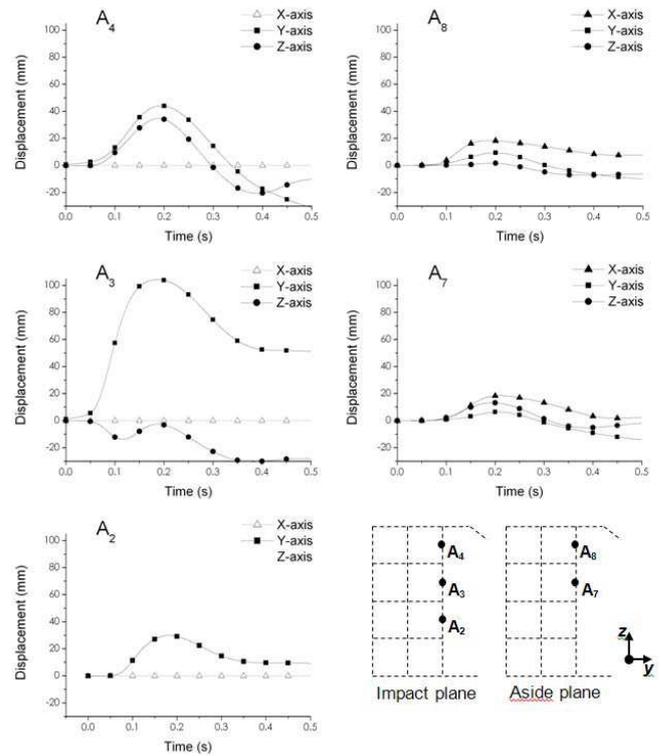
Figure 10. Displacement of the five sensors placed at the kernel–levee interface: A_2 , A_3 , and A_4 in the impact plane, A_7 and A_8 in the distant plane. Open symbol curves display assumed values.

The rather high displacement of point A_3 likely results from the fact that the levee soil was poorly compacted close to the kernel, as mentioned above. Nevertheless, displacements at the kernel–levee interface rapidly decrease with the distance from the impact axis direction (Fig. 10). The

maximal displacement along the y axis direction 1 m above and 1 m below A_3 in the impact plane does not exceed 44 and 30 mm, respectively (sensors A_4 and A_2). In the distant plane, the maximal displacement is less than 10 mm (sensors A_7 and A_8).

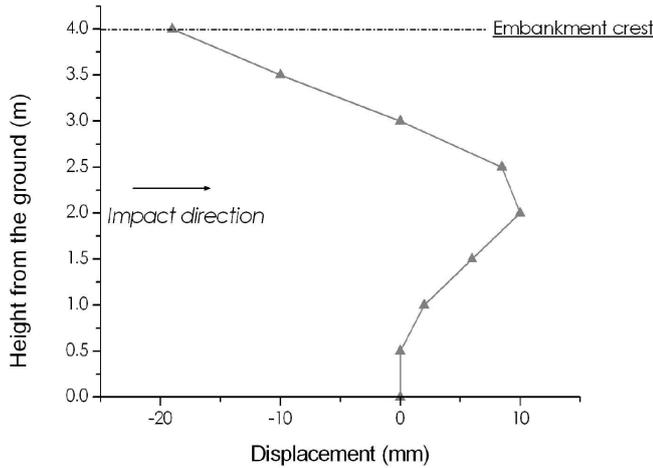
Figure 11. Displacements measured with the inclinometer within the levee, 0.50 m from the kernel–levee interface.

The residual displacements along the y axis are negative for sensors A_4 , A_7 and A_8 , suggesting that the structure moves globally opposite to the impact direction. This displacement is more pronounced close to the crest (e.g. A_4 vs. A_2). The same trend was observed within the levee above a height of 3 m from the ground (Fig. 11).

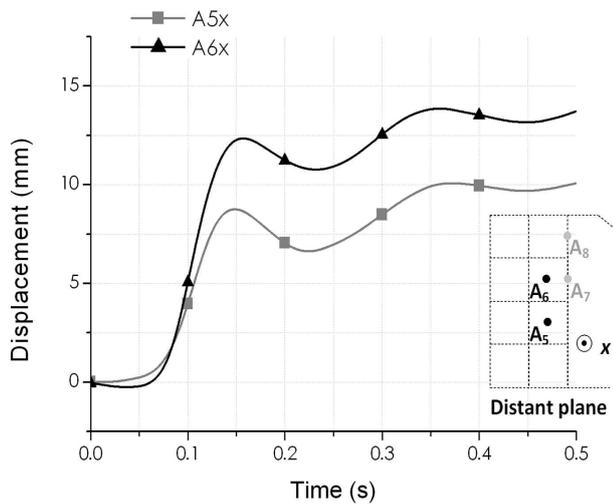
Figure 12. Displacements in the middle of the kernel, in the distant plane, along the x axis.

Similarly to what is observed for sensors A_7 and A_8 in the distant plane at the kernel–levee interface, sensors placed in the middle of the kernel in this same plane exhibit a significant residual displacement along the x axis (Fig. 12). Considering the position of these sensors with respect to the impact

point, this displacement is believed to result partly from the lateral expansion of the kernel in the impact axis direction, which undergoes compression along the y axis. The residual displacement along the x axis of A_7 is smaller than that of A_6 , both positioned 3.5 m from the ground (3 mm / 14 mm). This is attributed to the geocell wire netting along the kernel–levee interface that counters the displacement after the load peak (sensor A_7).

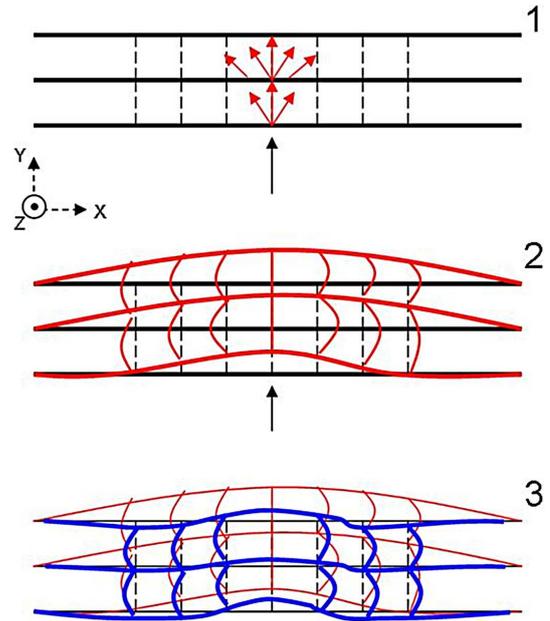
Figure 13. Schematic representation of the deformation of the sandwich wall at the impact height (2 m above the ground): (1) beginning of impact, (2) maximum deformation stage, (3) residual deformation.

Based on these measurements, a schematic analysis of displacements observed at the impact height (2 m above ground) over time can be proposed (Fig. 13). The second stage typically corresponds to the maximum projectile penetration. Each geocell deforms along the two directions, with compression in the impact direction (y axis) and dilation in the tangential direction (x axis). The latter mechanism is partly countered by the internal connecting wires and by the wire

netting at the vertical interfaces between the different layers. The deformation of the front facing does not concern the only impacted area. On the contrary, geocells around this area seem to be driven in the impact direction. This effect is attributed to the wire netting on the front facing that distributes the load to soil masses at a distance on both sides of the impacted area. As a consequence, the mass involved in the structure’s response is increased and the stress diffusion angle is also expected to be higher. Both these mechanisms have a beneficial effect on the structure’s ability to withstand the impact. The third stage corresponds to the global structure reverse displacement. This mechanism is mainly attributed to the elasticity of the sand–tyre mixture (Lambert et al., 2009).

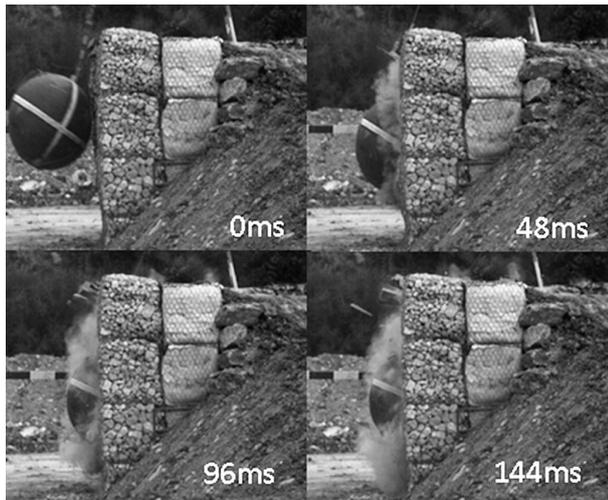
Figure 14. High-speed camera images during the fourth-impact test (2200 kJ).

The damage to the structure as well as the penetration increased with increasing projectile kinetic energy. As the structure arrested the projectile without collapsing, it can be considered that the maximum impact energy used in the tests remains below the nominal capacity of the structure (Fig. 14).

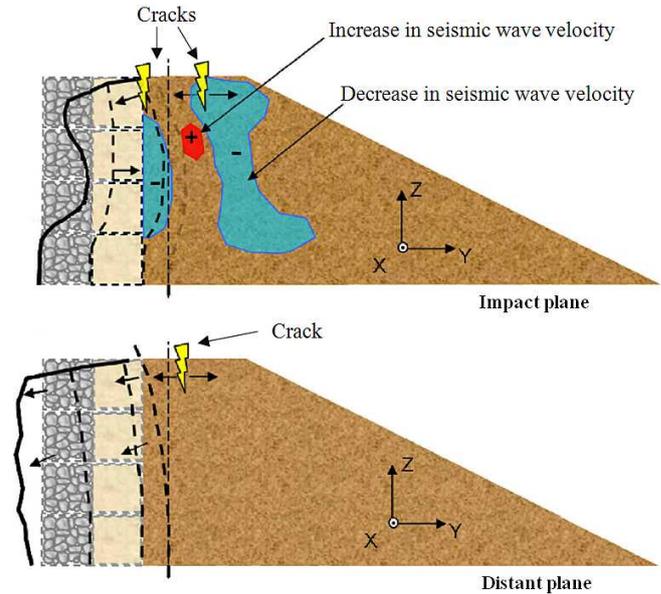
Figure 15. After the fourth impact, the sandwich wall exhibited a different deformation pattern from one plane to the other. Cracks, compaction and bulking were observed in the levee.

After the fourth test, the structure exhibited different deformation patterns depending on the plane: compression in the impact plane and bending in the distant plane (Fig. 15). Cracks parallel to the kernel–levee interface were observed on the embankment crest between the kernel and the levee as well as about 1 m from this interface. Levee soil density

changes were observed: bulking close to the kernel–levee interface as well as at a distance typically 2 m from this interface and compaction about 0.9 m from the interface, at a depth of 1–2 m from the crest.

of the kernel–levee interface, i.e. in the direction opposite to the impact direction, was 70 mm (test 4). This may result from the kernel layer elasticity rather than from real soil levee displacement. The sensor was connected to the wire netting whose reverse displacement led to a void between the geocell and the levee (cracks, see Fig. 15).

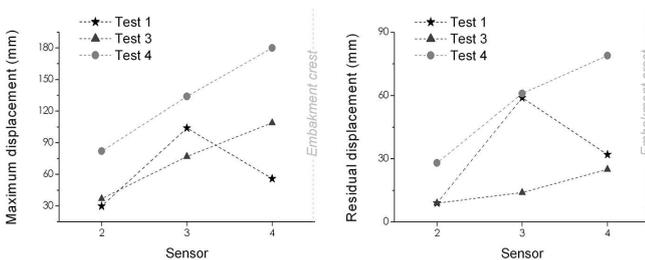
**Figure 16.** Maximum and residual incremental displacements at the kernel–levee interface in the impact plane after each impact (sensors A_2 , A_3 and A_4).

The incremental displacement of sensors in the impact plane during impact tests 1, 3 and 4 is depicted in Fig. 16. The displacements strongly depend on the point considered and on the impact test. In the case of sensor 3, the deformation localisation observed after test 1 vanished for the other tests. For sensors 2 and 4, respectively above and below the impact height, a clear increase trend from the first to the last test was observed for both the maximum and residual displacement values. This trend mainly results from the displacement along the y axis, this value predominating over the two other components. By contrast, the upward displacement increased during the test series and depends on the position of the sensor. At maximum, sensor A_4 moved by 160 and 80 mm along the y axis and z axis, respectively, during the last test.

The results reveal globally a change in the structure's response: while the first impact shows strain concentration, the two other impacts reveal a tilting movement on the whole structure, with higher amplitude close to the crest.

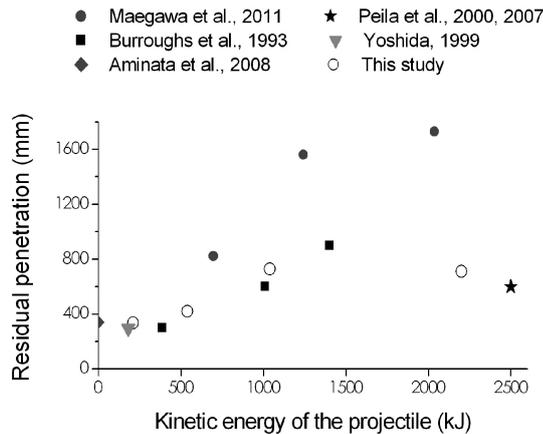
Figure 17. Penetration measured after impact on different real-scale structures.

and Maegawa et al. (2011) is considered. The considered experiments investigated an impact by a single projectile with a kinetic energy in the 50–2500 kJ range at approximately the structure’s mid-height. The criterion for comparison is the residual projectile penetration, since it is the only data recorded in all cases (Table 3, Fig. 17).
