Experimental study of the brittle-ductile transition in hot cutting of SG iron specimens

Experimental study of the brittle–ductile transition in hot cutting of SG iron specimens

The present paper investigates the brittle-ductile transition (BDT) of the primary shear zone during cutting of spheroidal graphite (SG) iron in the austenitization temperature range (around 1000 °C). The experimental tests were performed using a cutting test bench in the cutting speed range of 0.8 to 1.6m.s⁻¹. The cut surfaces were studied using optical microscopy and Scanning Electron Microscope (SEM) analysis techniques. The obtained results revealed either consequent deep fractured regions governed by a brittle-cracking regime (BCR) or a crack-free cut surface governed by a ductile-shear regime (DSR) with large plastic deformations.

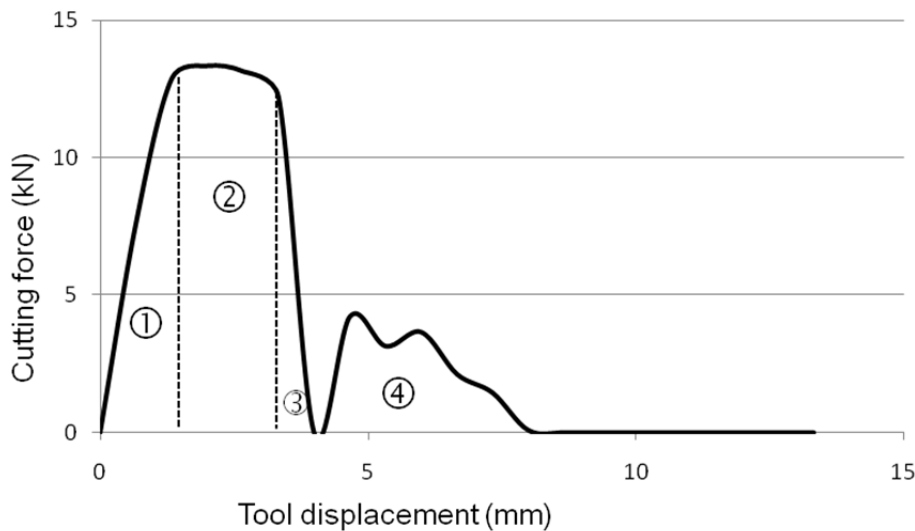
Figure 15. Typical cutting force-displacement curve for ductile-shear regime. [$1.3 \text{ m}\cdot\text{s}^{-1}$ -10° specimen i.e. Cutting speed = $1.3 \text{ m}\cdot\text{s}^{-1}$; rake angle = -10° ; $h = 15\text{mm}$ and $\phi = 10\text{mm}$].

- Stage ① corresponds to an elastic behavior of the material under the tool solicitation;
- Stage ② corresponds to the material plastic deformation by ductile shear. The cutting force rises to a plateau for a more or less short tool displacement according to the cutting speed tested (Fouilland and El Mansori, 2010);
- At the stage ③, the “Chip-pin” is broken free from the specimen along a shear plan. The cutting force falls suddenly to zero;
- Stage ④ reveals the shaping of the remaining excess metal with small thickness.

The existence of a fractured area within the cut surface is now directly related to the brittle behavior (BCR) without any plastic deformation stage identified from the force-displacement curve. On the contrary, a crack-free cut surface is associated to the ductile regime (DSR) with a large ductile deformation stage by shear (stage ② on figure 15).

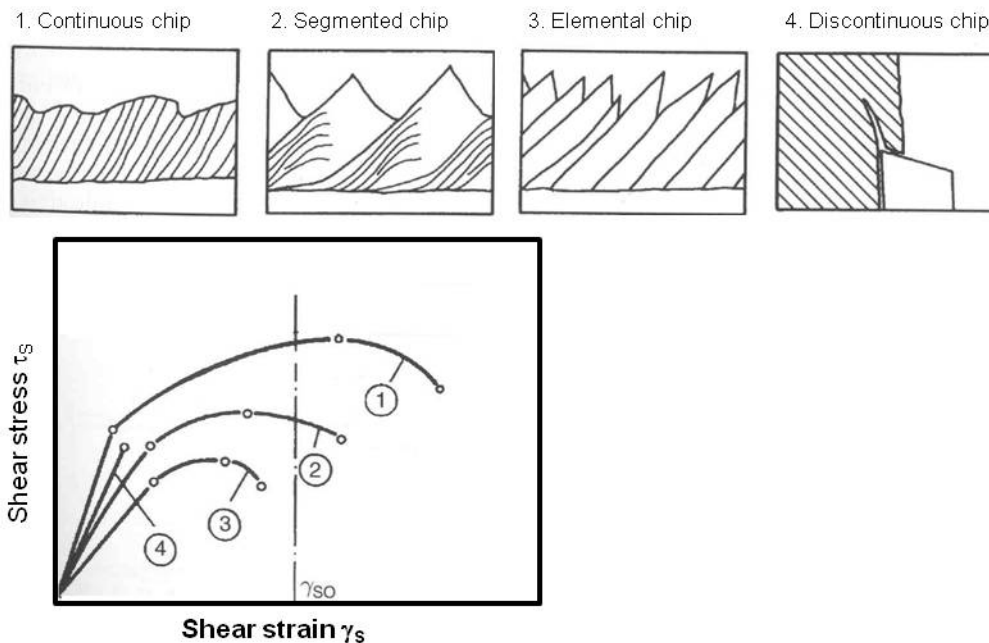
Figure 18. Chip formation mechanisms in terms of stress/strain curves [Grzesik (2008)].

Discontinuous chips are formed when machining brittle materials or materials containing point of stress concentration. Fracture occurs when material undergoes only elastic deformation (curve 4) and a crack propagates from the cutting edge to the free surface. When materials have sufficient

ductility, the formation of a continuous or a segmented (also called saw-tooth) chip takes place, which generally results in a good surface finish. Continuous chips are related to curve 1 with large plastic flow of the material and characteristic neck of a tensile specimen developed after the critical value of shear strain γ_{SO} . If the plastic flow is not so intensive and shear strain exceeds slightly γ_{SO} , the onset of chip segmentation is observed (partially segmented chip vs curve 2). During rapid plastic deformation (as speed increases), the chip segmentation starts to develop until complete separation (elemental chip vs curve 3). In this case, the material necks before fracture but at relatively lower shear stress. It should be noted that all three latter types of chips are formed by shearing mechanisms and are related to the plastic deformation of ductile work materials.

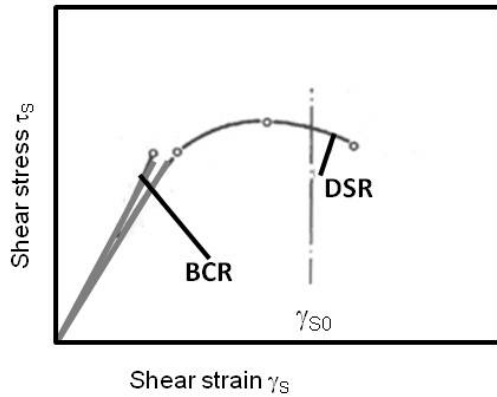
Figure 19. Chip-pin formation mechanisms in terms of stress/strain curves (BCR=Brittle Cracking Regime, DSR=Ductile Shear Regime).

In the present study, when the strain softening resulting from dynamic recrystallization is more pronounced than the associated strain-hardening, a ductile shear regime (DSR) takes place (figure 19 vs curve DSR) and the pin element is completely sheared (ductile sheared chip-pin in figure 19) following a flat shear surface in analogy with the segmented chip formation mechanism. The discontinuous chip formation mechanism described by Grzesik (2008) may also aid the brittle cracked chip-pin mechanism comprehension (figure 19 vs curve BCR) when the pin fracture occurs without any plastic deformation.
