## Multi-scale analysis of water alteration on the rockslope stability framework

Sandra Dochez, F. Laouafa, Christian Franck, Sylvine Guédon, François Martineau, Julie d'Amato, Albane Saintenoy

Sandra Dochez, F. Laouafa, Christian Franck, Sylvine Guédon, François Martineau, et al.. Multi-scale analysis of water alteration on the rockslope stability framework. *Acta Geophysica*, 2014, 62 (5), pp.1025-1048. 10.2478/s11600-014-0232-7. hal-01071277

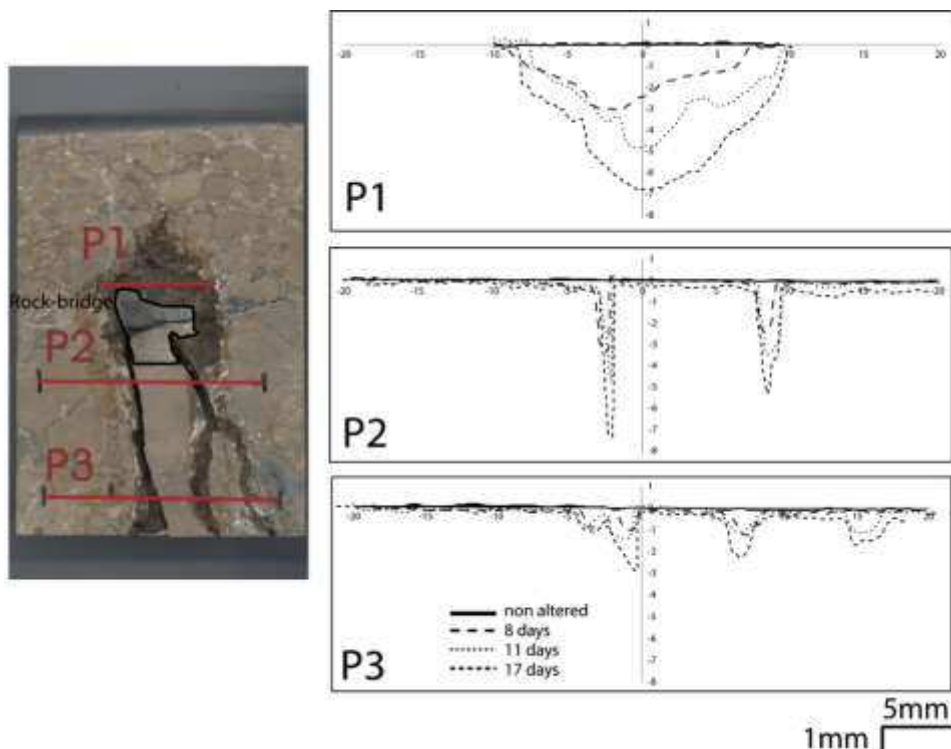
**Figure 16: Montagnole sample after acidic water runoff, line P1, P2, P3 represent the place we take the profile by laser (left). These graphs represent the 3 profiles done by laser, the different curves show the evolution of the “topography” of the sample surface during alteration period (right)**

We performed other laser profiles (Figure 16). Profile P1 was taken above the bridge then profile P2 just under the bridge, and the third P3 was measured on the below far from the bridge (Figure 16). These profiles were made at initial state, after 8 days of runoff, 11 days and at final state (17 days). Profile P1 is made near the place where the drop fell. It shows a digging which increases significantly over time. Profiles under the

bridge show two diggings (P2) then three (P3). These paths followed small fractures. These ones indicates preferential path of water circulation (P2 and P3).

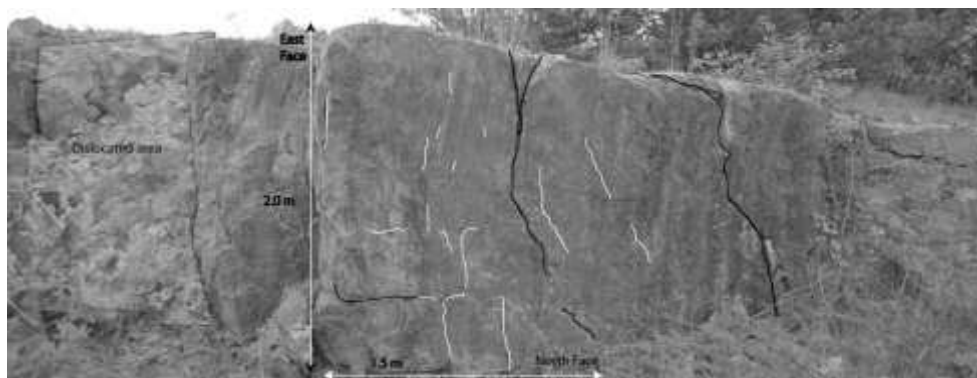
**Figure 17: View of the rock mass, it presents a dislocated area on the left, and major discontinuities are in black and superficial are in white.**

The site is located in Montagnole near Chambéry (73) in France. The block is a triangle shaped dihedral with fractures and it is apparently ready to fall (Figure 17). This work aims to evaluate the potential of Ground Penetrating Radar (GPR) measurements to find and estimate the quantity of rock bridges into a block with a discontinuity.

The first observation in situ reveals many discontinuities; the major ones represented in black on Figure 17 are those where we suppose there are rock bridges to maintain the stability of the rock mass. The white ones appear to be just on the surface but they are important for the surface degradation. The GPR reveals the possibility to identify the surface discontinuity (Figure 19). As a matter of fact radar-gram present some weirdness, these ones are the proofs of different environment as air or rock mass. These are analyzed and after a treatment, a 3D view of the discontinuity surface could be made as Figure 20 shows.
