High temperature behaviour of polypropylene fibres reinforced mortars

Mohammed Ezziane, Tahar Kadri, Laurent Molez, Raoul Jauberthie, Ali Belhacen

Mohammed Ezziane, Tahar Kadri, Laurent Molez, Raoul Jauberthie, Ali Belhacen. High temperature behaviour of polypropylene fibres reinforced mortars. *Fire Safety Journal*, 2015, 71, pp.324-331. 10.1016/j.firesaf.2014.11.022 . hal-01096150

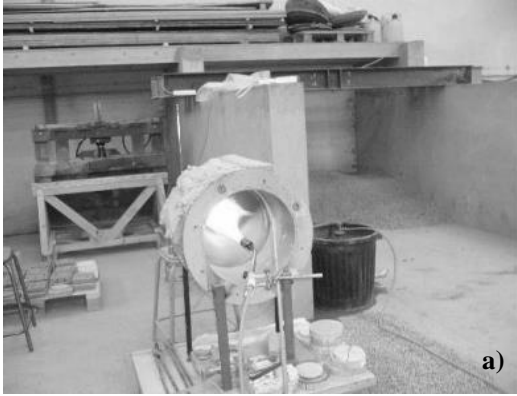
Figure 8: a) mounting flame test, b) drilled external face, c) thermocouples position.

181 The second heat treatment consists of placing plates of dimensions $16 \times 16 \times 4 \text{ cm}^3$ made of unreinforced
182 mortar and polypropylene fibre reinforced mortar in a flame test apparatus (figure 8a). Five
183 thermocouples were inserted in the plate (figure 8b) at different depth and two other thermocouples were
184 positioned in contact with the internal face (hot face) and external face (cold face) (figure 8c). The
185 temperature of the exposed face (dimensions $16 \times 16 \text{ cm}^2$) is forced to 1000°C and was maintained for one
186 hour. Figure 9 compares the rate of temperature between the experimental curve and the ISO 834 standard
187 fire. The experimental rate of temperature is similar to that of ISO 834 up to 1000°C . This rate leads to a
188 strong temperature gradient in the sample. The sample dimensions are assumed to be enough to observe
189 spalling.

190 The heat flux is assumed to be unidirectional. The flame position allows setting in a precise manner the
191 temperature of the surface.

197 - First series (equipped with 7 thermocouples (type K)): the evolution of the temperature of this series is
198 obtained by placing thermocouples (drilled after casting) at different depths of the sample (external face –
199 1 cm – 1.5 cm – 2 cm – 2.5 cm – 3 cm, and the internal side) as illustrated in figure 8c.

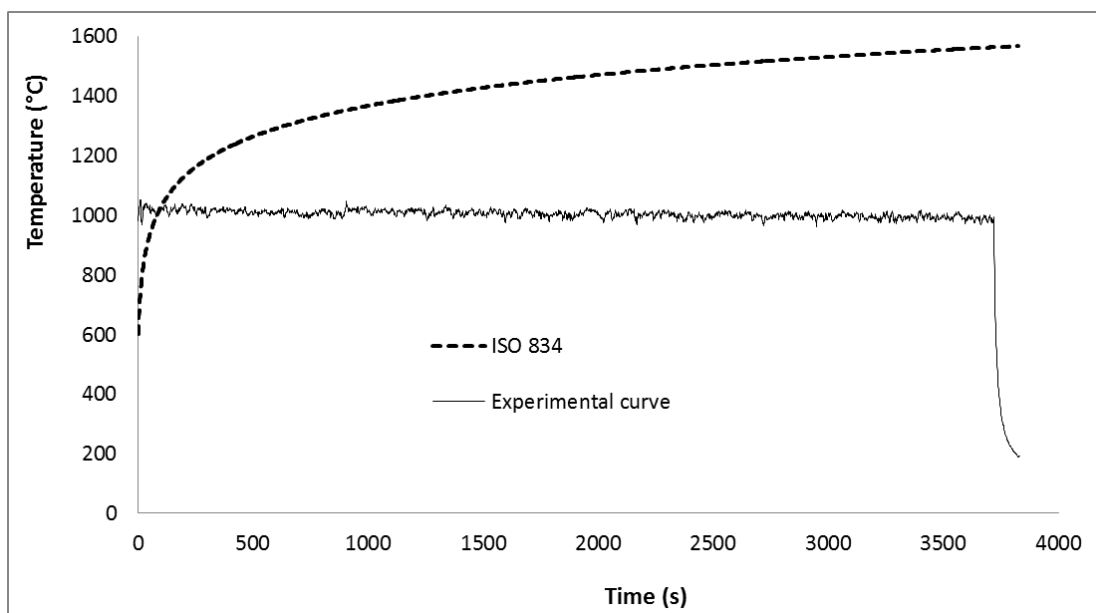
207 **Figure 9:** Comparison between ISO 834 fire and the experimental curve.

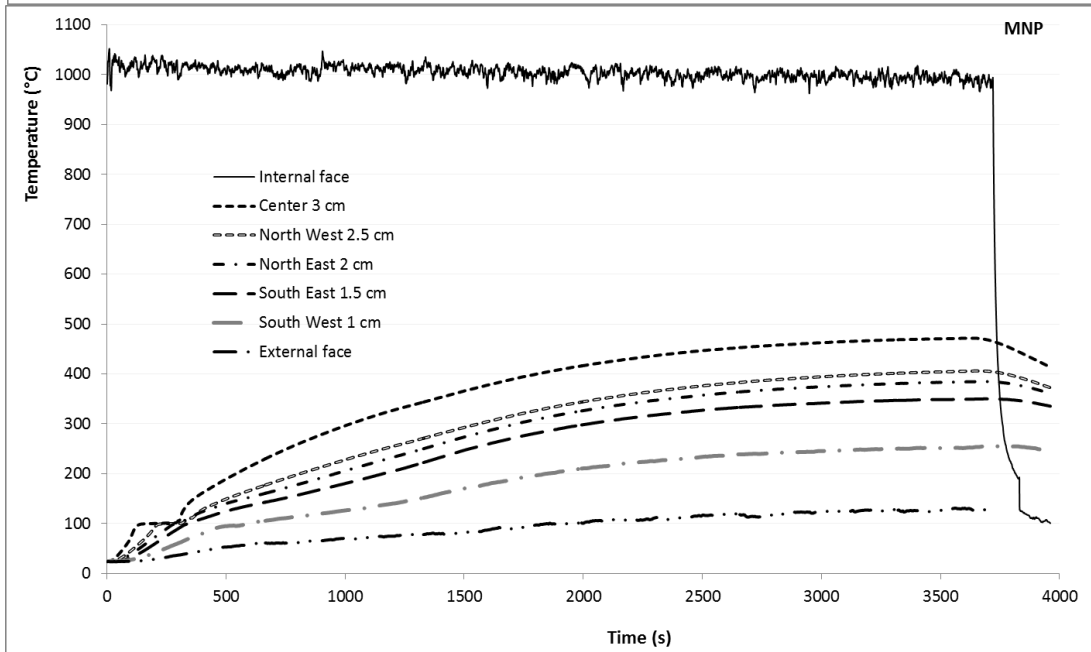
Figure 10: Evolution of the temperature at different depths of the non-fibre mortar and fibre mortar.

216 Figure 10 shows the evolution of the temperature of both mortars with respect of time and depth. The
217 temperature evolution consists of three stages: a rapid increase of the temperature until 100°C, an
218 isothermal stage around 100°C and an increase of the temperature. The isothermal stage around 100°C
219 corresponds to the evaporation of free water at different depths. Mindeguia et al., [8] observed this
220 plateau at 100°C for low compactness concrete.
