Fatigue of swollen elastomers

Mei Sze Loo, Jean-Benoit Le Cam, Andri Andriyana, Eric Robin, Amalina Muhammad Afifi

Mei Sze Loo, Jean-Benoit Le Cam, Andri Andriyana, Eric Robin, Amalina Muhammad Afifi. Fatigue of swollen elastomers. International Journal of Fatigue, 2015, 74, pp.132-141. 10.1016/j.ijfatigue.2014.11.015 . hal-01148178

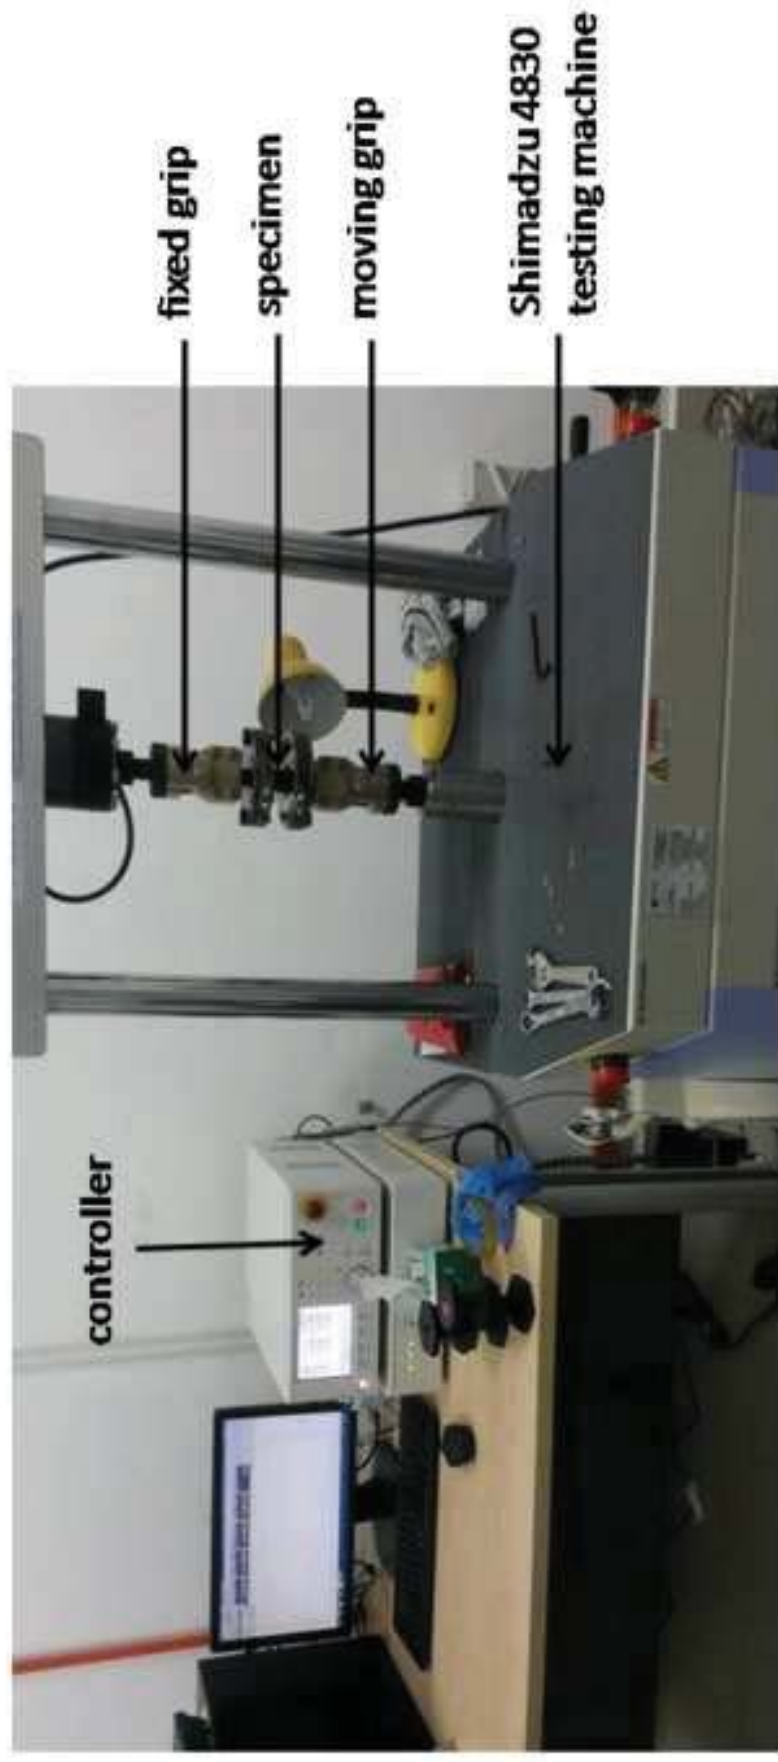
to a hollow-diabolo having a height, outer diameter, and wall thickness of 55 mm, 25 mm, and 6 mm, respectively. The detailed features of the specimen and chemical compositions of the palm biodiesel (B100) used in the study are provided in Figure 1 and Table 1.

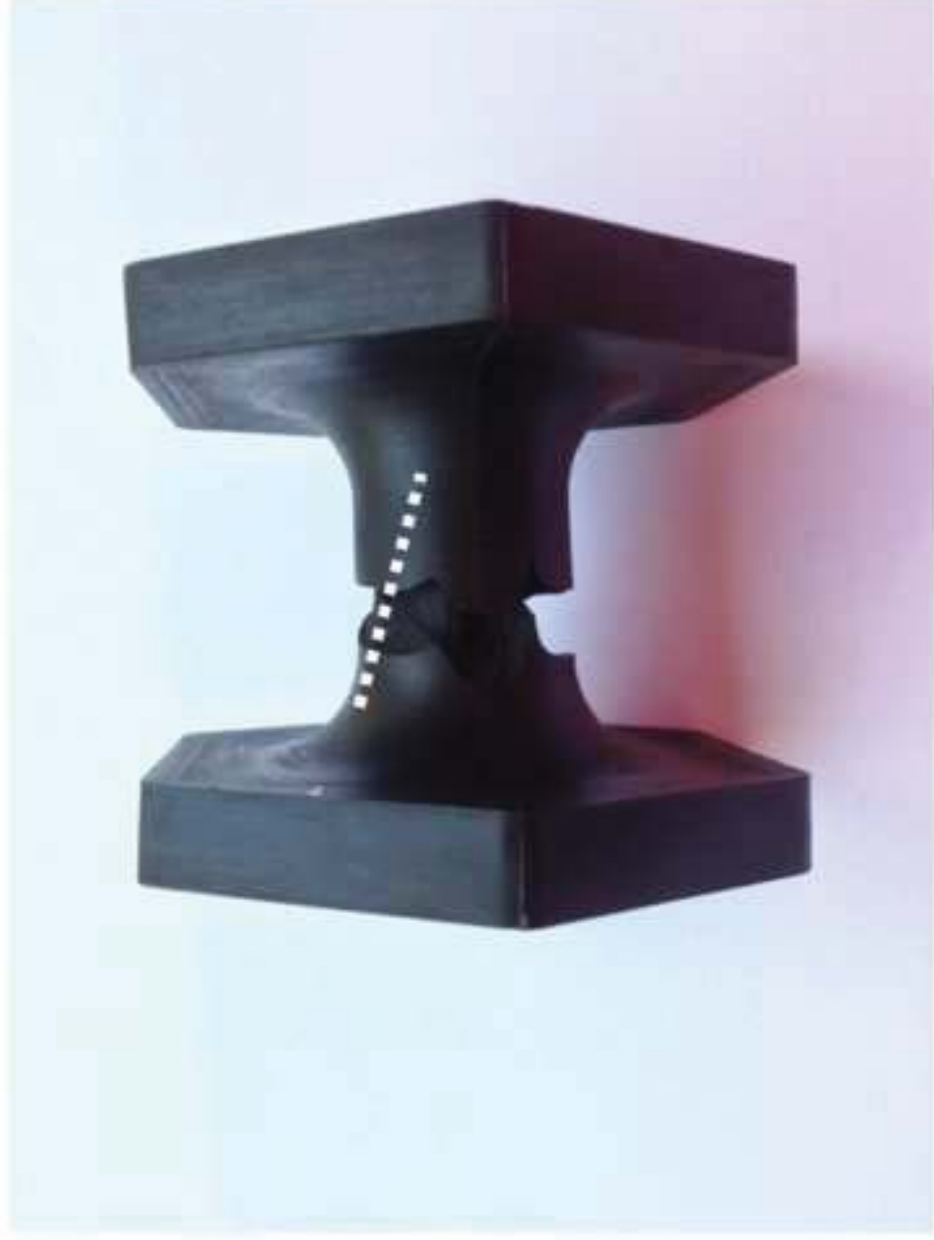
An overall feature of the ruptured specimen due to fatigue is illustrated in Figure 8. A white dashed line was marked on the specimen to illustrate the crack propagation plane. For this case, the crack propagation plane was not perpendicular to the imposed uniaxial loading. This was not expected in such non-crystallisable rubbers (see the reported work of Le Cam et al. (2014)). It seems to indicate that the hollow geometry had an effect on the mechanical

field at the local scale and especially in the crack tip vicinity. Moreover, crack initiation at the macroscopic scale was observed at the specimen surface. Further investigations have been carried out at the microscopic scale in order to define the precise location of crack initiation.

Finally, observations at the macro and microscopic scales have shown that cracks initiated at the specimen surfaces. As crack initiation at the macroscopic scale is often described as the result of crack propagation at the microscopic scale, typically from a site in the subsurface zone, it can be speculated if the propagation at the microscopic scale exists for the present case. This could indicate that crack initiation predictors based on the growth of an initial defect might not offer the most suitable approach. Hence, this result creates another opportunity for researchers to further investigate determination of an appropriate fatigue life predictor for swollen rubbers. The crack propagated in a plane which was not perpendicular to the loading direction
