Surface integrity after pickling and anodization of Ti–6Al–4V titanium alloy

A B S T R A C T

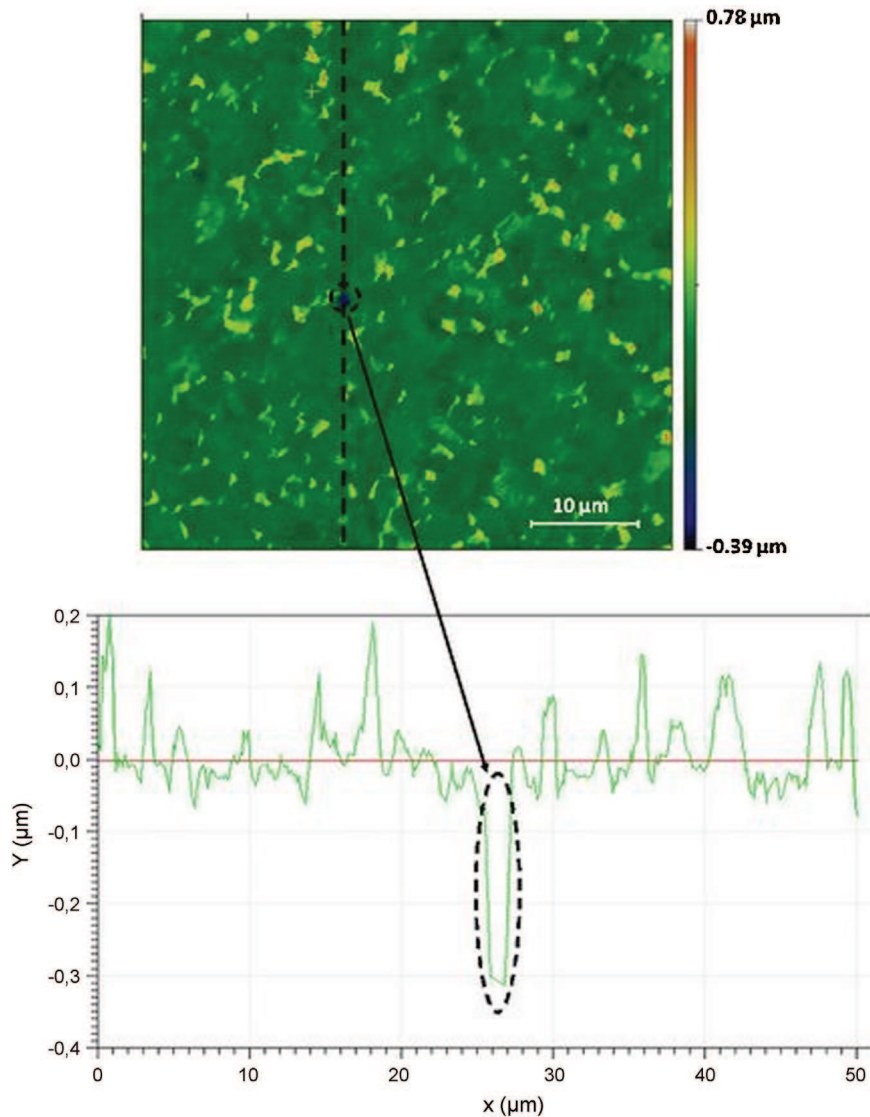
Fig. 6. SPM surface mapping and profile of polished then pickled sample ($\text{HNO}_3\text{-HF}$ (20–2 w%) solution, 20 °C, 200 s) showing a pit.

Thirdly, another way to increase roughness is pitting. However, Fig. 6 shows that pits were local and less than $1 \mu\text{m}$ in diameter, and the pit density was evaluated at about one pit for $200 \mu\text{m}^2$. Pits can be found at the grain boundaries, i.e. the interface between α and β phases, or also in the middle of α grains. SPM analysis revealed pit depth of about 400 nm (Fig. 6). So, preferential chemical dissolution and pitting phenomena resulting from the pickling step induced faults (respectively about 800 and 400 nm) lower than the roll roughness ($R_z = 2.70 \mu\text{m}$ in Table 1). Both these types of defaults could explain the roughness changes ($R_z = 0.58 \mu\text{m}$ in Table 1) in polished substrate.

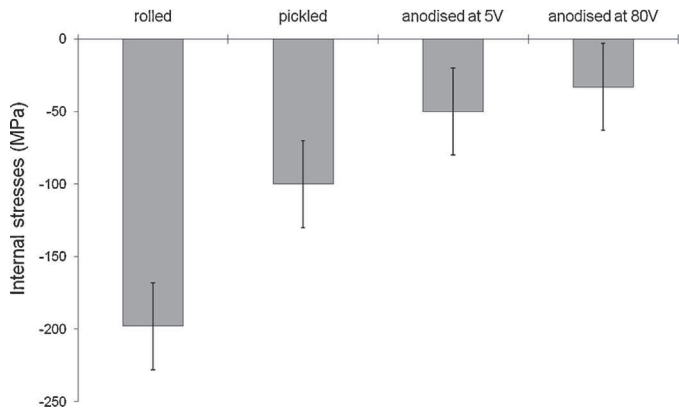
Fig. 9. Evolution of internal stresses obtained on four rolled samples after different surface treatments: rolled, rolled then pickled (HNO_3 -HF (20-2 w%) solution, 20 °C, 200 s), rolled then pickled and finally anodized at 5 V (1 M H_2SO_4 , 20 °C, 2 min) and a rolled then pickled and finally anodized at 80 V (1 M H_2SO_4 , 20 °C, 2 min).

Rolled sheets showed initial compressive internal stresses (-198 ± 50 MPa) in the laminate direction (Fig. 9) in agreement with Abdelkhalek et al. [60]. Then the pickling step halved the internal stresses (-100 ± 50 MPa). Knowing that in this case the pickling removed about 3 μm thickness from the outer surface suggests that the internal stresses were mainly located at the outer surface and that a stress gradient could be located in the first microns

of depth. Moreover, stress is seen to result from anodization, for the thinnest (16 nm at 5 V) and thickest (195 nm at 80 V) films, i.e. -50 ± 40 MPa and -39 ± 35 MPa respectively Fig. 9; the values can be considered as similar, and were clearly lower than the previous ones obtained after pickling (-100 ± 50 MPa). Moreover, the anodic film was mainly amorphous and consequently did not contribute to the XRD analysis. So, the measured remaining compressive stresses were probably located at the metal/oxide interface, in agreement with the mechanism proposed by Nelson and Oriani [31]. They explain that the anodization induces additional tensile stress (up to 50 MPa) due to vacancies generated by the formation and the migration of titanium ions at the metal/oxide interface. Such compressive stresses, detected at each step of the surface treatments (especially pickling and anodization) could clearly have a detrimental effect on the fatigue resistance [25,61,62].
