Experimental study of impact energy absorption by reinforced braided composite structures: dynamic crushing tests

O. Dorival^a, P. Navarro^a, S. Marguet^a, C. Petiot^b, M. Bermudez^b, D. Mesnagé^b, J.-F. Ferrero^a

Abstract

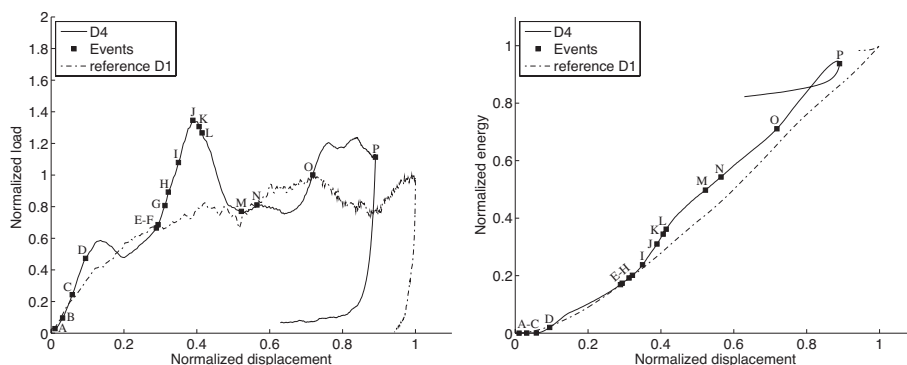
Figure 16: (left): Load-displacement plots and (right): energy-displacement plot for D4 design.

Note that in case of catastrophic crushing events for design D4, the concept is deteriorated in such a way that the sample works in a wrong manner very prematurely (after marks **G-H** in Fig. 16). Indeed the stiffness of the design suddenly drops down due to large cracks appearing in the foam, and consequently after the catastrophic crushing occurs, the energy is dissipated in a wrong and rather chaotic manner, what falsifies the interpretation of the area under the load-displacement plot. For that reason the values for design D4 were taken at the time when the catastrophic crushing occurred (at mark **H** in Fig. 16). The reason for this is to avoid erroneous interpretation of the potential of design D4 compared to other designs.

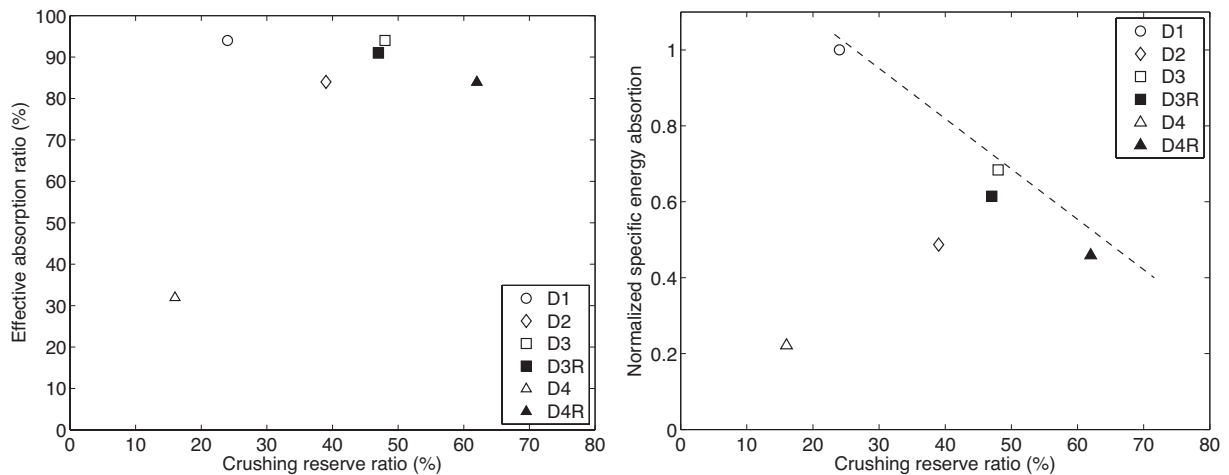
Figure 20: (left): Absorption ratio versus crushing reserve plot, and (right): Specific energy absorption versus crushing reserve plot.

The previous analysis shows that improvements of the simple reference design D1 require to take some specific decision in term of design. It looks necessary to retain or to delay the global bending of the outer fabric in order to improve the crushing force, but also to avoid long cracks in the foam that lead to early catastrophic deterioration of the design. This can be done either by an additional wall that holds the fabric, or by discrete reinforcements such as stitches or sewing. Such reinforcements can be of high interest in terms of energy dissipation and concept consumption, as shown by design D4R. However any type of reinforcements obviously decreases the specific energy ratio. Fig. 20 illustrate the performances of the designs. Choosing to reinforce or not requires referring to precise specifications. Especially Fig. 20-right tends to show that the choice is a question of compromise between the crushing reserve and the specific energy absorption, figured by the dotted line. However following the idea of reinforcing the reference design D1, it would be very interesting to study the influence of the size/number/material of such reinforcements in order to optimize the designs. Such optimization could drastically improve the specific energy absorption of the reinforced designs without decreasing the crushing reserve, what would result in ideal shock absorbers.
