Experimental study of impact energy absorption by reinforced braided composite structures: Dynamic crushing tests

Olivier Dorival, Pablo Navarro, Steven Marguet, C Petiot, M Bermudez, D Mesnagé, Jean-François Ferrero

O. Dorival^a, P. Navarro^a, S. Marguet^a, C. Petiot^b, M. Bermudez^b, D. Mesnagé^b, J.-F. Ferrero^a

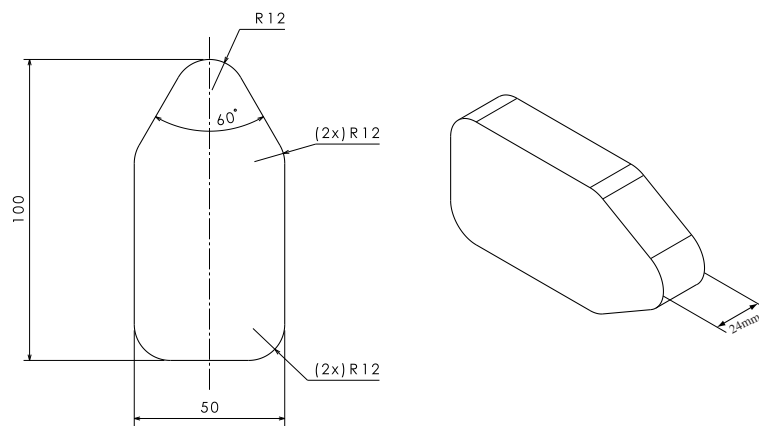
Figure 1: (*left*): dimensions of the external shape for all specimens, and (*right*): sample used for crushing tests.

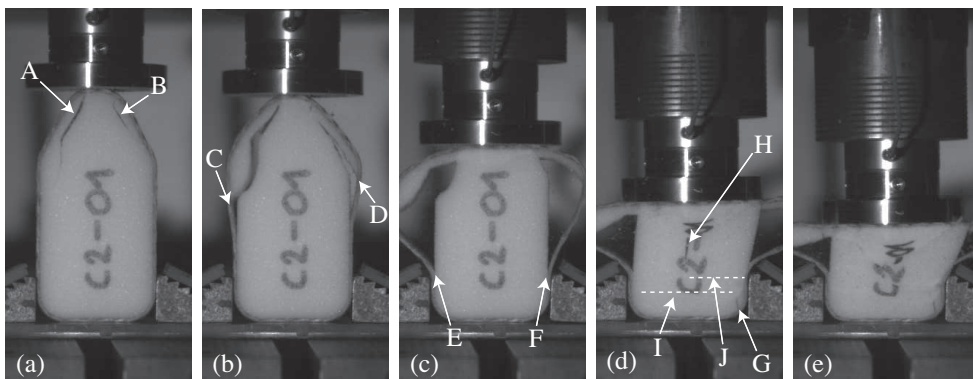
Figure 3: Fast camera analysis of D1 crushing test.

Some pictures from the camera are given in Fig. 3 and the corresponding load-displacement plot and energy-displacement plot are given in Fig. 4. Analysis of the fast camera pictures reveals the following damage scenario. For a better understanding the main events that are marked by capital letters in the text description are also located in Fig. 3 and in the curves shown in Fig. 4.

- (a) Soon after the contact, a crack appears in the left front part of the foam (**A**), under the woven composite. This crack is inclined at about 17° from the symmetry plane in the front end and then follows a 32° direction at approximately 5 mm under the fabric. Soon, a similar crack appears in the right part (**B**), mainly oriented at -32° from the symmetry plane, at approximately 3.5 mm from the fabric.

- (b) Cracks propagate towards the rear face of the specimen and reach the interface with the fabrics at (**C**) and (**D**). The propagation of the cracks continues in the form of debondings between the foam and the fabrics. In the same time, crushing of the front foam can be noticed. Direct observations of the post mortem samples showed that what is here referred to as debonding designates in fact the breakage of the first cell of the foam under the resin.

- (c) Debondings propagate simultaneously towards the rear face while fabrics are bending and the front foam is crushed by the indenter. The left debonding is stopped by the flange at (**E**) and the right debonding is stopped at (**F**).

- (d) Foam crushing goes on. Fabric bending results in a complete folding of the composite on both sides. A small localized crack appears in the right rear corner of the foam (**G**). At (**H**) the crushed foam shows a triangular form that creates a longitudinal crack. At (**I**) a transverse crack appears at about 10 mm from the rear face due to the compression of the foam, followed by similar transverse one (**J**) at about 20 mm from the rear.

- (e) The indenter starts its rebound (**K**). The foam is almost totally crushed (the indentation is 59.6 mm): the crushing reserve - defined by the ratio between the damage height of the specimen to its total height - is very small, but the energy dissipation is quite important (94%).

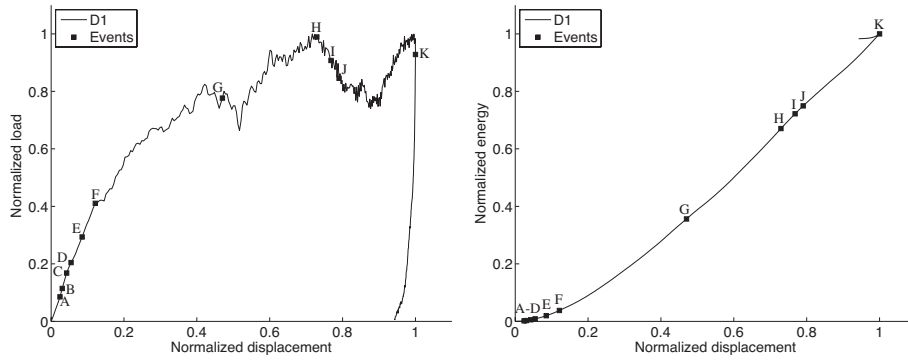
Figure 4: (left): Load-displacement plot, and (right): energy-displacement plot for D1 design

As the fabric quickly bends, the connexion to the foam is deteriorated. The main role of the composite skin is in participating to the initial stiffness together with the foam and to keep the specimen integrity. Consequently the reference specimen involves one main dissipation mechanism based on the crushing of the foam. The outer fabric plays no specific role in the energy absorption.

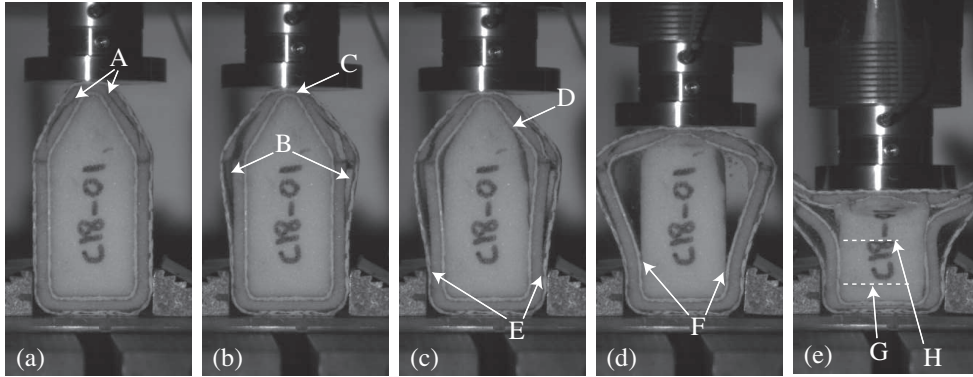
Figure 6: Fast camera analysis of D2 crushing test.

Pictures of the crushing tests shown in Fig. 6 and the corresponding curves given in Fig. 7 illustrate the following scenario:

- (a) After the contact with the indenter, two cracks quickly appear in the outer foam (**A**).
- (b) Cracks propagate as to create a debond at the outer foam/fabric interface (**B**). As the indenter advances, these cracks open up and the front outer foam is almost completely crushed (**C**). Up to this stage, the inner foam is mostly spared and the inner wall has almost not moved.

- (c) At (**D**) a crack appears in the inner foam close to the right edge and will soon result into debonding. Almost at the same time debonding takes place between the inner foam and the inner fabric in the opposite edge. As outer debondings are stopped by the flanges (**E**) inner debondings propagate and all the fabrics bend to help the indenter advance.

- (d) Internal and external fabric are bending resulting in the crushing of the internal foam and eventually closing the outer debondings. Inner debondings are stopped at about 25 mm of the rear face (**F**).

- (e) At (**G**) a transverse crack is noticed at about 10 mm of the rear face, due to the collapse of the foam by compression. The foam crushed by the indenter takes a triangular shape. Both internal and external fabrics are totally folded. At (**H**) one can notice another transverse crack at about 40 mm of the rear. The indenter starts its rebound at (**I**). The sample is highly crushed (indentation is 50.1 mm) although energy absorption is quite low (84%).

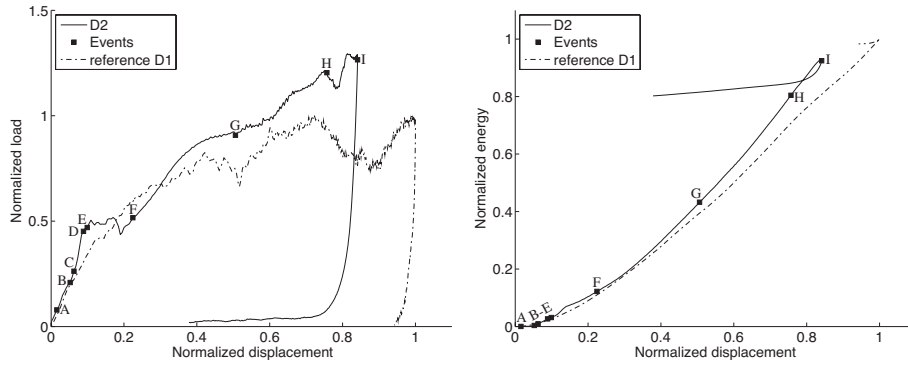
Figure 7: (left): Load-displacement plot, and (right): energy-displacement plot for D2 design.

From this analysis and from the curves of Fig. 7, we can conclude that the inner fabric in design D2 does not bring any significant improvement to design D1. Cracks quickly allow the fabrics to bend outside, with only a slight increase of 29% in the crushing load. The second fabric mainly affects the initial stiffness by delaying the “softening” of the slope; this results in a slightly lower indentation length (15 mm less). The only dissipation mechanism is the continuous crushing of the inner foam that is applied on a projected area that is

smaller than for reference design D1. This explains that the absorption ratio is lower than for D1 although the peak load is 29% higher.

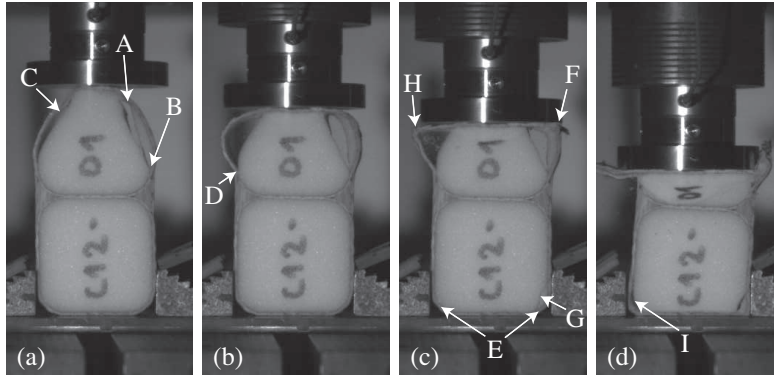
Figure 9: Fast camera analysis of D3 crushing test.

Pictures shown in Fig. 9 and curves from Fig. 10 illustrates the following events:

- (a) A crack appears in the front bumper close to the right fabric (**A**). Soon the crack reaches the foam/fabric interface (**B**) and opens as the lower skin starts to bend outside to help the indenter with the crushing of the foam. At (**C**) a second crack appears in the left part of the front bumper that has already reached the interface with the fabric.

- (b) The resulting debonding propagates in the front bumper while both fabrics bend outside and the front foam is crushed. Debonding is stopped at (**D**).

- (c) The rear edges start to collapse (**E**). The right skin of the front bumper breaks by folding (**F**) as foam crushing goes on in the front bumper. A small crack appears in one of the rear edge (**G**) of the sample when it is crushed against the flange. The left fabric also breaks in bending (**H**).

- (d) At (**I**), a debonding appears in the other rear edge. Both rear edges are crushed in a square shape against flanges. The indenter starts its rebound (**J**). Damage of the foam in the rear bumper is almost non-existent (indentation is only 41.8 mm) associated with an important energy absorption (94 %).

The pictures in Fig. 9 and the curves in Fig. 10 show that the presence of the inner wall has two positive effects: firstly it avoids the global bending of the fabric, what delays the softening of the initial stiffness resulting in a higher crushing load; secondly it avoids the rear foam being crushed prematurely. This leaves an important part of the design mostly undamaged.

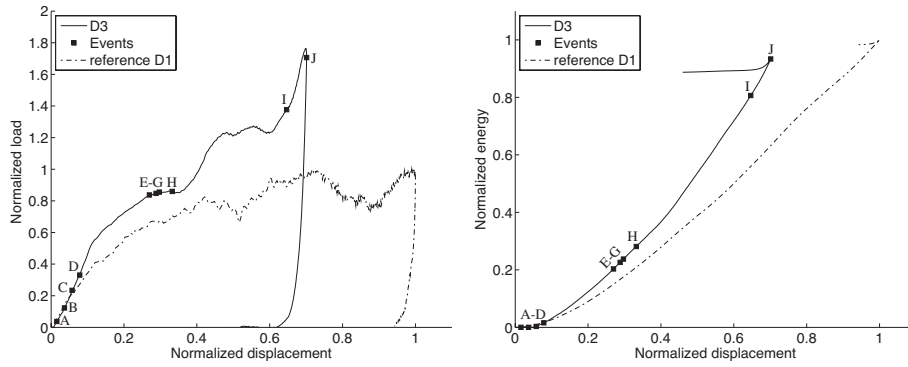
Figure 10: (left): Load-displacement plot, and (right): energy-displacement plot for D3 design.

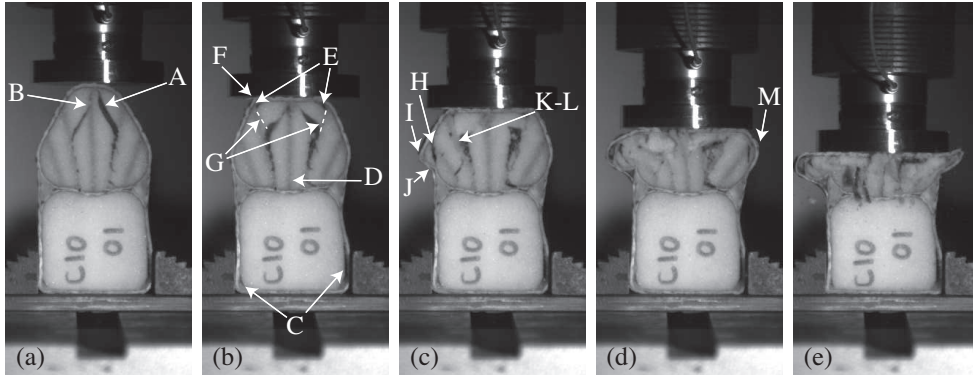
Figure 12: Fast camera analysis of D3R crushing test.

As illustrated in Fig. 12 and in the corresponding load-displacement plot and the energy-displacement plot given in Fig. 13, the following mechanisms occur:

- (a) Just after the contact, the very rear part of the foam is settled because the reinforcements in the front bumper bring additional stiffness. Then one inclined crack appears in the front bumper (**A**), initiated from the foam leading edge. Soon it follows the direction of the side reinforcement. Immediately a symmetric crack appears (**B**) in the front bumper. Both cracks are slightly open but no debonding with the fabric is noticed: reinforcements link the foam and the fabric together.

- (b) Settling of the rear foam goes on, specially in the corners (debonding at (**C**)), while the front bumper looks stiff. The inner wall bends due to the forces exerted by the reinforcements. The central reinforcement seems to break at (**D**) (the breakage is not clearly visible on the picture, but a sudden release of the inner wall is noticed). A very small foam/fabric debonding is noticed in the front bumper at (**E**), but stays very localized due to the reinforcements keeping everything together. Crushing is then favored since the sample keeps its structure. The left skin folds against the indenter at (**F**). In the front bumper, cracks have generated several “parts” of foam; two of them start to bend and breaks at (**G**).

- (c) A small crack appears in the left rear part of the front bumper (**H**). Another crack appears in the front bumper, the beginning of which follows the direction of one reinforcement. At (**I**), the inner fabric of the front bumper folds in its middle without debonding from the outer fabric. A small debonding between the outer braid and the inner braid is noticed at (**J**). One of the side reinforcements buckles (**K**) and quickly breaks (**L**).

- (d) The outer fabric of the front bumper folds (**M**).
- (e) The indenter starts its return at (**N**). As for D3, the rear foam is mostly spared (indentation is 41.0 mm) and the energy absorption is slightly less than for D3.

From the analysis of pictures in Fig. 12 and from the curves given in Fig. 13, one can draw the following conclusion: compared to D3, the two major effects of reinforcements in D3R is in the initial stiffness and in the resulting peak load. The dissipation mechanism involves foam crushing and breakage of the reinforcements, but the latter does not present a substantial improvement compared to D3.

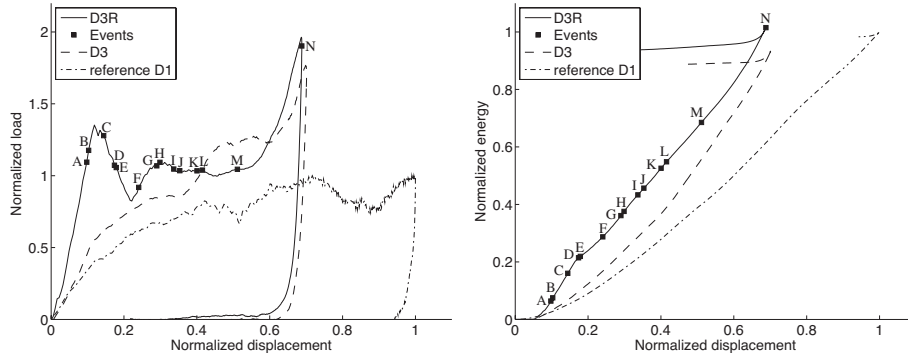
Figure 13: (left): Load-displacement plot, and (right): energy-displacement plot for D3R design.

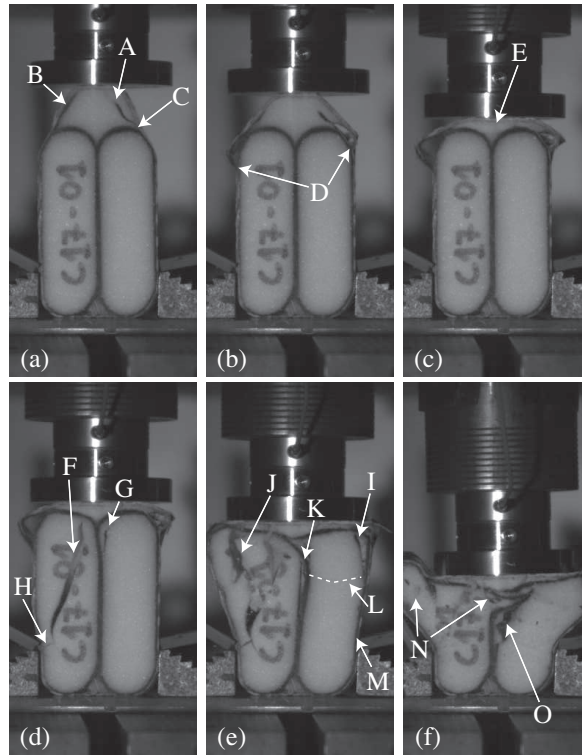
Figure 15: Fast camera analysis of D4 crushing test.

Fig. 15 and Fig. 16 illustrates the following scenario:

- (a) In the front bumper, a crack appears in the right part of the foam (**A**) just before that a foam/fabric debonding takes place in the left part (**B**). As the indenter advances, the front foam crushes and the fabrics bend outside, opening both the debonding and the crack. The crack reaches the edge between the outer fabric and the right carbon bumper (**C**).

- (b) Similarly the left debonding reaches the edge between the outer fabric and the left bumper and continues in a debonding between the outer fabric and the carbon composite of the left bumper. Debondings propagate and are soon stopped at the interface with the oblong bumpers (**D**). The fabrics are then put into bending.

- (c) The indenter advances while the right fabric exhibits folding consecutive to bending. Whereas the rear bumper foam is mostly undamaged, the front foam is totally pulverized and starts pushing on the rear bumpers (**E**).

- (d) An important crack appears in a rear left bumper (**F**). It propagates to the rear in an inclined direction and opens to help the indenter compression. A local crack takes place in the front of the right rear bumper close to the central wall (**G**). The left crack allows the bending of the left foam which results in a small transverse crack (**H**) that immediately reaches the foam/fabric interface.

- (e) Another crack appears in the front of the right bumper (**I**) that continues in debonding. Another important crack appears in the left bumper (**J**) due to the difference between the part of the foam put into bending and the one put into compression. Debonding between the left foam and the central wall takes place (**K**), propagates and opens up. At (**L**) a transverse crack appears in the right foam due to bending. Simultaneously the right debonding propagates, reaches the right flange (**M**) and stops.

- (f) At (**N**) two other cracks appear due to bending of the left foam. Suddenly a crack appears (**O**) by buckling of the mean wall. Debonding in the mean plane is immediately closed as the later crack is opened. When the indenter rebounds (**P**), the sample is almost totally crushed and bent against the flanges. The foam left undamaged is very small (the indentation is 53.1 mm).

In this case the design does not work properly. Although the inner fabrics avoid a global buckling of the full fabric, they do not bring any sensible additional stiffness or dissipation. Instead, the main effect of the rear bumpers is to “split” the foam into two parts, what helps them in buckling. As a consequence, the crushing of the foam is deteriorated and partly replaced by bending and crushing against the flanges.

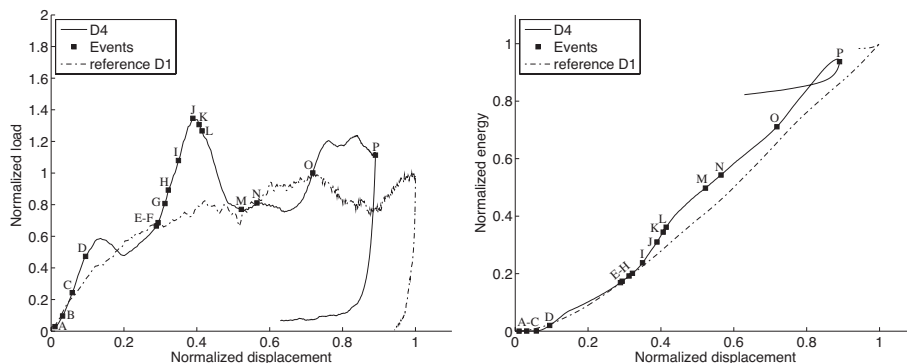
Figure 16: (left): Load-displacement plots and (right): energy-displacement plot for D4 design.

Note that in case of catastrophic crushing events for design D4, the concept is deteriorated in such a way that the sample works in a wrong manner very prematurely (after marks **G-H** in Fig. 16). Indeed the stiffness of the design suddenly drops down due to large cracks appearing in the foam, and consequently after the catastrophic crushing occurs, the energy is dissipated in a wrong and rather chaotic manner, what falsifies the interpretation of the area under the load-displacement plot. For that reason the values for design D4 were taken at the time when the catastrophic crushing occurred (at mark **H** in Fig. 16). The reason for this is to avoid erroneous interpretation of the potential of design D4 compared to other designs.

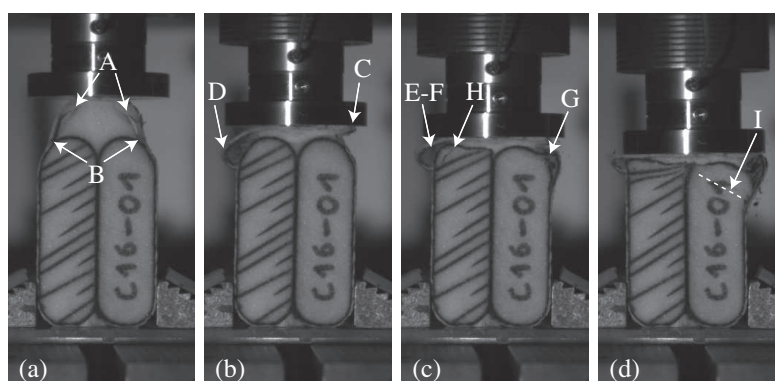
Figure 18: Fast camera analysis of D4R crushing test.

Pictures from the camera shown in Fig. 18 in relation with curves in Fig. 19 illustrates the following events:

- (a) Two cracks appears under the fabrics in the front bumper (**A**). As the indenter advances, the front foam is crushed and the cracks reach the interface but the corresponding debondings are soon stopped at the joint with rear bumpers (**B**).

- (b) Very soon, bending of the fabrics is very important because it remains local. The right fabric breaks (**C**) just before the left one shows an important damage close to the joint with the rear part (**D**). The front foam is almost completely crushed. Deformation and damage in the two rear bumpers are very low.

- (c) Deformations now appear in the rear bumpers, mainly behind the indenter. Debonding takes place in the left rear bumper (**E**) but is quickly stopped by the buckling of the left fabric (**F**). A second buckling appears in the right fabric (**G**). A localized crack appears in the front part of the left bumper (**H**) quickly followed by a transverse crack in the right one (**I**) that creates debonding.

- (d) Debondings propagate only very moderately. The crushing of the foam is in accordance with the orientation of the stitches, and only in the vicinity of the indenter. When the indenter returns at (**J**), the two rear bumpers are very lowly damaged, mainly behind

the indenter. The crushing reserve is important (indentation 32.3 mm) but the energy absorption is a little bit lower than for other design (84 %).

The influence of the stitches is very important. As for D4, the presence of the rear bumpers stops the global bending of the fabric. However in addition, stitches keep the shape of the structure together and avoids the apparition of long cracks or debondings leading to catastrophic buckling for D4. The initial stiffness is approximately maintained during all the crushing. The increase in the crushing load is very significant and a large part of the design remains completely undamaged.

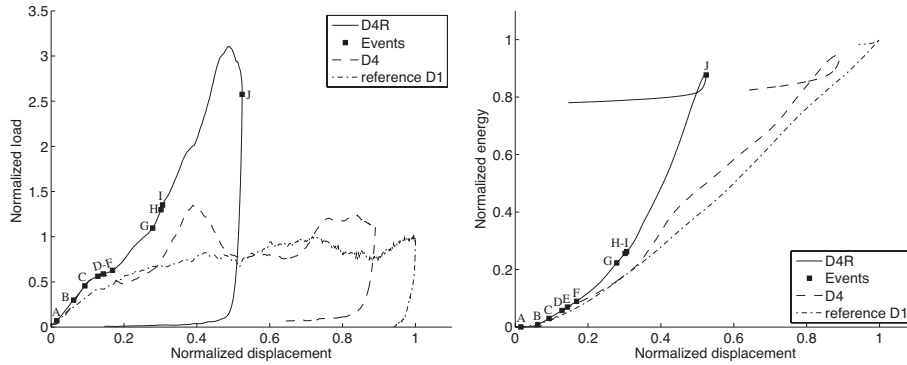
Figure 19: (left): Load-displacement plots and (right): energy-displacement plot for D4R design.

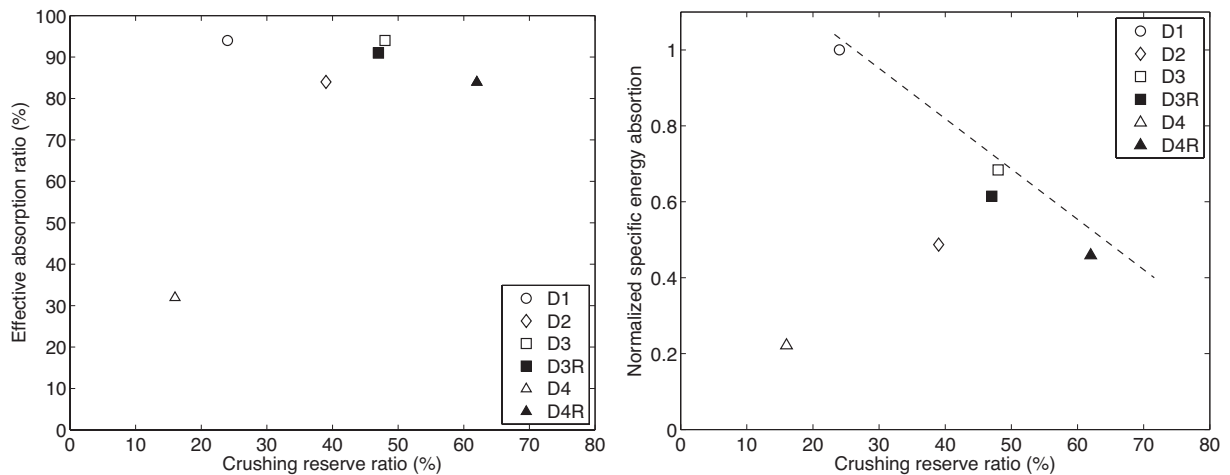
Figure 20: (left): Absorption ratio versus crushing reserve plot, and (right): Specific energy absorption versus crushing reserve plot.

The previous analysis shows that improvements of the simple reference design D1 require to take some specific decision in term of design. It looks necessary to retain or to delay the global bending of the outer fabric in order to improve the crushing force, but also to avoid long cracks in the foam that lead to early catastrophic deterioration of the design. This can be done either by an additional wall that holds the fabric, or by discrete reinforcements such as stitches or sewing. Such reinforcements can be of high interest in terms of energy dissipation and concept consumption, as shown by design D4R. However any type of reinforcements obviously decreases the specific energy ratio. Fig. 20 illustrate the performances of the designs. Choosing to reinforce or not requires referring to precise specifications. Especially Fig. 20-right tends to show that the choice is a question of compromise between the crushing reserve and the specific energy absorption, figured by the dotted line. However following the idea of reinforcing the reference design D1, it would be very interesting to study the influence of the size/number/material of such reinforcements in order to optimize the designs. Such optimization could drastically improve the specific energy absorption of the reinforced designs without decreasing the crushing reserve, what would result in ideal shock absorbers.
