Short-term Geomorphic Observations in the Nepal Himalayas: Contribution to the Knowledge of Geo-disasters Along a Road Corridor

Fort M. ¹.

Keywords: Landslide, Flood, Hillslope-channel coupling; Geomorphic mapping; Road design, Nepal Himalaya

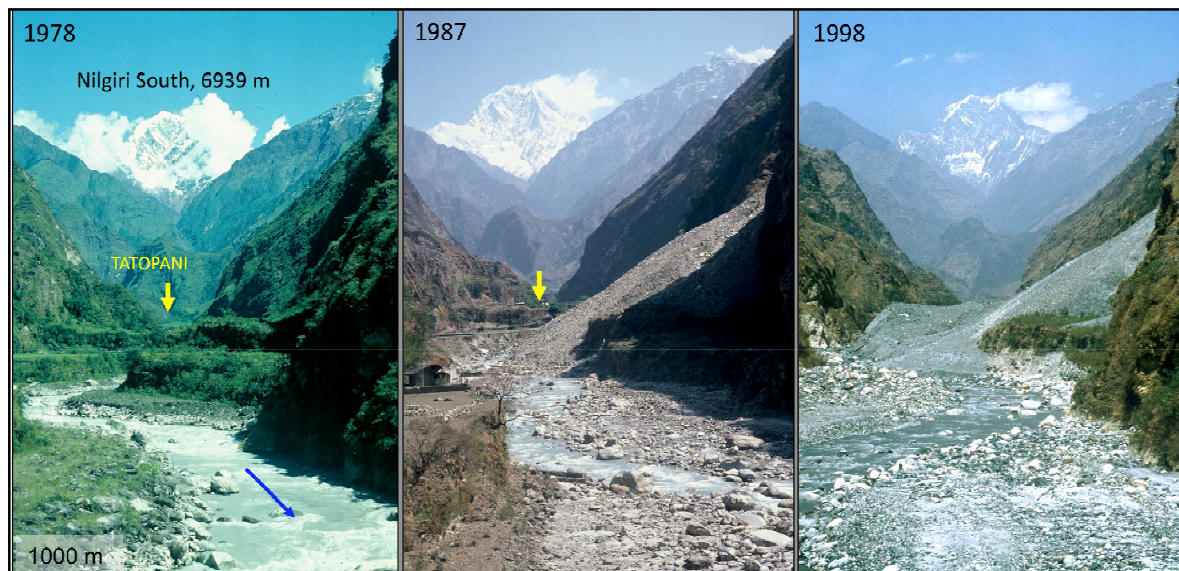
Fig 1. Evolution of the Kali Gandaki (KG) hillslope south of Tatopani (looking upstream). 1978: Tatopani village settled on the lower (+30m) terrace of the KG River; 1987: a first collapse has occurred with rubble accumulation forcing river diversion; 1998, View after the rockslide dam bursting out, with major change of river bottom morphology (© M. Fort).

15 years after the Tatopani debris slide (Fig. 1) which dammed the KG river for a few hours, the landslide mass is still affected by shallow translational slides, supplying a flux of debris (pulverized slates) to the KG river, causing undercutting of alluvium fills, collapse of colluvium upslope, resulting in road closures during the monsoon season. Persisting instability may again induce larger slope failures, valley damming, and then submersion of the entire village and new road upstream.

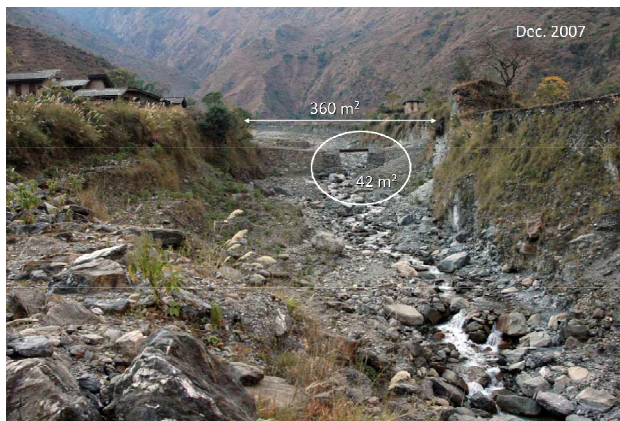
Fig 2. Ghatte khola, very narrow, undersized hydraulic, cross sectional area of the road bridge, that was destroyed by the monsoon flood in late July 2008 (first season following bridge construction) .

Although most of the time it is completely dry in its fan, the Ghatte khola (Dana village) is affected by sporadic, destructive debris flows during spring. Generated by a series of landslide dam outburst floods up in the catchment, the debris flows may dam the KG for a few hours like in 1974 (Fort 1974). The design of the new road across the apparently “safe”, large, flat Ghatte Khola alluvial fan may turn out to be more dangerous than initially thought, as shown by the poor design of the bridge (fig. 2), now replaced by a ford reinforced by gabions.
