Influence of localized plasticity on oxidation behaviour of austenitic stainless steels under primary water reactor

Sarata Cissé^a, Lydia Laffont^{b,*}, Marie-Christine Lafont^b, Benoit Tanguy^a, Eric Andrieu^b

A B S T R A C T

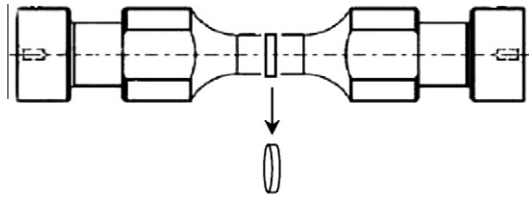
Fig. 2. Schematic representation of specimens containing localized deformation bands which are then exposed to simulated PWR water.

Two kinds of specimen were tested in the oxidation section: (1) specimen without deformation - rectangular samples ($10 \times 10 \times 2 \text{ mm}^3$) machined from heat aged rods which are deformation free, (2) specimen deformed - small plates machined from pre-cycled fatigue specimens as displayed in Fig. 2.

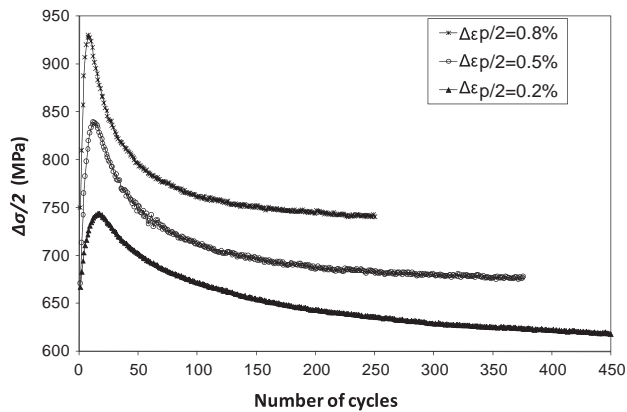
Fig. 5. Half true-strain amplitude ($\Delta\sigma/2$) versus number of cycles for the precipitation-hardened A286.

Fig. 5 plots the half-stress amplitude ($\Delta\sigma/2$) against the number of fatigue cycles for three plastic strain amplitudes in precipitation-hardened A286.

Global LCF behaviour is similar for the different levels of plastic strain. Three steps are distinguished: first the alloy work-hardens during the first cycles (9 cycles for 0.8% of plastic strain, 14 cycles for 0.5% and 18 cycles for 0.2%) before showing cyclic softening. The last stage is the saturation of the softening. Macroscopic cyclic softening, in terms of stress, may be defined as the difference between the hardening peak stress and the stress level corresponding to the softening plateau. For the 0.8% plastic-strain half-amplitude test, the stress-strain curves for the 8th cycle (hardening peak cycle) and the 150th cycle (stabilized softening cycle) are shown in Fig. 6a and exhibit a cyclic softening of 188 MPa. The cyclic softening (CS) was greater when plastic strain amplitude was increased, than when the hardening peak stress was increased.

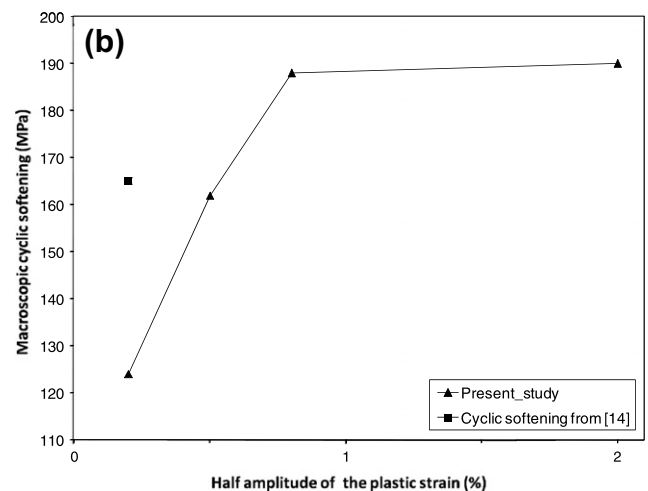
Fig. 6. (a) Typical hysteresis loops generated during symmetrical cyclic loading for A286 aged for 50 h at 670 °C with $\Delta\epsilon_p/2 = 0.8\%$. The 8th cycle (peak hardening cycle) and the 150th cycle (cyclic softening) are displayed. (b) Macroscopic cyclic softening versus plastic strain amplitude.

A typical plot of the experimental cyclic softening obtained after the LCF test versus plastic strain is presented in Fig. 6b.

also reported in Fig. 6b. Note that under cyclic strain, cyclic softening exhibits an initial increase followed by saturation at higher plastic strain control values. This indicates that over one plastic strain value, softening does not vary any more (or little) and that there is a plastic strain range corresponding to the location of the plastic deformation in the alloy.

However, it can be noted that for $\Delta\epsilon_p/2 = 0.2\%$, the softening obtained in the present study (123 MPa) was much lower than that reported in [11] (165 MPa) for similar experimental conditions. Moreover the γ' precipitates of [11] had a mean diameter of 5 nm, a distance between the precipitates of 18 nm and a volume fraction of 8.1% while γ' precipitates of our study had a mean diameter of 3.4 nm. It is suggested that the cyclic softening is strongly linked to the γ' precipitates size and to the initial chemical composition of the alloy which was slightly different in [11].

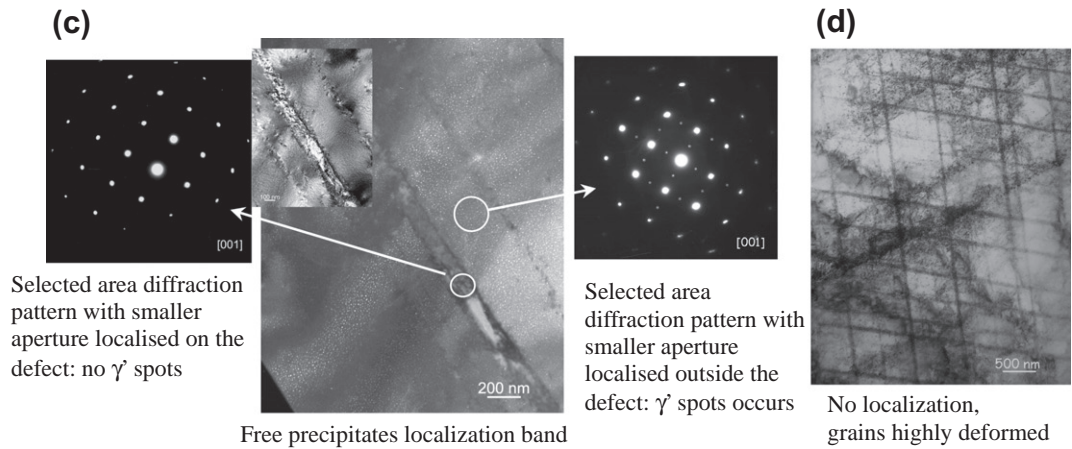
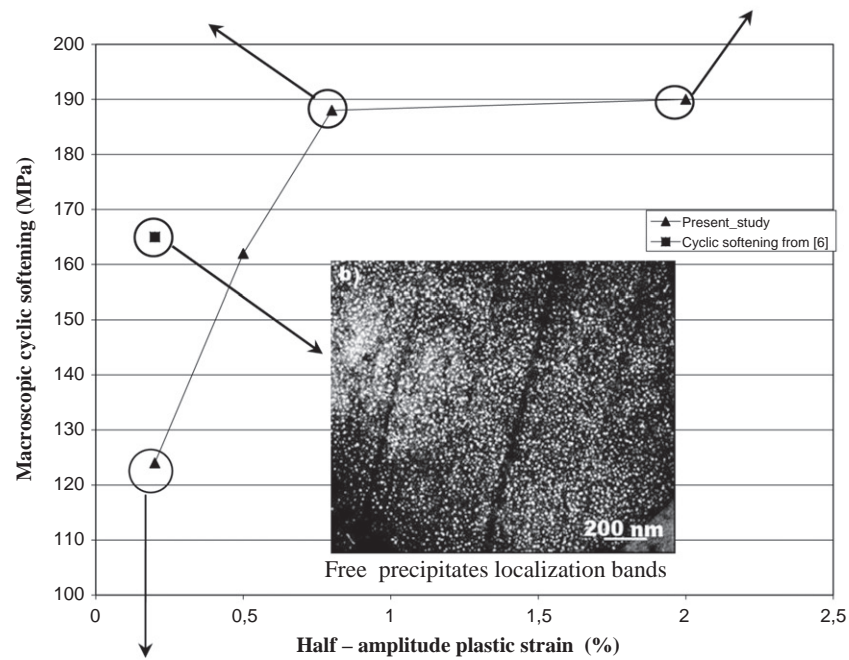
Fig. 7. Typical bright and dark field micrographs showing deformation microstructures associated with cyclic softening induced by LCF at room temperature. (a) $\Delta\epsilon_p/2 = 0.2\%$, (b) $\Delta\epsilon_p/2 = 0.2\%$, from [11], (c) $\Delta\epsilon_p/2 = 0.8\%$ and (d) $\Delta\epsilon_p/2 = 2\%$.

associated to cyclic softening induced by LCF at plastic strain amplitudes from 0.2% to 2% is shown in this figure.

Fig. 7a shows images corresponding to the specimen submitted to 1000 cycles at 0.2% of plastic strain. Stacks of dislocations lying along $\langle 111 \rangle$ slip planes are observed, and between these planes, γ'

phase coherent with the γ matrix was present. During cyclic softening, two slip systems are activated and the resulting bands are intense for both systems. At saturation of cyclic softening (1000 cycles), all slip systems are persistent but no γ' -free bands are observed, even if deformation is localized in intense bands.

Fig. 7c displays the dark field image of a specimen that underwent 116 cycles at 0.8% using the superlattice reflexion (010) γ' of the zone axis [001]. A precipitate-free band, close to 100 nm wide, surrounded by a γ matrix epitaxial with the γ' phase is

clearly shown in this image. It is then concluded that the sample deformed for 116 cycles at 0.8% leads to strain localization in precipitate-free bands. Since these bands are free of obstacles, the dislocations move in slip planes, deformation being easily accommodated in these bands and becoming highly localized during cyclic loading.

For a plastic-strain half amplitude of 2%, the result is quite different from that expected. A typical bright-field TEM image from a specimen subjected to 173 cycles at 2% is reported in Fig. 7d. Many deformation bands along two slip systems are observed. Unlike previous observations, dense dislocation tangles are noted throughout the matrix between deformation bands. For these cyclic conditions, deformation appears to be widespread in some grains, suggesting that cycling with a high plastic amplitude tends to homogenize deformation, due to a higher number of activated slip planes.

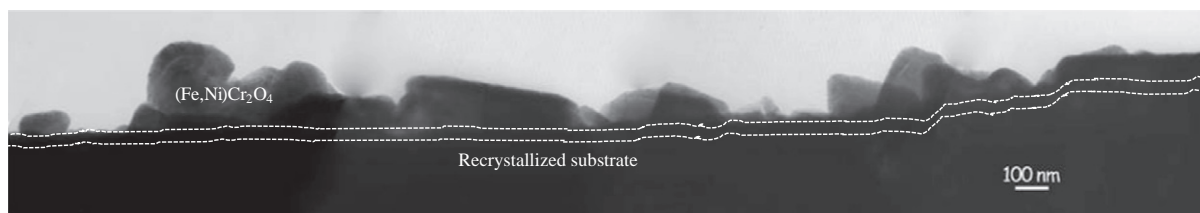
Fig. 8. Bright field image of the oxide layer cross section after exposure of non-precycled, aged A286 alloy to simulated reactor primary water (340 °C, 500 h).

A cross section showing the surface layer of the non-precycled alloy after 500 h at 340 °C is reported in Fig. 8.

The surface layer is inhomogeneous and composed of two distinct strata: the external oxide layer and the internal or interfacial oxide layer.

They are dispersed on top of the internal oxide layer, which is compact and enriched in chromium. The thickness of this layer, also named interfacial layer, varies from 20 to 30 nm. The duplex nature of the oxide layer morphology for an austenitic stainless steel exposed to reactor primary water has been reported by many authors [16–20].

In the vicinity of the interfacial layer, the substrate is disordered to a depth of 190 nm. This disruption leads to the recrystallization of the initial austenitic grains, resulting in finer, generally elongated, grains.

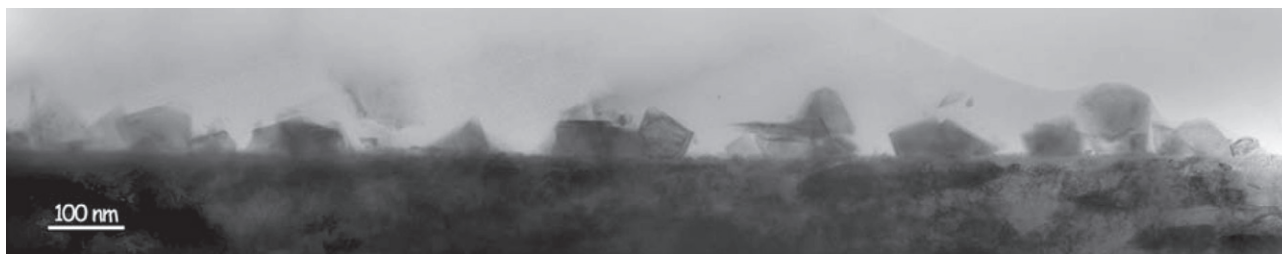
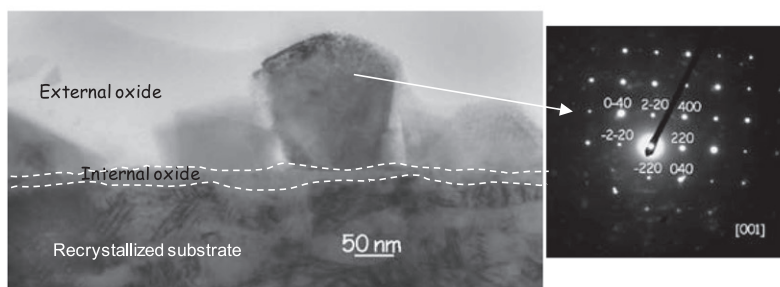
Fig. 10. Cross section of the oxide layer on pre-cycled (0.5%, 350 cycles) aged A286 alloy after 500 h exposure to simulated reactor primary water. (a) Bright field image of the oxide layer and (b) crystallite of magnetite associated with its diffraction pattern (zone axis [001]).

A cross section showing the oxide layer of the pre-cycled alloy (0.5% for 350 cycles) is reported in Fig. 10.

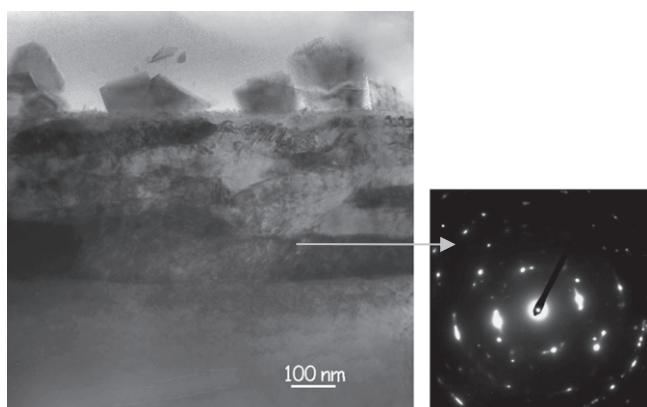
Fig. 11. Bright field image showing elongated nanograins in the substrate and a specific diffraction pattern in the recrystallized area.

Finally, under the internal layer, the substrate is recrystallized and composed of elongated nanograins to a depth of 500 nm (Fig. 11). This is shown by the diffraction pattern of this area, characteristic of a disordered zone, with cold working dislocations. However, no evidence of γ' -free bands at the substrate/oxide layer interface was observed.

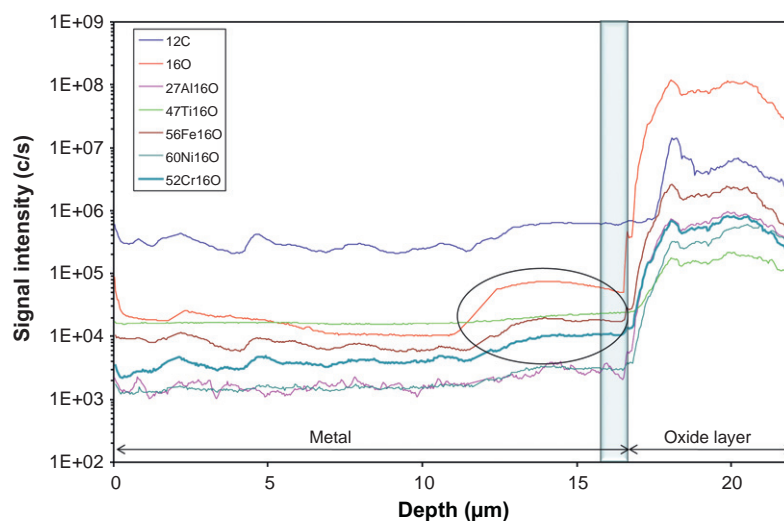
Fig. 12. Diffusion profiles of elements (from base metal up to the oxide) of A286 after 116 cycles at 0.8% and exposure to simulated reactor primary water. The blue box encompasses the recrystallised zone as determined by TEM and the ellipse highlights enhanced oxygen penetration. (For interpretation of the references to colour in this figure legend, the reader is referred to the web version of this article.)

Along the base metal, the intensity of the aluminum oxide signal (as well as of carbon, titanium oxide and chromium oxide) is quite regular and stable, but showed a sharp increase in the outer oxide layer. For the oxygen signal, the intensity was also relatively constant in the first 11 μm in the base metal and sharply increased when the beam reached the oxide layer. However, at 5 μm from the oxide layer the oxygen signal presents a singularity in the base metal. This singularity is similar to that observed for the chromium oxide, the nickel oxide and the iron oxide signals. It suggests the presence of dissolved oxygen and/or intergranular penetrations (e.g. chromium, nickel and iron oxide-spinel type $(\text{Fe}, \text{Ni})\text{Cr}_2\text{O}_4$) connected to the oxide layer, at a depth of 15 μm in the base metal. In order to confirm the presence of oxide penetration, the levels of different components (^{12}C , ^{16}O , $^{16}\text{O}^{52}\text{Cr}$, $^{16}\text{O}^{56}\text{Fe}$) were mapped at two depths: 5 μm and 15 μm where the oxygen signal intensity was disrupted and are displayed in Fig. 13. The nickel component map ($^{16}\text{O}^{60}\text{Ni}$ - not shown here) is similar to $^{16}\text{O}^{52}\text{Cr}$, $^{16}\text{O}^{56}\text{Fe}$ maps.

Note that the recrystallized nanograins (blue areas in Fig. 12) are included in this 5 μm area of intergranular penetrations that may explain the depletion of chromium in the bulk highlighted in the last section, the amount of chromium available in the bulk being used in grain boundaries for intergranular precipitation. Moreover, 3D tomography of ^{16}O element (not shown here) shows that the oxygen is segregated in subsurface along the grain boundaries (shown in Fig. 13) and not along the localized deformation bands (width ~ 100 nm).

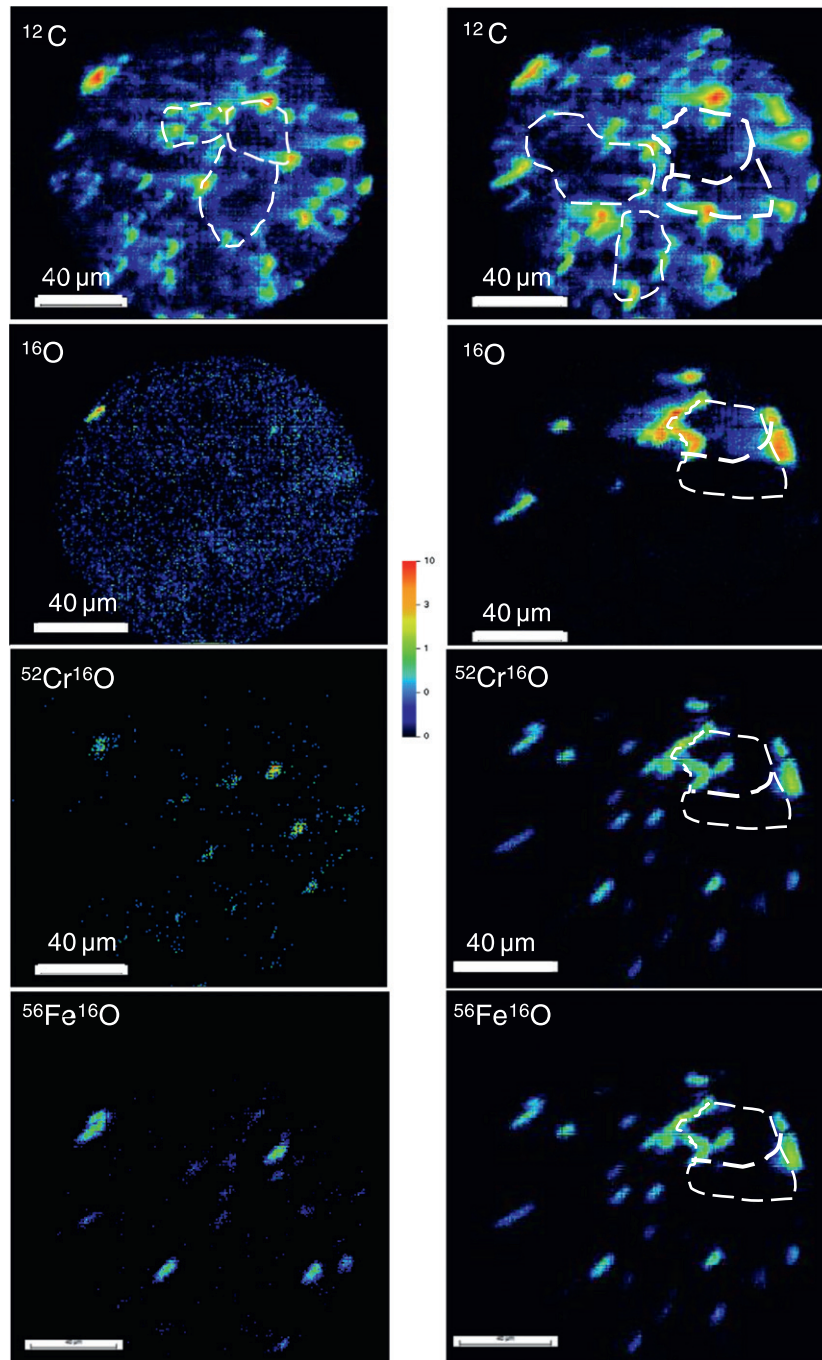
Fig. 13. Carbon (^{12}C), oxygen (^{16}O) elements and chromium and iron oxides ($^{16}\text{O}^{52}\text{Cr}$, $^{16}\text{O}^{56}\text{Fe}$) mapped at 5 μm (images on the left) and 15 μm depths (image on the right). Note that the dotted lines indicate the outlines of intergranular penetrations.

Mapping the levels of ^{12}C element at 5 and 15 μm depth showed that the signal was intensified at precise areas surrounded by dark. The microstructural characterization of the aged alloy (Fig. 3) showed that γ' (Ni_3Ti) precipitates in epitaxis with austenitic γ matrix, and also that secondary precipitation such as that of

Fig. 13 also displays the maps of ^{16}O element, and as expected from the diffusion profile (Fig. 12), the intensity signal at 15 μm is higher than that at 5 μm . However, at 15 μm , it can be noted that the oxygen signal is intensified in areas identified as grain boundaries (represented by dotted lines); this suggests that grain boundaries are preferentially oxidized in the subsurface. The map of chromium, iron and nickel oxide (not shown here) at 15 μm supports this idea, confirming the presence of chromium, nickel and iron oxide or of an oxide enriched with chromium, nickel and iron at grain boundaries in the subsurface under the oxide layer, as in the bulk, these oxide penetrations do not exist. Therefore, the evidence strongly suggests intergranular penetration (spinel type $(\text{Fe}, \text{Ni})\text{Cr}_2\text{O}_4$) when the pre-cycled alloy is exposed to simulated reactor primary water. Similar evidence has been validated by Bruemmer [21], whose study reported intergranular penetrations for a 316L core exposed to a BWR and a PWR environment.
