Bardia Esmaeillo, Joseph Fitoussi, Fodil Meraghni, Abbas Tcharkhtchi. Micro-mechanisms of fatigue in short glass fiber reinforced polyamide 66: A multi-scale experimental analysis. ECCM16 - 16th European Conference on Composite Materials, Jun 2014, Séville, Spain. hal-01229782

# MICRO-MECHANISMS OF FATIGUE IN SHORT GLASS FIBER REINFORCED POLYAMIDE 66: A MULTI-SCALE EXPERIMENTAL ANALYSIS

**Keywords:** polyamide composite, fatigue behavior, damage mechanisms

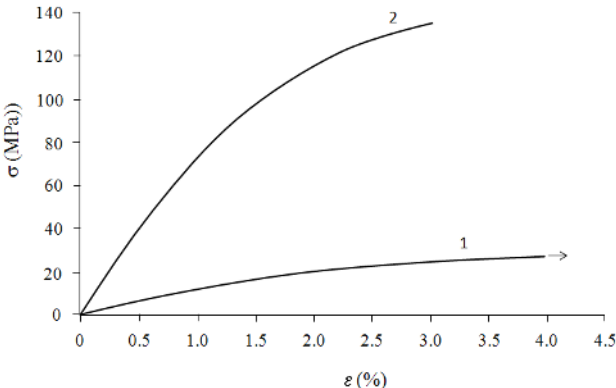
**Figure 1.** Strain-stress curves of tensile tests performed at room temperature on the neat PA66 matrix (1) and the P66/GF30 composite (2). Strain is measure by means of an extensometer

Figure 1 compares the results of tensile tests performed on the pure PA66 and on the composite PA66/GF30 at room temperature. The presence of the strongly oriented glass fibers leads to an increased modulus and a low value of strain to failure (3%). For the pure PA66 matrix the strain to failure occurs after a necking and can reach up to 200%. One can also observe a non-linear behavior beginning up to 30% of the ultimate stress. The first

nonlinearity in the composite behavior corresponds to the non-linear behavior of the matrix since the important loss of ductility is due to damage mechanisms occurring at the microscopic scale.

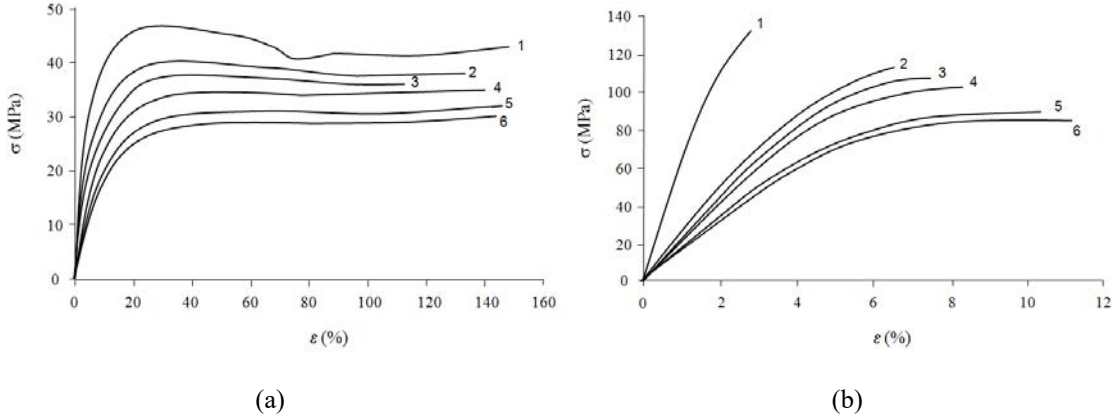
**Figure 2.** Stress-strain curves of pure PA66 (a) and PA66/GF (b) at various temperatures 25°C (1), 35°C (2), 45°C (3), 55°C (4), 75°C (5) and 90°C (6).

In order to evaluate the influence of the temperature on the pure PA66 matrix behavior, tensile tests have been performed on both PA66 and PA66/GF in a weathering (environmental) chamber at various temperatures ranging from 25°C to 90°C (figure 2). The strain was obtained using the temporal derivative of the displacement measured by a LVDT displacement sensor. Because of the limitation of chamber height, the test on pure matrix has been stopped before fracture. It can be seen in figure 2 that the mechanical properties are significantly affected by temperature especially when the temperature is higher than Tg.

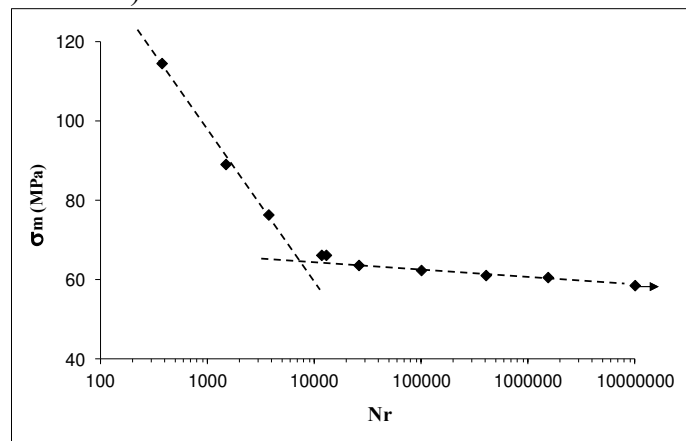
**Figure 3.** Wöhler curve obtained from TTF tests performed at room temperature in tension-tension for a frequency of 20Hz and  $R=0.1$ .

Tension-tension fatigue tests (TTF) have been performed at room temperature for a frequency of 20Hz. The minimum applied stress is always chosen to be equal to 10% of the maximum applied stress (load ratio  $R = 0.1$ ). The aim of this work being to analyze the main mechanisms and fatigue regimes, only one TTF specimen was tested for each of the nine chosen applied maximum stress levels mentioned in section 1.2. From these TTF tests one can build the Wöhler curve given on figure 3.

This Wöhler curve is obtained for the studied material molded according to the specific injection conditions assuring an homogeneous distribution of the fibers through the thickness of the sample as mentioned above in section 1.1. As it can be noticed, the fatigue life is about  $10^5$  cycles for a maximum applied stress equal to 62 MPa. It reaches about  $10^6$  cycles for a maximum applied stress of 60 MPa. So, a variation of only 2 MPa leads to a fatigue life 10 times higher. It is worth noting that a pseudo-endurance limit can be reached for a stress level of 58 MPa. It corresponds to a state where no macroscopic failure on the specimen was noticed or detected until  $10^7$  cycles. However, at this level of stress local damage mechanisms can occur.

Basically, this Wöhler curve presents two different domains: higher (from 67 to 114 MPa) and lower values (from 58 to 64 MPa) of applied maximum stress. It can be noticed that the maximum stress,  $\sigma_m$ , in each of these domains can be approximated by a linear function of  $N_r$ . These two domains are separated by a transition zone around 65 MPa (intermediate maximum applied stress level).

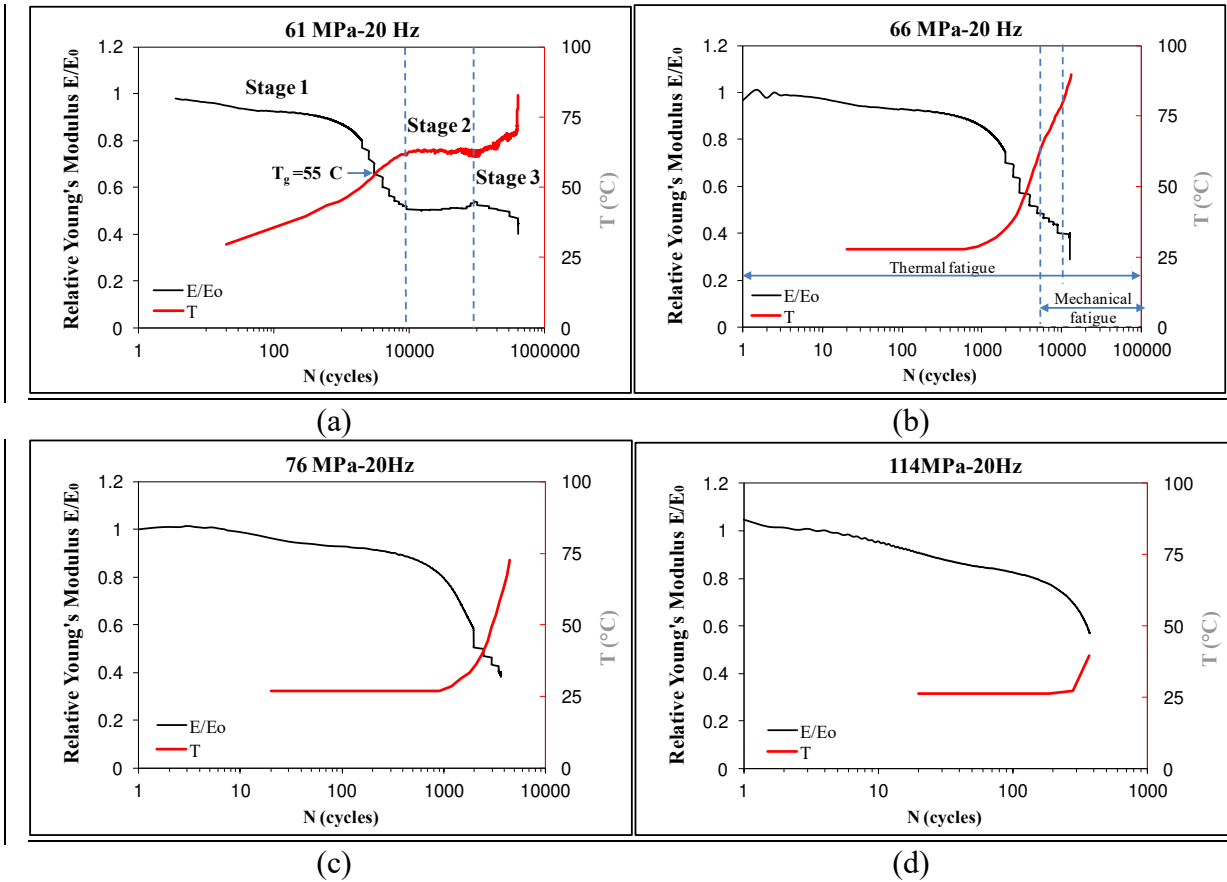
**Figure 4.** TTF curves : Evolution of the relative Young's modulus ( $E/E_0$ ) and temperature versus the number of cycles for different maximum applied stress.

The chosen frequency is high enough to induce a thermal fatigue process in PA66/GF30 composite due to the self-heating of the matrix. Indeed, the observed temperature rise is mainly due to self-heating but can also be related to damage dissipation. The TTF curves are presented hereafter through the evolution of the relative Young's modulus (defined as the ratio of the Young's modulus ( $E$ ) at cycle  $N$  to the initial Young's modulus ( $E_0$ )) versus the number of cycles. It can be noticed in the following TTF curves (figure 4) that the temperature follows the evolution of the loss of stiffness. The temperature evolution appears to be a good indicator of the fatigue behavior.

The evolution of the relative Young's modulus and the temperature has been analyzed as a function of the number of cycles. Figure 4(a) shows these results obtained for a low maximum applied stress (61 MPa)

The evolution of the relative Young's modulus and of the temperature during a fatigue test shows three stages (see figure 4(a)):

- 1) Stage 1 is characterized by a rapid decrease of the relative Young's modulus according to two regimes. Simultaneously, the temperature rises due to self-heating. This stage corresponds to the setting up of a thermal regime. One can notice that during this stage, the temperature exceeds the glass transition temperature ( $T_g=55^\circ\text{C}$ ).
- 2) Stage 2 is characterized by a plateau for both Young's modulus and temperature. During this stage, the thermal regime is established and characterized by a stable value of the temperature (up to  $63^\circ$ ) during a range of cycle from  $10^4$  to  $10^5$ .
- 3) Stage 3 is characterized by a new decrease of the Young's modulus simultaneously with a new increase of the temperature until final rupture is observed.

For intermediate level of stress (figure 4(b)) corresponding to the knee point in the Wohler curve shows an inflexion point : stage 2 (stable thermal regime) tend to disappear and stage 3

(damage) remains relatively short. Indeed, one observe that the stage 2 becomes very confined for intermediate level of stress (figure 4(b)) and both stage 2 and 3 completely disappear for higher stress level (figure 4(c) and 4(d)).

The inflexion point observed in figure 4(b) is the result of the competition between thermal fatigue and mechanical fatigue. Indeed, due to the early contribution of the damage (from 5000 cycles), the stabilized thermal regime observed for the lower stress level (stage 2 in figure 4(a)) do not succeed to take place. The application of a higher stress level tends to produce a continuously increase of the temperature mainly due to self-heating and an emerging damage. For intermediate value of the maximum applied stress level, although the effect of the damage persists, thermal fatigue tends to become predominant. For the highest values of the maximum applied stress (higher domain of the Whöler curve) fatigue response is mainly governed by thermal fatigue (self-heating). No damage stage is observed. However, one can note that self-heating is also limited when the stress level increases. Indeed, applying a high level of stress leads to a rapid failure.

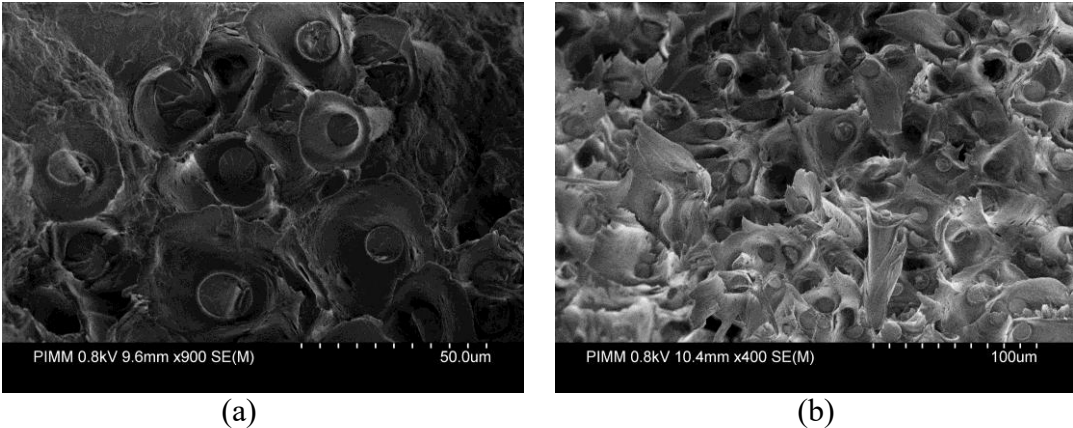
**Figure 5.** Apparition of micro-ductile areas around the fibers: (a) in the case of tension-tension fatigue test, (b) in the case of a tensile test performed at 90°C.

In order to determine the microscopic mechanisms at the origin of the fatigue behavior, SEM observations have been performed on the fracture surfaces of fatigue specimens. Micro-ductile areas have been observed around the fibers (figure 5)). This phenomenon have also been observed in the case of high strain rate loading performed on thermoplastic composites [6]. These local deformations are distributed over the whole observed fracture surfaces and are mainly due to stress concentration around the fibers leading to a more intensive self-heating localized around the fiber-matrix interface.

During a fatigue test, the presence of the fiber creates heterogeneous stress and strain fields enhancing locally self-heating due to cyclic variations of the applied stress. Consequently, the cyclic variations are more intensive around the fiber. The average temperature consecutive to self-heating is higher around the fiber. This temperature gradient leads to a more clear failure in fatigue (figure 5(a)) than in the case of the tensile test performed at 90°C (figure 5(b)).

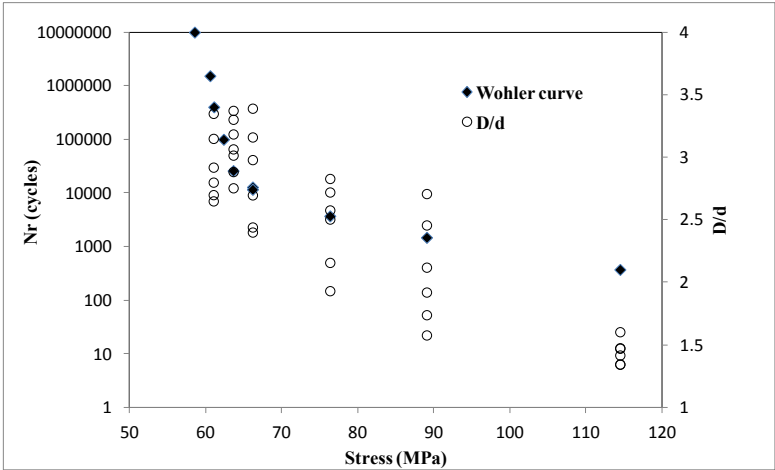
**Figure 6.** Evolution of the size of the micro-ductile areas as a function of the maximum applied stress.

Image analysis have been performed on the fracture surfaces.  $D$  is defined to be the diameter of the locally deformed area and  $d$  corresponds to the diameter of the considered fiber. In order to understand the influence of this local effect on the fatigue life, a statistical quantitative analysis relating the size of these micro-ductile areas to the maximum applied stress is proposed hereafter. Each measurement of  $D$  corresponds to average of 4 values. The evolution of the ratio  $D/d$  is plotted in figure 6 as a function of the maximum applied stress together with the number of cycle at rupture. The micro-ductile areas are observed for

maximum applied stresses ranging from 61 to 114 MPa. In this range, D/d decreases with the maximum applied stress.

When the composite is submitted to lower applied loads the whole specimen is firstly submitted to a quit uniform temperature consecutive to self-heating. However, at the microscopic scale, due to the concentration of stress, the micro-ductile zone around the fibers keep on developing (average D/d up to 3) over the whole volume of the specimen. Note that in this case, around 80% of the fracture surfaces show micro-ductile zones.
