Ibrahim Messaoudene, Laurent Molez, Raoul Jauberthie, Oussama Kessal,  
Lahcene Slama

Ibrahim Messaoudene, Laurent Molez, Raoul Jauberthie, Oussama Kessal, Lahcene Slama. Effect of The Quenching in Water of the Cementitious Materials Subjected to Fire . *Courrier du Savoir*, 2015, 20, pp.09-14. hal-01365986

# EFFECT OF THE QUENCHING IN WATER OF THE CEMENTITIOUS MATERIALS SUBJECTED TO FIRE

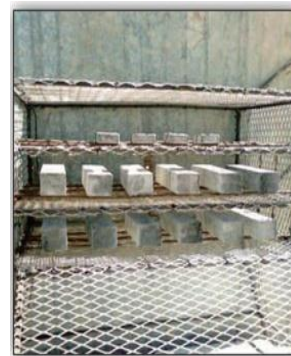
**Figure 1: The arrangement of the test body**

To simulate a real fire, we proceeded to fabricating a device which ensures a homogeneous distribution of fire on all samples of cement pastes and mortar (see Fig. 1). The device in the form of a cage is composed of high temperatures resistant steel rods. It consists of three superimposed rooms separated by grids to facilitate the dissemination of heat through the test body. The device is instrumented with thermocouples.

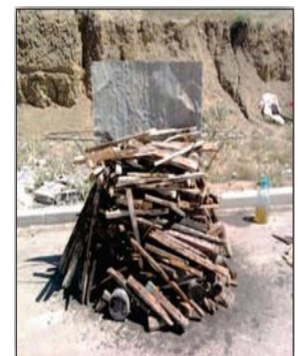
**Figure 2: Test body covered with wood**

The body's tests are covered by wood. The fire is lit on a bed of gasoil (see Figs. 2 and 3). The wood is added in a regular way to maintain the fire for one hour. This choice is guided by fire conditions and emergency intervention. The test is conducted in the open-air in spring weather at a temperature of  $23^\circ\text{C}$  and a moderate wind from the

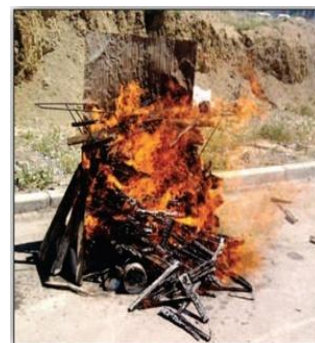
**Figure 3: Test fire**

The flame and the surface of the body's test temperature is recorded every 10 min. At the end of the test, the flame has reached  $700^\circ\text{C}$  and  $410^\circ\text{C}$  for the surface of the test body. The fire is allowed to turn in air.

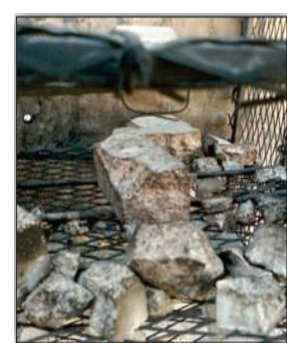
**Figure 4: Burst test bodies**

The fire resulted the bursting of test body (Fig. 4). However, four specimens and two pastes have kept their good form and are subject to two types of cooling before to be tested: cooling at ambient air and sudden quenching in water.

The bursting of test body is explained by rapid heating of its surfaces. Rapid heating causes thermal stresses, from the high thermal gradients that create compressive stresses and tension in the structure. Khoury (3) considers that these constraints have a key role to play in instabilities due to the geometry of the material. Kanema Tshimanga (4) shown that the phenomenon of bursting happens for surface temperature between  $300$  and  $350^\circ\text{C}$  (in our case  $410^\circ\text{C}$ ).
