EFFECT OF THE QUENCHING IN WATER OF THE CEMENTITIOUS MATERIALS SUBJECTED TO FIRE

IBRAHIM MESSAOUDENE ^(1,3), LAURENT MOLEZ ⁽²⁾, RAOUL JAUBERTHIE ⁽²⁾, OUSSAMA KESSAL ⁽³⁾, LAHCENE SLAMA ⁽³⁾

KEYWORDS: Cementitious materials, wood fire, quenching in water.

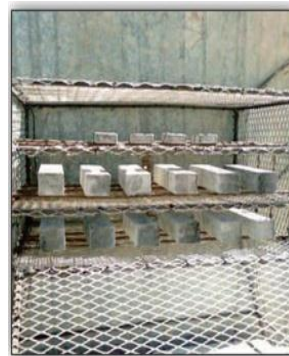
To simulate a real fire, we proceeded to fabricating a device which ensures a homogeneous distribution of fire on all samples of cement pastes and mortar (see Fig. 1). The device in the form of a cage is composed of high temperatures resistant steel rods. It consists of three superimposed rooms separated by grids to facilitate the dissemination of heat through the test body. The device is instrumented with thermocouples.

Figure 1: The arrangement of the test body

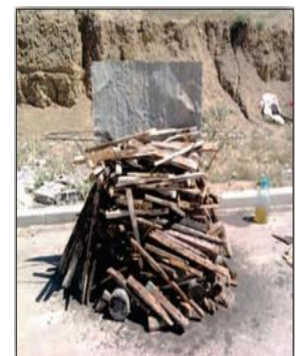
The body's tests are covered by wood. The fire is lit on a bed of gasoil (see Figs. 2 and 3). The wood is added in a regular way to maintain the fire for one hour. This choice is guided by fire conditions and emergency intervention. The test is conducted in the open-air in spring weather at a temperature of 23°C and a moderate wind from the

Figure 2: Test body covered with wood

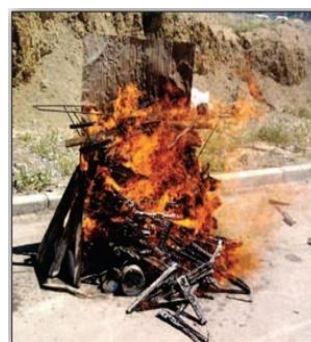
The flame and the surface of the body's test temperature is recorded every 10 min. At the end of the test, the flame has reached 700°C and 410°C for the surface of the test body. The fire is allowed to turn in air.

Figure 3: Test fire

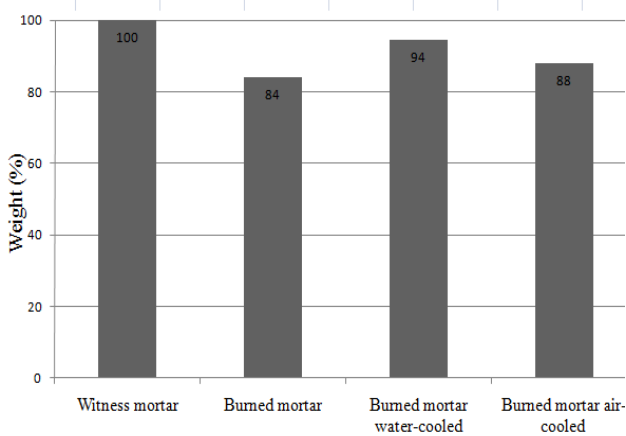
Figure 5 shows the evolution of the masses of mortar specimens for both cooling methods: cooling at ambient air

and sudden quenching in water. The masses of burned mortar were compared to the mass of the witness mortar (30 days of curing in water). The specimens are weighed until stabilization of the masses.

- The burned mortar has undergoes strong mass loss (16%) resulting from the departure of the free water and bound water.
- The burned mortar and cooled in water has regained 10% its lost mass. This can be explained by re-saturation of specimens and probably a new rehydration of cement components.

On the other hand, the burned mortar and cooled at ambient air is characterized by very low weight gain (4%). It can be explained by a water uptake in the pores due to moisture from the air.

Figure 5: Evolution of mortar mass

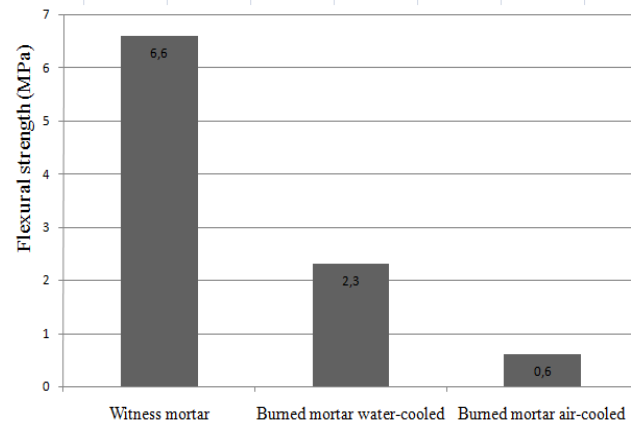
Figure 6 shows the average of residual and relative strengths (normalized to resistance of the witness mortar unheated) to the 3-point bending obtained for the different types of mortars. Whatever the mode of cooling of burned mortar, flexural strengths show a significant drop: 70% for the water-cooled mortar and 90% for the air-cooled mortar.

Figure 6a : Flexural strength

Figure 6b: Flexural strength: values normalized to the strength of witness mortar

These resistances are consistent with the evolution of mortars mass. This confirms that the re-humidification in water allows a new hydration of cement components. However; this rehydration has no appreciable effect on the

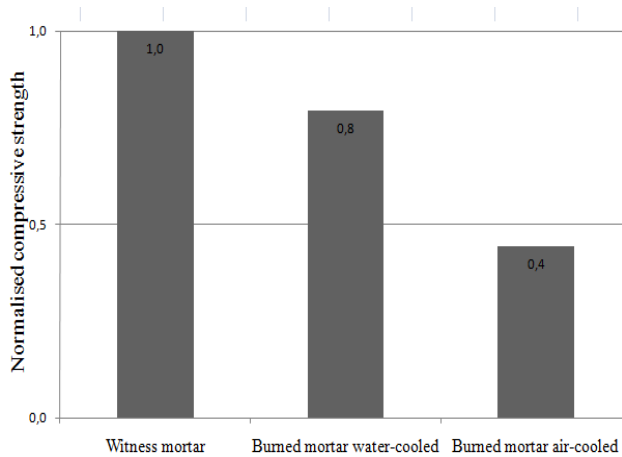
Figure 7 shows the average of residual and relative compressive strength obtained for the different types of mortars. The strength of air-cooled burned mortar dropped significantly (about 60%), while that the burned mortar cooled in water dropped by about 20%.

Figure 7a: Compressive strength

Figure 7b: Compressive strength: values normalized to the strength of witness mortar
