Comparison of damaging behavior of oxide scales grown on austenitic stainless steels using tensile test and cyclic thermogravimetry

E. Fedorova, M. Braccini, V. Parry, C. Pascal, M. Mantel, F. Roussel-Dherbey, D. Oquab, Y. Wouters, D. Monceau

E. Fedorova, M. Braccini, V. Parry, C. Pascal, M. Mantel, et al.. Comparison of damaging behavior of oxide scales grown on austenitic stainless steels using tensile test and cyclic thermogravimetry. Corrosion Science, 2016, 103, pp.145-156. 10.1016/j.corsci.2015.11.012 . hal-01367841

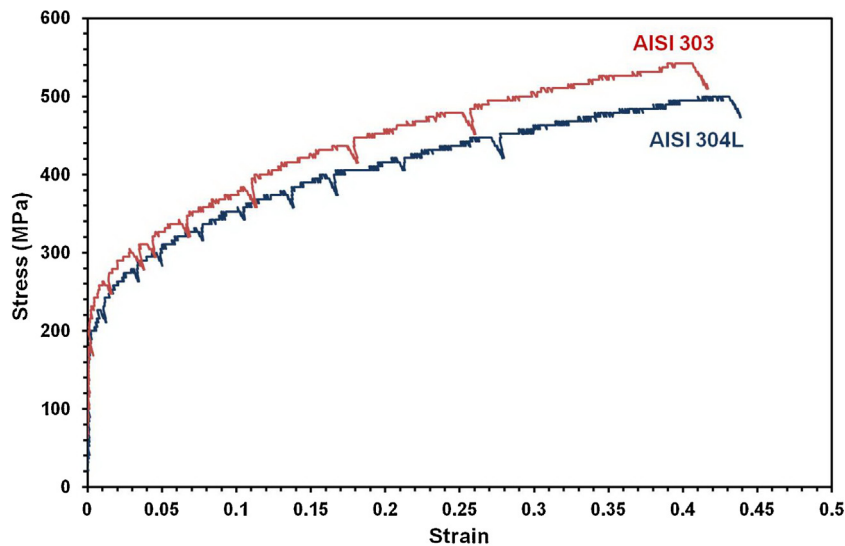
Fig. 5. Stress-strain curves of AISI 303 and AISI 304L steels obtained during tensile tes.

In situ SEM tensile tests were driven on the isothermally oxidized steels (50 h at 1000 °C). The two stainless steels exhibit similar stress–strain curves (see Fig. 5) even if the AISI 303 steel seems to have a slightly higher hardening rate. Nevertheless, the behavior of the oxide layers were quite different (see Fig. 6). While we observed transverse crack initiation and growth in the oxide scale for both steels, the crack patterns were different. In both cases the cracks grew perpendicular to the tensile direction, but while cracks in the oxide scale of the AISI 303 steel propagated straightly (Fig. 6b), the ones in the AISI 304L steel looked like waves (Fig. 6c). During the in situ SEM tensile tests, cracks are observed earlier in

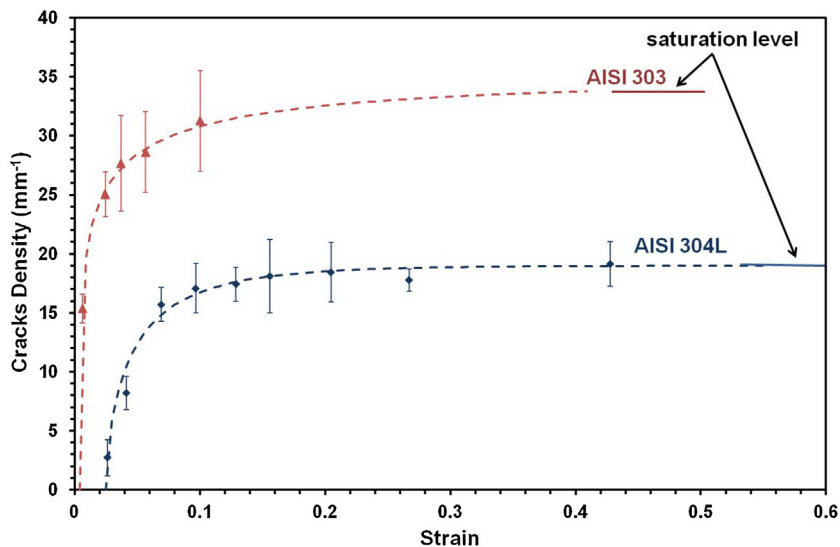
Fig. 7. Crack density evolution during in situ tensile test.

$d(\epsilon) = d_{sat} \{1 - \exp[-A(\epsilon - \epsilon_c)^n]\}$ (1) where d_{sat} is the crack density at saturation, ϵ_c the critical strain for the cracking of the film, and A and n are constants. d_{sat} is determined by experimental measurement. ϵ_c is obtained by an extrapolation at $d=0$. A and n are obtained by fitting the linear plot of $\ln(-\ln(1 - d/d_{sat}))$ as a function of $\ln(\epsilon - \epsilon_c)$. The parameters obtained for the two samples are given in Table 2. Those parameters reflect what can be observed on the graph and confirm a more brittle behavior of the AISI 303 oxide scale: lower critical strain for crack initiation ϵ_c and higher saturation density of cracks d_{sat} . The values for the n exponent found here are similar to the ones obtained in a previous work on passivation films deposited on an aluminum substrate [17].

So, both oxide scales exhibit a similar cracking behavior composed of three stages: crack initiation, increase in crack density and finally saturation, i.e. strain without additional cracks. Nevertheless, cracking mechanisms are different for each steel. For AISI 304L, crack initiation appears more difficult and happens for a higher strain value. From cross-section observations after tensile testing (Fig. 8a), the transverse cracks in the oxide layer can be linked to grain boundaries in the metal underneath. So in this case, the cracks may initiate at the metal/oxide interface, facing grain boundaries. Those grain boundaries are themselves embrittled by the growth of SiO₂ oxides. If the cracks grow from the interface up to the surface, this explains their wavy-shape because they follow the morphology of the grain boundaries underneath. In the AISI 303 specimen, the cracks initiate for a lower strain value and most probably from internal flaws in the porous Fe-rich oxide. The cross section in Fig. 8b shows that grain boundaries in the metal also opened during the tensile test, however, here, transverse cracks in the oxide scale grew not only facing these opened grain boundaries but also between them. Finally, in AISI 303 the porosity of the oxide scale also eases the cracks' growth, they can therefore propagate in straight lines, perpendicular to the tensile direction.

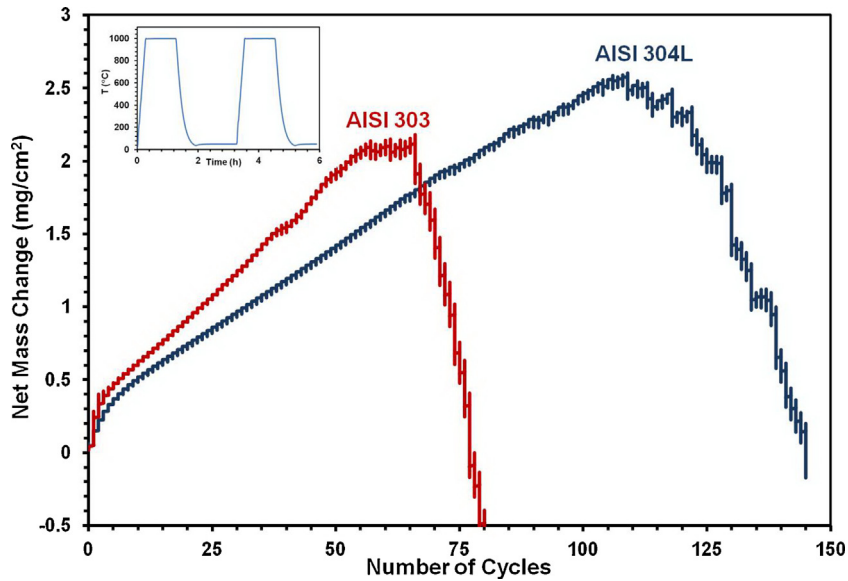
Fig. 9. Cyclic oxidation behavior of AISI 303 and AISI 304L samples at 1000 °C and thermal profile of the first two cycles.

as a function of the number of cycles for AISI 303 and AISI 304L samples are compared in Fig. 9. Oxidation kinetics data includes the mass gain due to oxidation (uptake of oxygen) and the mass loss due to spalling (loss of oxide). Results show the similar cyclic oxidation behavior of the two steels. Indeed, the general shape of the curves is identical. Nevertheless, for AISI 303 steel, the initial oxidation rate was higher and spallation events began earlier than for AISI 304L. The cyclic oxidation behavior revealed the expected improvement in scale retention as the S content decreased. After 55 cycles, the AISI 303 alloy sample underwent significant oxide spallation and drastic loss of oxide scale after 73 cycles, whereas the same phenomena both occurred at 110 cycles for the AISI 304L alloy. The lifetime is approximately doubled between AISI 303 and AISI 304L. It can also be seen that the breakdown of the oxide scale occurs for a higher M^{NMC} for alloy AISI 304L, which means that AISI 304L is able to retain a thicker oxide scale than alloy AISI 303.

A second observation is that the oxidation kinetics are not parabolic for both alloys. For alloy AISI 304L, the initial M^{NMC} shape is apparently parabolic up to 15 or 20 cycles before becoming linear. For alloy AISI 303, apparent linear kinetics is found after only a few cycles.

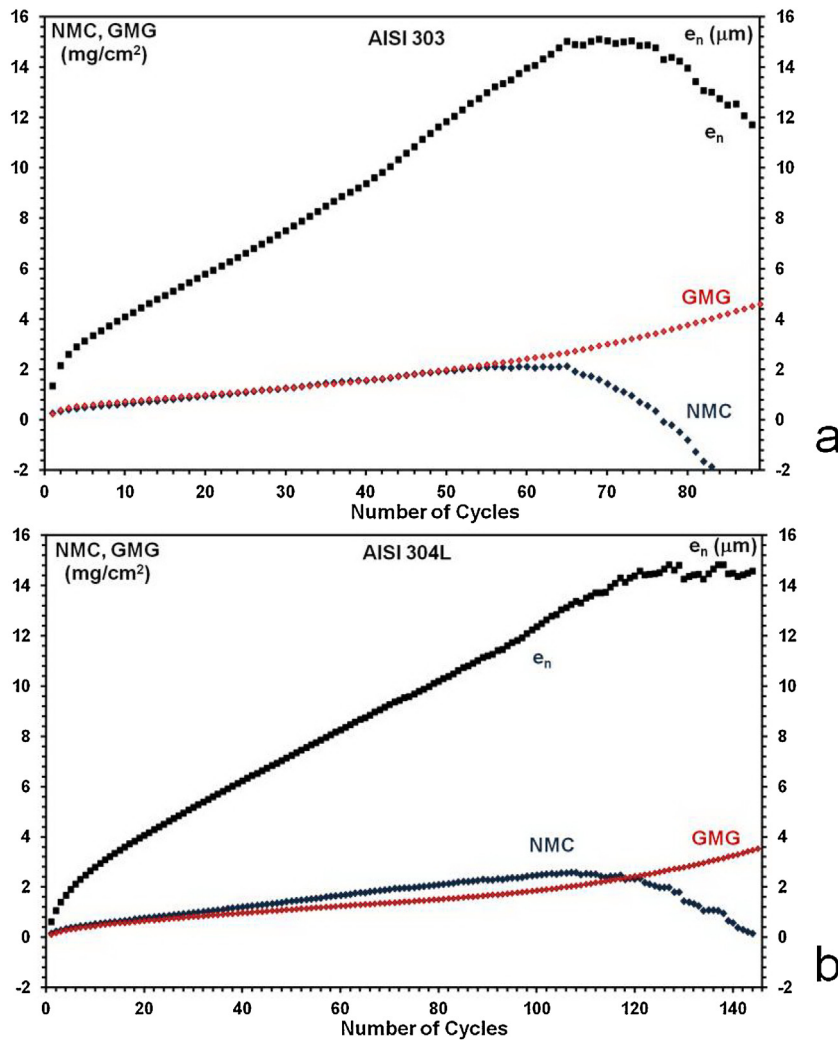
Fig. 10. Net Mass Change (NMC), Gross Mass Gain (GMG) and average oxide scale thickness (e_n) for AISI 303 (a) and AISI 304L (b) using thermogravimetry during thermal cycling at 1000 °C.

The resulting values for AISI 303 and AISI 304L are plotted in Fig. 10 as a function of the number of cycles. The oxidation during the non-isothermal periods was neglected compared to the oxidation during the high temperature dwell. This approximation leads to a small error, as can be seen in Fig. 10b (AISI 304L), where the gross mass gain and the net mass change curves cross while the gross mass gain should be equal to the net mass change in the absence of spallation and higher than the net mass change when

Despite this slight approximation, it can be clearly seen from the graphs that the oxide scale thickness increases almost linearly after about 5 cycles for AISI 303 and after 20 cycles for AISI 304L. Break-away occurred at 5 and 20 cycles respectively, meaning that the oxide scale does not offer a good diffusion barrier and that oxidation kinetics is controlled by the reaction rate. The average oxide scale

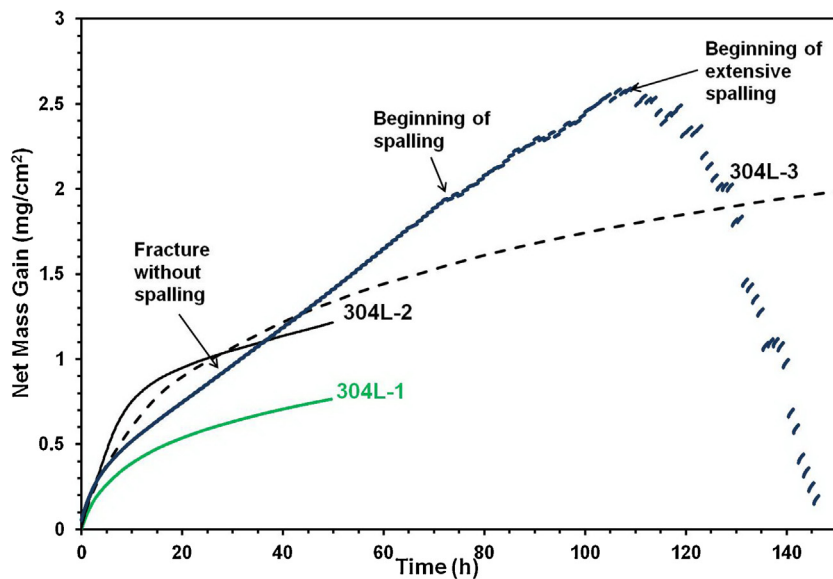
Fig. 11. Net Mass Change of AISI 304L samples oxidized during 50 h (304L-1, 2) and 150 h (304L-3) in isothermal condition at 1000 °C and during 145 cycles of 1 h at 1000 °C under synthetic air flow for the same flow rate. Mass gain during heating and cooling is not included.

protective parabolic behavior after 10–15 h (Fig. 11). During thermal cycling, the same thing occurs at the beginning, but a few cycles after the establishment of an oxygen diffusion barrier of a few micrometers thick oxide (Fig. 10), fractures of the scale occur during cooling inducing an enhanced re-oxidation during next heating cycle and high temperature dwell. This causes the overall oxidation kinetics to increase from a parabolic law to a linear law. The oxide scale becomes thicker than for isothermal kinetics and such enhanced oxidation kinetics eventually leads to the spalling of the oxide scale. Spalling during isothermal oxidation does not occur because of the absence of thermal stresses and because the oxide scale is thinner than for thermal cycling. Nevertheless, as reported in our previous paper [9], some spalling occurs during the final stage of cooling of the 50 h isothermal experiment.
