EXPERIMENTAL INVESTIGATION ON THE SIGNIFICANCE OF THE CONVENTIONAL ENDURANCE LIMIT OF A SPHEROIDAL GRAPHITE CAST IRON

T. PALIN-LUC,¹ S. LASSERRE¹ and J.-Y. BERARD²

Abstract—Fatigue tests were performed on a spheroidal graphite cast iron in four point plane bending under constant stress amplitude and block loading conditions. The microstructure of this material has a ‘bull’s eyes’ appearance, i.e. the spheroids of graphite are surrounded by ferrite and these nodules and ferrite zones are included in a pearlitic matrix. Scanning electronic microscope observations were carried out at different fractions of life for constant stress amplitude loadings above and below the conventional endurance limit. Non-propagating micro-cracks were observed at a stress level equal to the conventional endurance limit. These observations showed that another limit can be defined below the conventional endurance one, i.e. one below which micro-cracks were not observed to initiate in the matrix. These cracks were found to arrest at the ferrite/pearlite interface when the material was tested below this new limit. This concept was used to rationalize fatigue results from tests with loading in blocks above

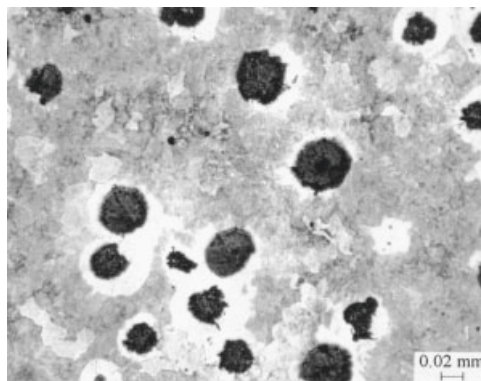
Fig. 1. Optical micrograph of the spheroidal graphite cast iron (after nital etching).

The test material was a spheroidal graphite cast iron with a pearlitic matrix (close to FGS 800-2 AFNOR standard) as used in the production of engine crankshafts. Ferrite was localized around the spheroids of graphite, with the ferrite and nodules included in a pearlitic matrix. This structure is called ‘bull’s eyes’ (Fig. 1). The chemical composition of this material was as follows (wt%): C = 3.50–3.90, Si = 1.80–2.80, Mn = 0.85, Cu = 0.03, Sn = 0.01, Ni = 0.03, S < 0.02, P < 0.05. After the heat treatment of heating and holding at 920°C for 1–2 h, slow cooling at 870°C for 3–4 h, then air cooling, the main mechanical characteristics of this cast iron are as follows: Young’s modulus = 164.9 GPa, Poisson’s ratio = 0.275, Proof (0.02%) stress = 320 MPa, $S_m = 795$ MPa, $A = 9\%$, $S_d = 280$ MPa, $S_d(sq) = 268$ MPa.

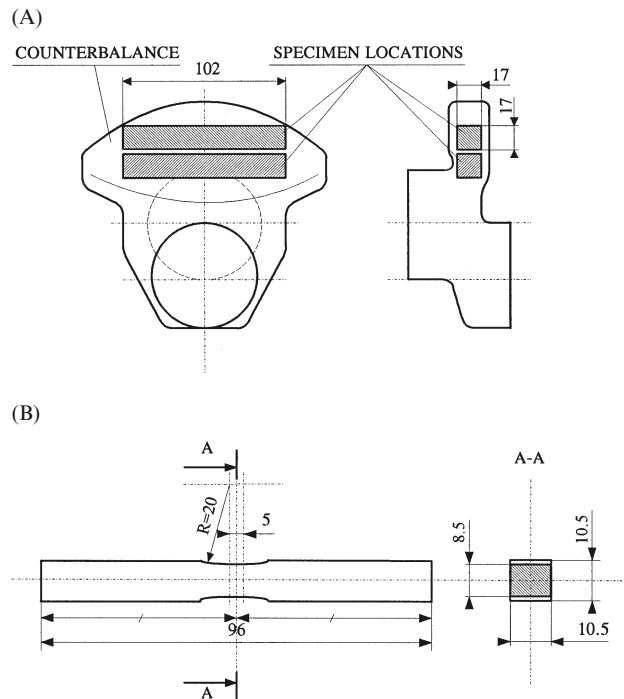
Fig. 2. (A) specimen locations in the crankshaft counterbalance; (B) geometry of specimens (dimensions in mm).

All the specimens used in this study were machined from the counterbalances of crankshafts after casting and the heat treatment described above. Parallelepiped blocks were cut in the counterbalances as indicated in Fig. 2(A) and then specimens were machined from these blocks to dimensions shown in Fig. 2(B). The testing area was ground and polished with emery paper of 1000 grade and finished with diamond powder (2 μ m grain size).

Five specimens of square cross-section (Fig. 2(B)) were loaded in fully reversed four point plane bending under constant stress amplitude. Their conventional endurance limit (infinite life) under this loading is $Sd(sq) = 268$ MPa. Four stress amplitudes were chosen: 280, 268, 230 and 180 MPa. According to the $S-N$ curve of the material the probabilities of failure before 10^6 cycles under the stress amplitudes 280 and 268 MPa, respectively, are: 0.50 and 0.12. For 230 and 180 MPa these probabilities of failure are less than 3×10^{-6} which are low enough to consider that the behaviour of the specimens loaded under these amplitudes was not representative of any phenomenon linked with the endurance limit. Each specimen was loaded under one of these stress amplitudes and then observed in the SEM during test interruptions. However, under 268 MPa two specimens were tested.

specimens were cut from the crankshafts. Specimens were produced from cast iron which was located far from the geometric centre of the crankshaft (Fig. 2). In such an area of the component, which is not the last solidification area of liquid metal, there is very little chance to find microporosities. On the contrary, when the specimens are machined at the centre of cast rods [4,6,12] or from large blocks [7] there is a greater probability to have porosities because specimens are made with the last solidified metal.

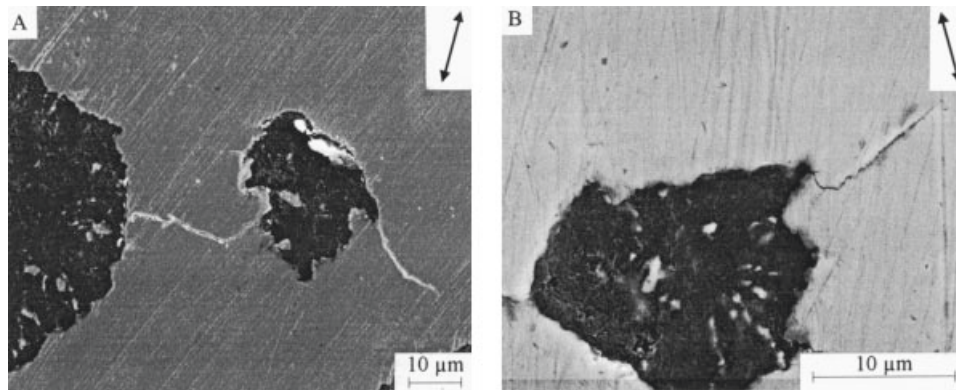
Fig. 3. SEM observations of a specimen surface loaded at (A) 280 MPa, (B) 268 MPa; each after 50,000 cycles. Arrows indicate loading direction.

- (i) either the distance between two spheroids is less than 20 μm which is approximately the diameter of spheroids (Fig. 3(A));
- (ii) or the shape of the spheroid is very irregular and a micro-crack initiated at a spheroid sharp edge (Fig. 3(B)).

The high stress concentrations generated by the spheroids in these two cases explained the crack initiation behaviour.

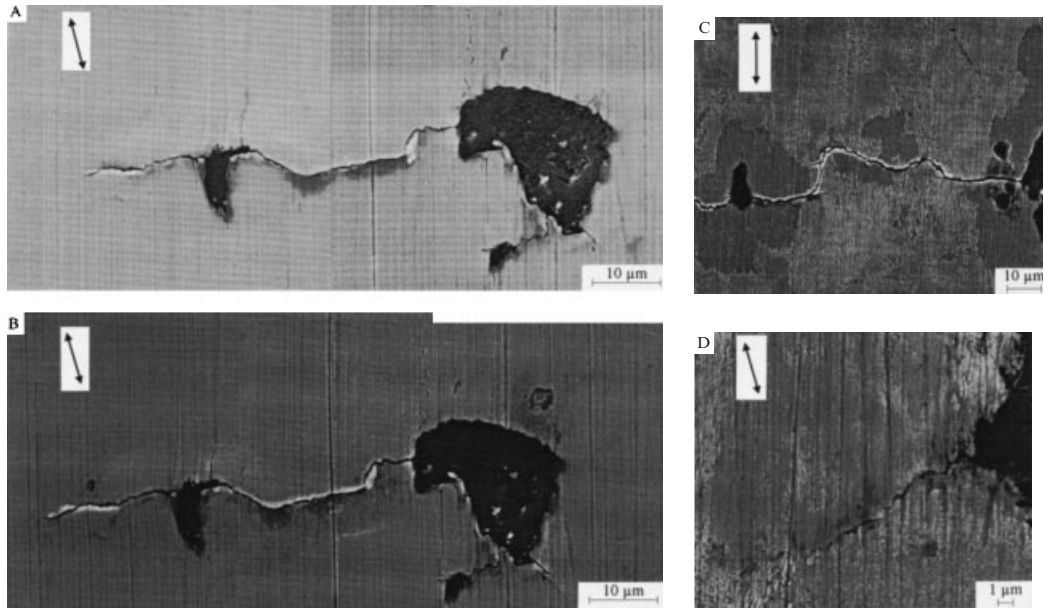
Fig. 4. SEM observations of a specimen surface. Arrows indicate loading direction. (A) loaded at 268 MPa for 150,000 cycles, (B) loaded at 268 MPa for 10^6 cycles. (C) 268 MPa for 10^6 cycles; after a nital etching. (D) 180 MPa for 10^6 cycles; after a nital etching.

Under the three higher stress levels (280, 268 and 230 MPa) several micro-cracks initiated and propagated between zero and 150,000 cycles. After this number of cycles, micro-cracks did not evolve significantly (see Fig. 4(A) and (B)). On the specimen loaded at 180 MPa, the micro-cracks which appeared between 150,000 and 300,000 cycles did not grow, even after 10^6 cycles. They were always very small (Fig. 4(D)).

The observations on specimens after a nital etching showed that micro-cracks had propagated across the pearlitic matrix of the material when the specimens were loaded at the three higher stresses (see example in Fig. 4(C)). On the specimen loaded at the lower stress amplitude, 180 MPa, micro-cracks never propagated across the matrix, i.e. they never propagated through the boundary between ferrite and pearlite even after 10^6 cycles of loading (Fig. 4(D)).

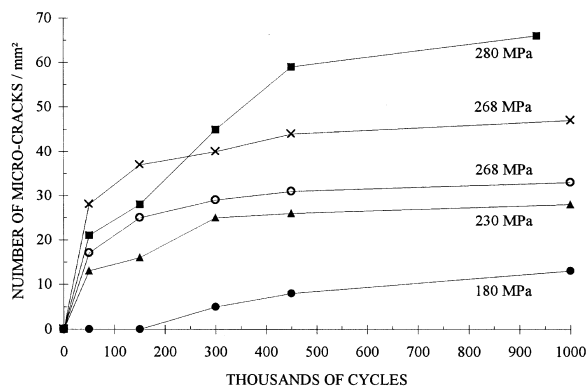
Fig. 5. Evolution of the surface density of micro-cracks for each specimen.

was scanned. The evolution of the surface density of micro-cracks as a function of the number of cycles is shown in Fig. 5.

For the specimen loaded at a stress amplitude of 180 MPa, the surface density of micro-cracks increases more slowly than for the other specimens loaded at higher stresses. The first micro-cracks appear between 150,000 and 300,000 cycles for a stress amplitude of 180 MPa while they initiate before 50,000 cycles for the higher stress amplitudes as shown in Fig. 5.

Furthermore, the curves in Fig. 5 flatten out and have an horizontal asymptote. It seems to prove that the number of micro-cracks does not evolve when the number of loading cycles tends to infinity ($> 10^6$ cycles). This conclusion has to be moderated because the counting method used

to draw these curves did not take into account the micro-cracks which have coalesced between two observation stages. When two micro-cracks coalesced only one micro-crack was counted. Nevertheless, this disadvantage of the method is not important for the significance of Fig. 5 for the number of cycles below 300,000. Up to this number only a few coalescences were observed; at the lowest stress amplitude no coalescence was ever observed.

The curves shown in Fig. 5, corresponding to the two specimens loaded at 268 MPa, are somewhat different from each other. This difference is probably due to the very large scatter of the number of cycles to failure when the stress level is near the endurance limit. On one of these two specimens a macro-crack was detected after 933,500 cycles in the fatigue testing machine; the test was stopped. This specimen was probably a 'weak specimen'.

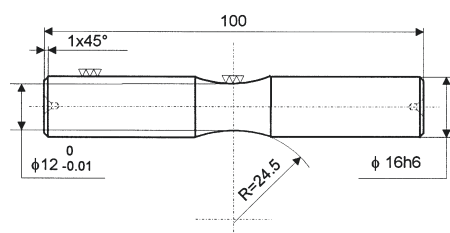
Fig. 6. Specimen used for cumulative damage tests (dimensions in mm).

Cumulative damage tests, in a stress-block format, have been done on smooth cylindrical specimens (Fig. 6) in the same material as before. The specimens were ground; the roughness of the median torus is such that $Ra < 0.2 \mu\text{m}$. This torus creates a theoretical stress concentration factor of 1.07 in bending. Each specimen was loaded in four point plane bending; each loading was composed of two different types of blocks (low and high) alternatively applied to the specimen until failure (Fig. 7). The block duration was fixed at 5000 cycles. Transition between two blocks was less than 10 cycles at the operating frequency of 50 Hz. This can be neglected when compared with the duration of one block.

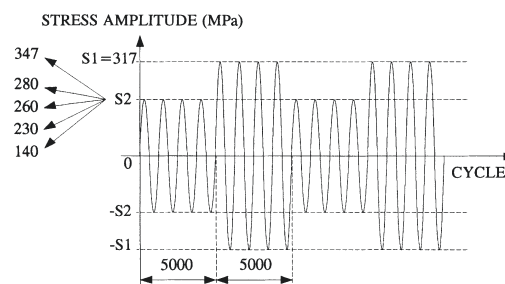
Fig. 7. Loading in blocks. S_1 is the same for all the specimens, S_2 is specimen-dependent.

Five test series were carried out. Several loadings were applied on 50 specimens (10 in a series). One type of block was fixed to a fully reversed stress amplitude S_1 of 317 MPa (above the endurance limit), the corresponding median life on the $S-N$ curve is 315,000 cycles. Five different stress amplitudes S_2 were tested for the second type of block: 140, 230, 260, 280 and 347 MPa (Fig. 7). In plane bending, the conventional endurance limit of the specimens used (Fig. 6) is $S_d = 280 \text{ MPa}$; this is different from the limit of the specimens with a square cross-section $S_d(sq)$ [9]. Under a loading where the two blocks have the same amplitude (317 MPa) the lifetime is

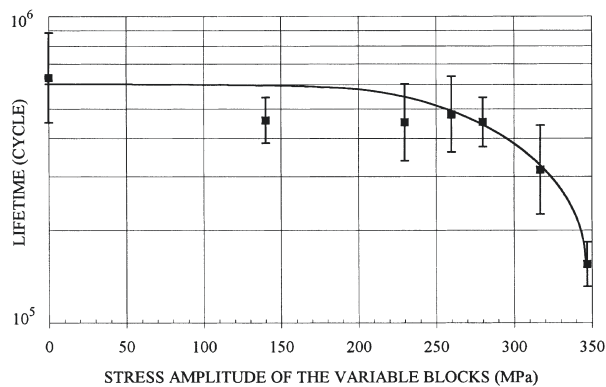
Fig. 8. Cumulative damage test results.

Fatigue test results are shown in Fig. 8. This figure shows the lifetime as a function of the different stress amplitudes S_2 used in tests. The points represent the median lives, the bar lines show the standard deviation of the lifetime. Note that 68% of the test results are within each scatter band.

Figure 8 shows that the total life of the specimens under block loading (with blocks below the endurance limit) is shorter than the expected life if these blocks did not contribute to the damage process. On the tested spheroidal graphite cast iron specimens, blocks below the endurance limit participate in damage when they are applied to specimens with other blocks above the endurance limit. Furthermore, the curve of Fig. 8 proves that when the amplitude of the low blocks is higher than about 210–250 MPa, their influence is more significant than when they are below 210 MPa.

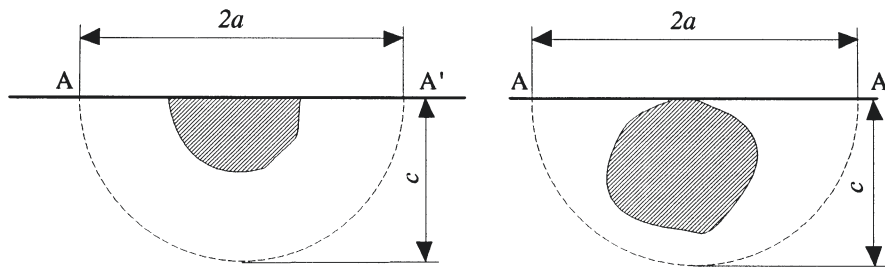
Fig. 9. Three-dimensional aspect of a micro-crack around a spheroid (from [4,6]).

A number of assumptions have to be made about the equilibrium shape of the observed micro-cracks. We have supposed (as proposed in [4] and [6]) that micro-cracks are in one of the configurations illustrated by Fig. 9. Even if the apparent size of a nodule at the surface is small we suppose, as suggested in [6], that the nodules behave like holes which give rise to the formation of a crack on their equatorial plane. With this assumption, Fig. 10(A) illustrates the non-propagating crack length ($2a$) observed on the surface of the tested specimens versus the stress amplitude.

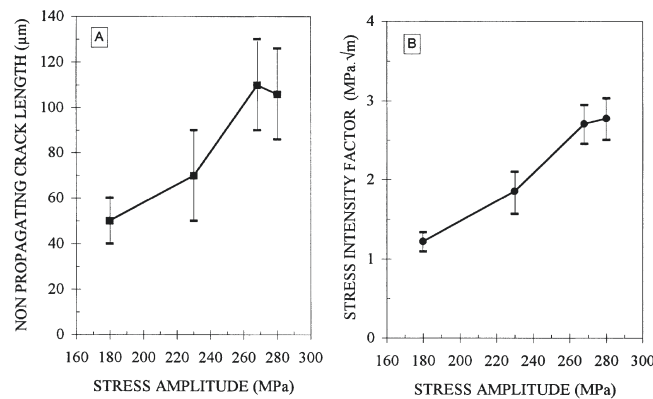
Fig. 10. The effect of stress amplitude on (A) non-propagating crack length, $2a$, and (B) maximum value of the stress intensity factor.

Each scatter band represents 68% of the measured crack lengths $2a$ (5 to 10 micro-cracks at each stress amplitude).

For a plate specimen, with finite thickness t , in a bending configuration the real crack shape at equilibrium is a semi-circle [13] such that $c/a = 1$. By using the results of Scott and Thorpe [13] we have plotted in Fig. 10(B) the maximum of the stress intensity factor, K_{\max} , versus the stress amplitude applied to the specimen; dark marks represents the K_{\max} value corresponding to the mean value of crack length, each segment shows the scatter associated with the scatter of crack length (values calculated with 5 to 10 micro-cracks). These values of K_{\max} were calculated at the intersection AA' between the nodule and the specimen surface (Fig. 9), where its value is higher than along the other parts of the particule contour [6].

The fatigue tests reported in this study were done in plane bending with $R_\sigma = S_{\min}/S_{\max} = -1$. It is difficult to compare the previous values of K_{\max} with the values given in the literature because they are usually given for a stress ratio $R_\sigma > 0$. Nevertheless, we can see in Fig. 10(B) that at the endurance limit ($Sd(sq) = 268$ MPa) of the specimen $K_{\max} = 2.7$ MPa \sqrt{m} for cracks arrested in the pearlitic matrix. This value is close to the threshold value reported in [6] for tests with plate specimens loaded in plane bending ($R_\sigma = 0.1$) at their endurance limit, i.e. $K_{\max} = 3.1$ MPa \sqrt{m} ; this value corresponds to short cracks (length of about 0.1 mm) arrested in the matrix of a ferritic spheroidal graphite cast iron. For the micro-cracks which are arrested at the interface between ferrite and pearlite (specimen loaded at 180 MPa) the stress intensity factor is small, $K_{\max} \approx 1$ MPa \sqrt{m} , compared with the corresponding value at the endurance limit. We can conclude that this is an approximate value of the threshold of the stress intensity factor for micro-cracks arrested at the ferrite/pearlite interface for a bull's eyes cast iron.
