# In-situ SEM study of fatigue crack growth mechanism in carbon black-filled natural rubber

S. Beurrot, B. Huneau & E. Verron

*Institut de Recherche en Génie Civil et Mécanique UMR CNRS 6183,  
École Centrale de Nantes, Nantes Cedex, France*

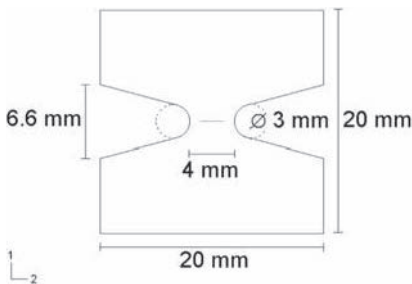
Figure 1. Geometry of samples.

As mentioned above, a special shape of sample was chosen in order to achieve large strain in crack vicinity and to propagate it; the corresponding geometry is shown in Figure 1.

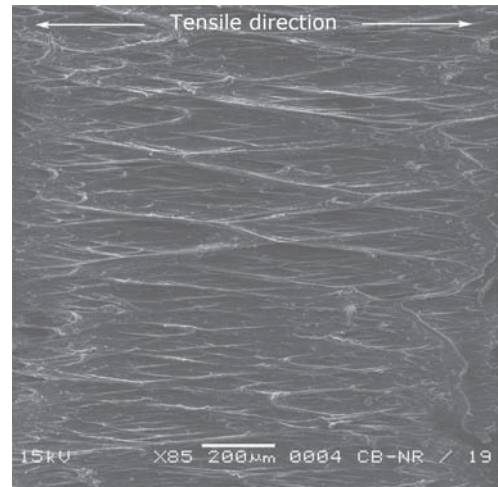
Figure 2. Top view of a representative crack tip.

Figure 2 presents the front view of the fatigue crack tip. In the former figure, tensile direction is indicated by white arrows and the propagation direction is normal to the photomicrograph. As observed previously (Le Cam et al. 2004; Hainsworth 2007), the crack tip is composed of number of diamond-shaped zones separated by ligaments. The pattern of ligaments and diamond-shaped zones can be described as multi-scaled as large diamond-shaped zones delimited by large ligaments are themselves made up of smaller zones delimited by smaller ligaments. The diamond-shaped zones are flat and smooth compared to the ligaments, and those ligaments emerge from the smooth surfaces. The most noticeable characteristic of the crack tip is the pattern regularity. Surprisingly, the ligaments are not parallel to the tensile direction. In fact, they are parallel to two directions which are symmetric with respect to the tensile direction. The angle between the direction of ligaments and the loading direction decreases with the extension of the sample. Consequently, at a given deformation even if the size of diamond-shaped zones varies, all of them have the same length-width ratio. For instance, in Fig. 2, this ratio is 4 to 1. Nevertheless, the size of the diamond-shaped zones is not uniform; indeed the knots of the pattern are not regularly located. Finally, the crack tip also contains another relief feature: as it will be established in

the following, it corresponds to previously broken and then shrunk ligaments. They are located at the knots of the pattern, i.e. at the intersection of the ligaments.

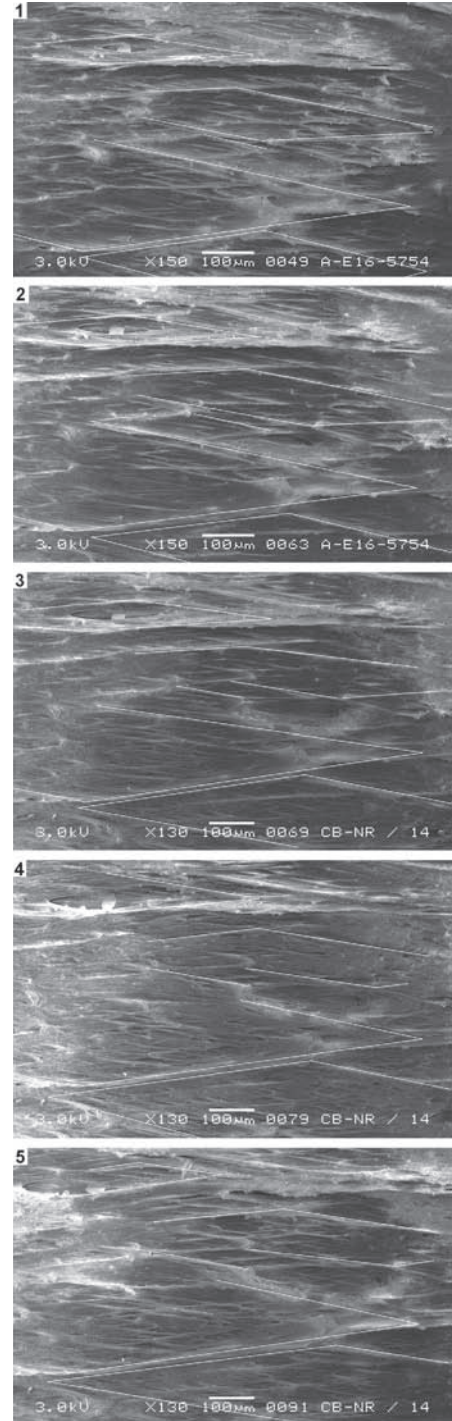
Figure 4. Evolution of a crack tip during cyclic loading after respectively 1, 10, 21, 31 and 41 in-situ cycles.

Figure 4 shows six SEM images of a  $0.5 \text{ mm}^2$  area of the crack tip taken respectively for the maximum stretch of in-situ fatigue cycles 1, 10, 21, 31 and 41. The micromechanism of fatigue crack growth in rubber can be established thanks to this figure. From one SEM image to another, it clearly appears that all the crack tip zones are affected by crack growth: positions of ligaments change with loading as shown by the white lines drawn on images. It means that the crack front is a surface rather than a line. Moreover, the evolution of the diamond-shaped zones suggests a three-step mechanism for crack propagation as emphasized in Figure 5. In order to describe this evolution, we choose Fig. 5 (a) as the reference state of the zones. Under loading, zones become larger (see changes between Fig. 5 (a), (b) and (c)), and cavities and inclusions appear on the surface (see Fig. 5 (c)). It means that the matter tears and the zone grows deeper in the direction normal to the crack surface, i.e. the direction of crack growth (it cannot be seen in the figure). The more the zone goes deeper, the more the ligaments which delimit it are stretched. Then after a few number of cycles, one of these ligaments breaks (see Fig. 5 (d)) and shrinks (see Fig. 5 (e)). Two different evolutions of the microstructure are observed: a new ligament may emerge or the two diamond-shaped zones

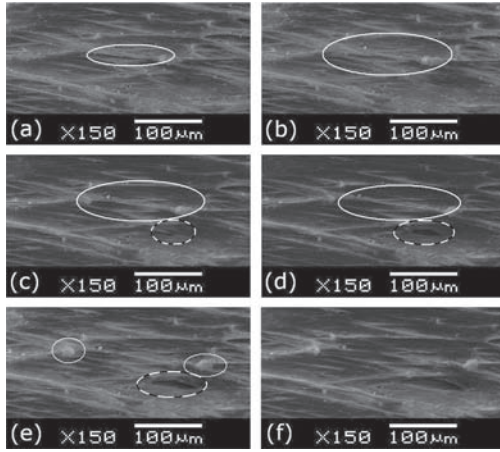
Figure 5. Successive photographs of the same detail of a crack tip during the rupture of a ligament after respectively 1, 3, 4, 5, 6 and 8 in-situ cycles.

separated by the broken ligament may coalesce as shown in Fig. 5 (f). In both cases, the matter reorganizes itself in a large vicinity of the broken ligament through the displacement of ligaments and diamond-shaped zones. In fact, this mechanism repeats itself in every diamond-shaped zone of the crack front. From a temporal point of view, this phenomenon occurs in a continuous manner with different velocities in each point. From a spatial point of view, it can happen simultaneously in different locations of the crack front.

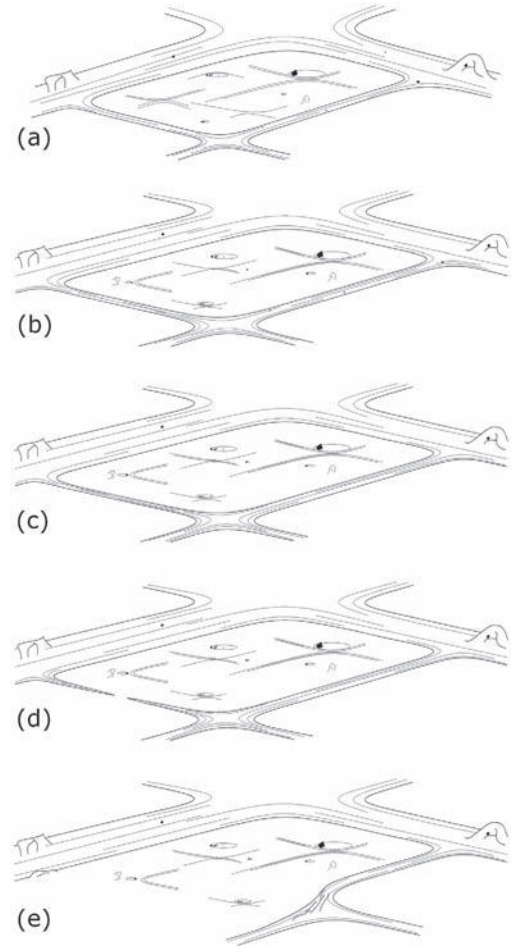
Figure 6. Fatigue crack propagation mechanism.

To close this section, we summarize the main elements of the previous mechanism with the help of a five-step scenario as depicted in Figure 6.

- Fig. 6 (a) presents the initial state of a diamond-shaped zone and its delimiting ligaments; it is a detail of the drawing of the crack tip in Fig. 3,
- the diamond-shaped zone grows larger and deeper, showing new inclusions and ligaments (see Fig. 6 (b)),
- as a consequence, ligaments which delimit the zone are stretched and one of them gets thinner than in the previous cycle (see Fig. 6 (c)),
- eventually, this ligament breaks (see Fig. 6 (d)),
- finally, the matter reorganizes itself through coalescence of the diamond-shaped zone with one of its neighbours (see Fig. 6 (e)).

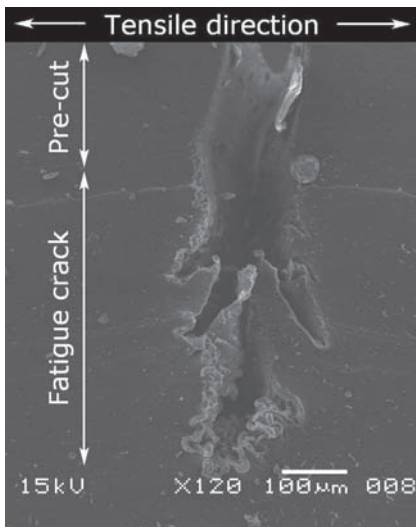
Figure 7. Crack path observed in a cut sample.

cut in two with a scalpel along the plane defined by the tensile and propagation directions in the middle of the crack. Figure 7 presents the side view of the crack which is slightly open to observe more easily the crack path. It highlights the main crack path which is normal to the tensile direction and several secondary cracks. Similarly to (Hamed 1994), the term “secondary crack” refers to short deviated cracks developed from the main one. Their length varies from  $10\text{ }\mu\text{m}$  to  $100\text{ }\mu\text{m}$ . In order to establish the scenario of secondary cracks formation also called “crack branching phenomenon”, it is necessary to determine how diamond-shaped zones evolve relatively to the others. In this purpose, the crack tip is observed with a different orientation from the previous images (Figs. 4 and 5): samples are rotated  $90^\circ$  in the SEM chamber to change the orientation of the ligaments with respect to the

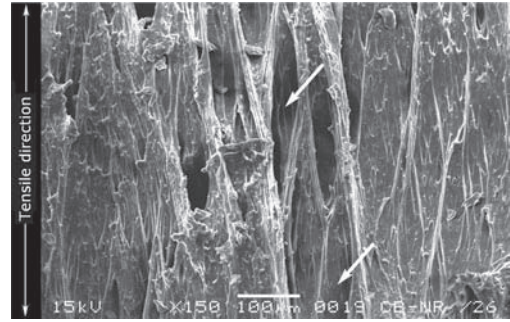
Figure 8. Top view of a crack tip  $-90^\circ$  rotated specimen in the chamber of the specimen.

secondary electron detector. The obtained image is presented in Figure 8; it emphasizes the relief of the crack tip due to the shadow contrast. It shows that all diamond-shaped zones are not in the same plane: some of them are deeper than others (see those indicated by white arrows in Fig. 8).

The crack propagation mechanism proposed in Section 3.2 does not take into account kinetics. The presence of diamond-shaped zones of different deepness in Fig. 8 suggests that even though the diamond-shaped zones evolve in a continuous manner, they do not grow deeper at the same speed. Moreover, recalling that the crack front is a surface rather than a line, the crack branching scenario will be established with the help of Figure 9. It shows the evolution under fatigue loading of three contiguous diamond-shaped zones (*a*, *b*, *c*) located at the crack front surface. It is a simplified representation of the crack tip cross-section: the right-hand drawings describe the close crack with the same view as in Fig. 7 and the left-hand drawings show the same crack but opened. To simplify the discussion, the scenario is established by considering three successive steps:

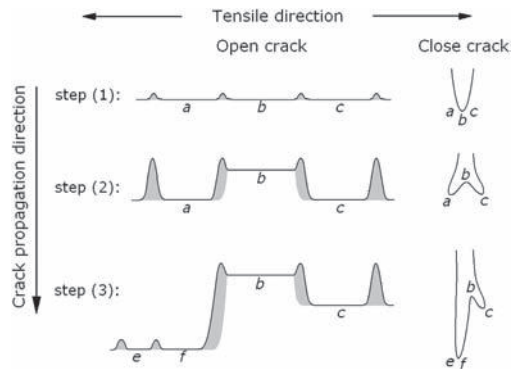
Figure 9. Branching phenomenon mechanism.

1. Initially, the three diamond-shaped zones *a*, *b* and *c* are separated by ligaments (grey in the figure) and have the same depth. When the crack is closed, there is only one branch.
2. Later on, when the crack has propagated, zones *a* and *c* have grown deeper than zone *b*. So, the close crack presents two similar branches. The main crack will develop from one or the other (*a* or *c*).

3. As the crack continues to propagate, one of the two previous branches will become the main crack due to both local mechanical conditions and microstructure. In the figure, zone *a* has become the main crack, and turned into two new diamond-shaped zones *e* and *f* because the former ligaments which delimited zone *a* broke and new ones appeared; zone *b* does not evolve anymore because it is partially relaxed; and zone *c* forms a secondary crack.

During crack propagation, the elementary scenario described above repeats: zones *e* and *f* will evolve in the same manner as zones *a*, *b* and *c* in step (1). It is to note, that zones *a*, *b*, *c* can be three single diamond-shaped zones or three groups of several zones.
