In-situ SEM study of fatigue crack growth mechanism in carbon black-filled natural rubber

Stéphanie Beurrot-Borgarino, Bertrand Huneau, Erwan Verron

Stéphanie Beurrot-Borgarino, Bertrand Huneau, Erwan Verron. In-situ SEM study of fatigue crack growth mechanism in carbon black-filled natural rubber. Sixth European Conference on Constitutive Models for Rubber (ECCMR VI), Sep 2009, Dresde, Germany. pp.319-324, 10.1002/app.31707 . hal-01387690

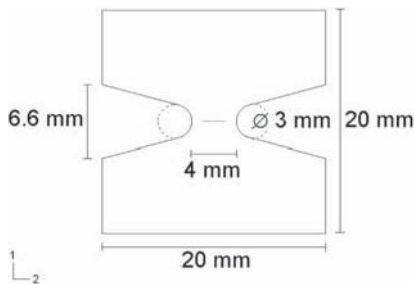
Figure 1. Geometry of samples.

As mentioned above, a special shape of sample was chosen in order to achieve large strain in crack vicinity and to propagate it; the corresponding geometry is shown in Figure 1.
