Investigating brittle failures in multiple-nail steel-to-timber connections

A Dupleix[†] and P Quenneville
Civil Engineering Department, University of Auckland, New Zealand

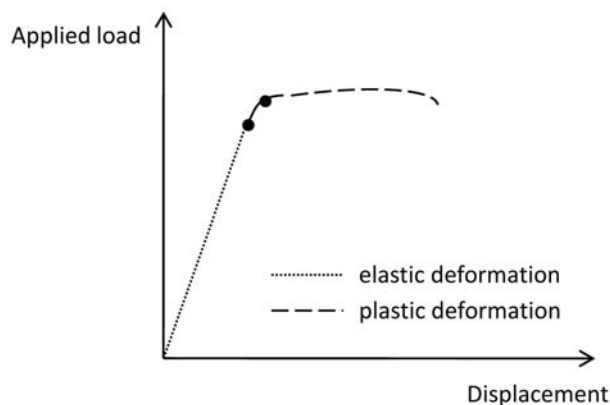
Figure 1: Schematic load-displacement curve of elastic and plastic deformations.

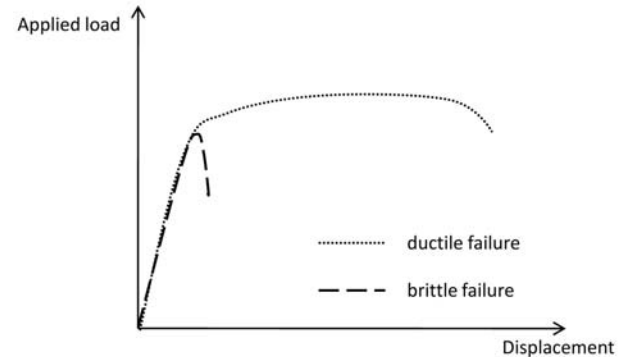
Figure 2: Schematic load-displacement curves for brittle and ductile materials loaded to failure.

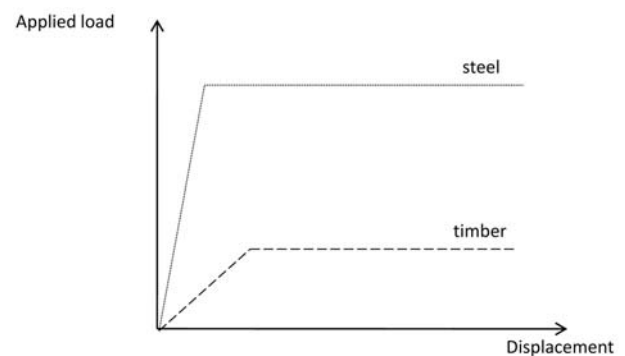
Figure 3: Schematic assumed load-displacement curves for steel and timber (Madsen, 2001).

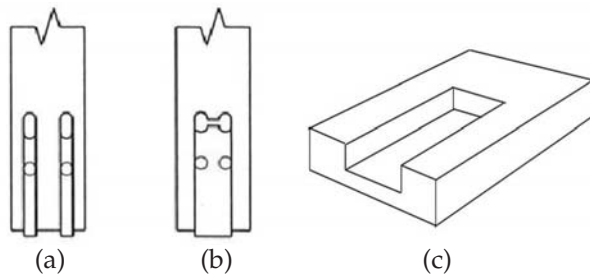
Figure 4: (a) Row-shear failure, (b) block-shear / plug-shear failure, and (c) plug-shear failure (Johnsson, 2004; Quenneville & Morris, 2009).

Brittle failures in timber connections were already in the spotlight of timber research needs, especially since 2003 when the collapse of a roof structure in Jyväskylä, Finland, was found to be due to a brittle mode of failure. Brittle modes of failure have been described in multiple fastener connections (Quenneville & Morris, 2009). Brittle failures occur when timber is torn out of the rest of the member. A brittle failure is known as a row-shear failure if each row of nails is torn out independently (figure 4(a)) and as a block-shear or a plug-shear failure if the whole connection is involved (figure 4(b)). A block-shear failure penetrates entirely the timber member while there is only partial penetration of the timber member in a plug-shear failure (figures 4(b) and 4(c)).

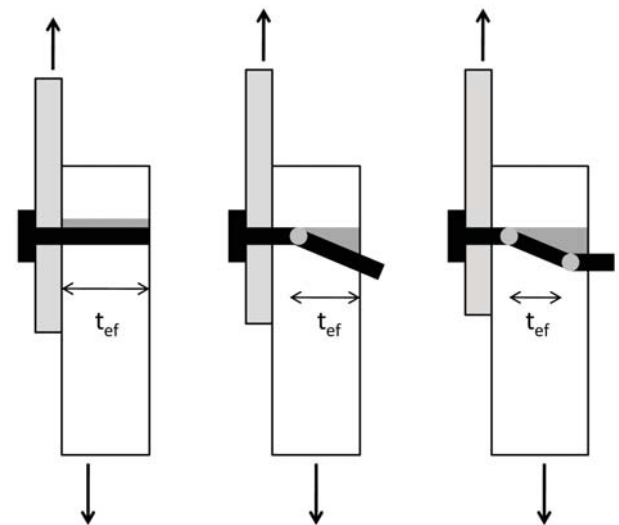
Figure 5: Johansen's predicted ductile modes of failure.

where p_{ef} is given by the effective thickness of the timber t_{ef} for each mode (figure 5).

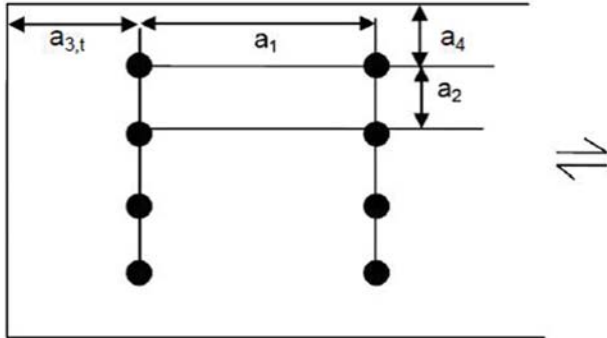
Figure 6: Minimum spacing, edge and end distances recommended by the NZS3603 and the EC5.

In order to address recent critics towards the lack of consideration of brittle modes of failure, the NZS3603 and the EC5 recommend minimum spacing between the fasteners, edge and end distances to minimise the risk of brittle failures according to the nails diameters d (spacing parallel to the grain a_1 , spacing perpendicular to the grain a_2 , distance to the loaded end $a_{3,t}$, distance to the edge a_4).

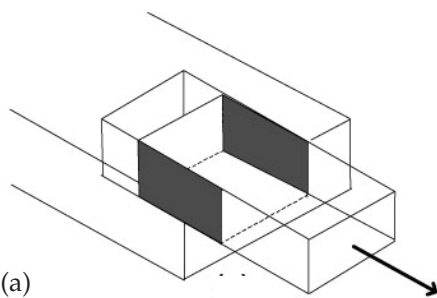
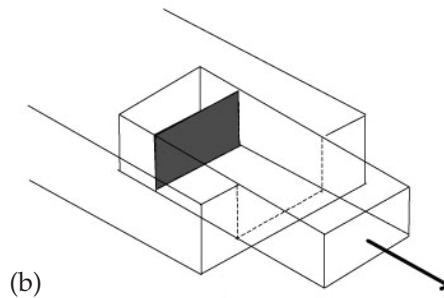
Figure 7: (a) $p/H < 1/2$, and (b) $p/H > 1/2$ (Johnsson, 2004).

According to Johnsson (2004), the resistance of multiple-nail steel-to-timber connection to plug-shear failure R_{plug} is either due to the tensile resistance of the end face (figure 7(a)) or to the shear resistance of the two side faces (figure 7(b)). It depends on the ratio p/H (the penetration depth of the nail p to the height of the timber member H , equations (4) and (5)).

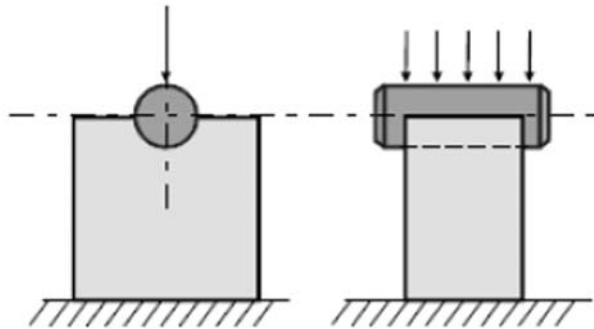
Figure 8: Loading configuration according to the American standard (ASTM, 2005).

The American half-hole test method (ASTM, 2005) was used in order to avoid any problems concerning potential bending of the nails (figure 8).

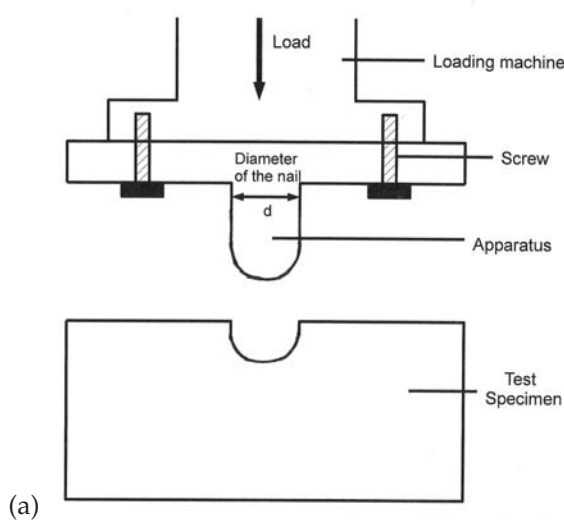
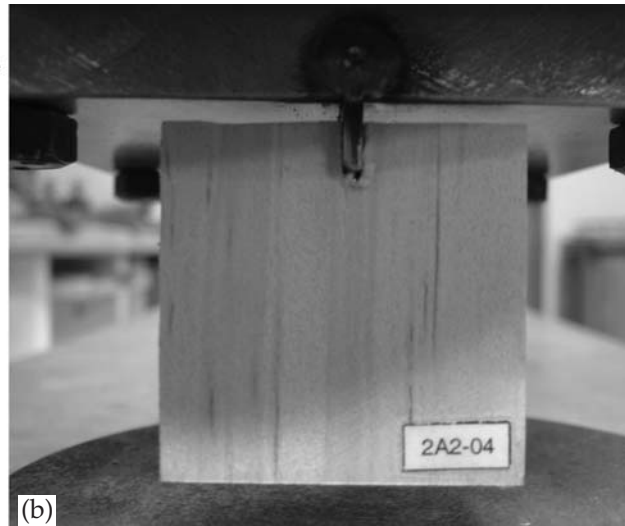
Figure 9: (a) Schematic loading apparatus and (b) realisation in the lab.

The restricted embedment to half the diameter of the nail of the American half-hole test method was highly problematic in the present case of small nail diameters. In order to ensure the reach of the peak load before the loading machine touches the specimen, the following apparatus with a groove acting as the nail was used (figure 9).

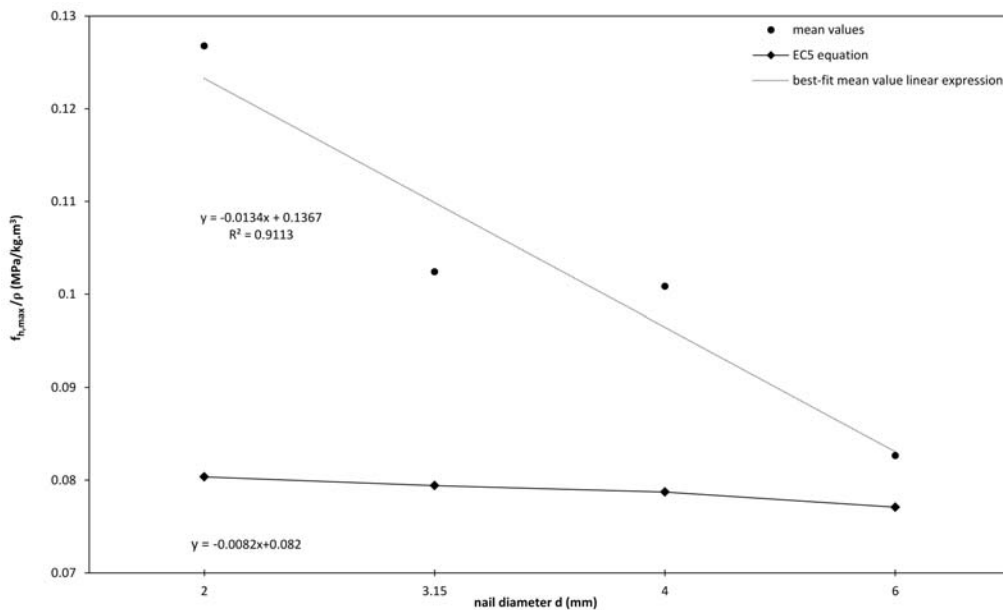
**Figure 10:** Comparison of $f_{h,max}$ experimental results to the EC5.

The mean values of the experimental results are compared in figure 10 to the EC5 predicted values.

The high coefficient of determination R^2 shows consistent experimental results in accordance with the linear relationship predicted by the EC5 between embedding strength and nail diameter. Finally, the EC5's equations are conservative for all tested nail diameters and can be safely used to predict the embedding strength of small nail diameters for New Zealand Radiata Pine solid timber.

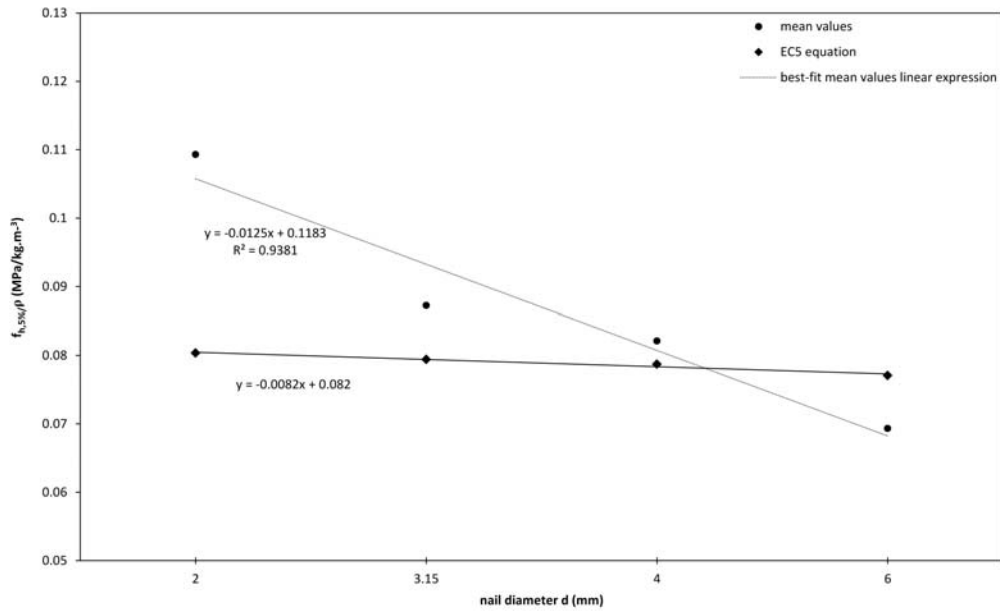
Figure 11: Comparison of $f_{h,5\%offset}$ experimental results to the EC5.

However, the use of the maximum load to calculate the embedding strength has been controversial because it would overestimate the resistance of wood to embedding by 20% (Bléron, 2000). But in case of small nail diameters for New Zealand Radiata Pine solid timber, the use of the American 5% offset method – based on the intersection load between the load-displacement curve and an offset line at 5% of fastener diameter – gives similar results. The general tendency of the EC5's equations is to be more conservative than the experimental results (figure 11).

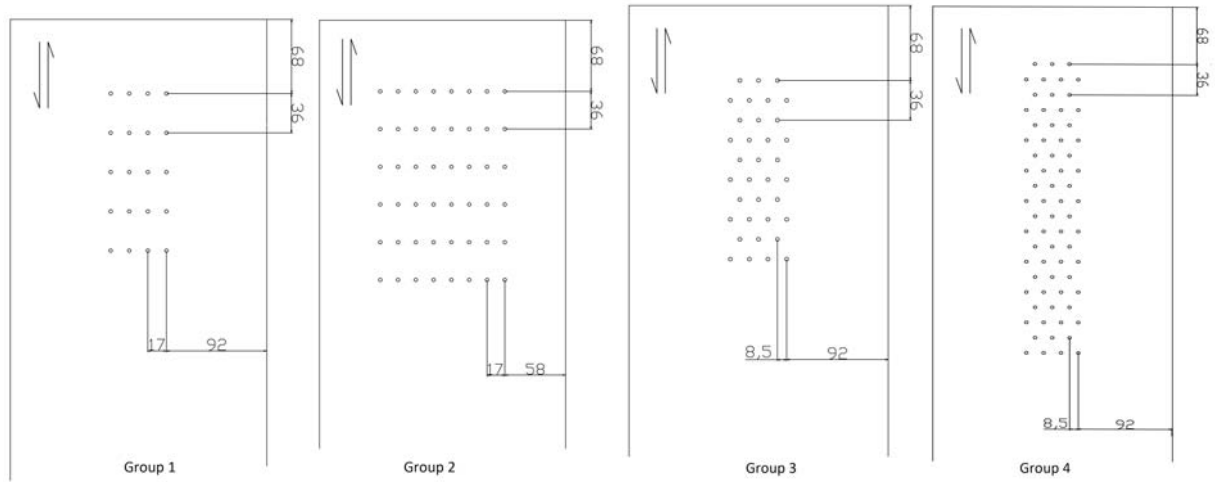
Figure 12: Nailing patterns of the tested groups represented in the timber member.

The aim of the experiments was to determine if the risk of brittle failures is significant in case of multiple-nail steel-to-timber connections made with New Zealand Radiata Pine solid timber. That is why small spacing especially perpendicular to the grain and high number of nails per row were chosen in order to maximise the risk of brittle modes of failure. The nails patterns of the steel plates are described with the geometric parameters used in the EC5. Four groups of connections with nails of 3.33 mm diameters have been tested. The first group, Group 1, comprised eight replications and the following three groups, Groups 2 to 4, comprised six replications for a grand total of 26 tested specimens. Groups 1 and 2 featured the smallest spacings recommended by the EC5. In Groups 3 and 4, spacing perpendicular to the grain a_2 was reduced by 2 in order to test the influence of reduced spacing perpendicular to the grain on brittle modes of failure (figure 12). The number of nails per row n and of rows parallel to the grain m were determined according to calculations made on the predicted load-carrying capacities of the connections which are explained later in the text.

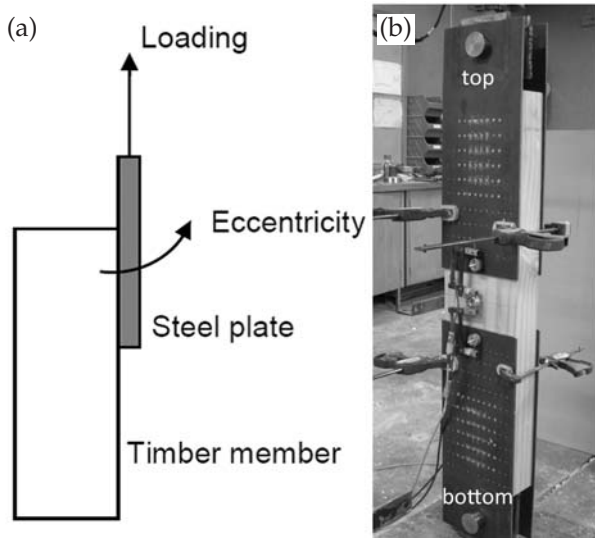
Figure 13: (a) Experimental set-up and (b) problems of eccentricity.

in tension parallel to the grain. Four multiple-nail connections were involved per test: the timber member was connected on both ends to obtain the most accurate results and integrate the probability of the weakest end to fail first (figure 13(a)) and on both sides to avoid problems of eccentricity (Figure 13b). The load was applied to one end of the

curve titled “Bottom” (resp. top) represents the displacement of the steel plates located at the bottom of the timber member (resp. at the top) (figure 13).

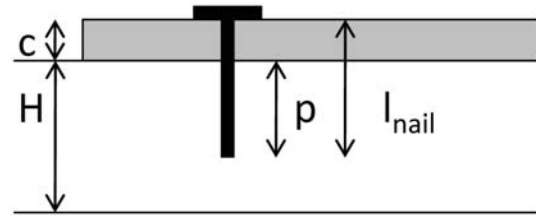
Figure 14: Penetration depth of the nails p in the timber member.

Nails had a diameter $d = 3.33$ mm and were 38 mm long so that the penetration depth of the nails p given by $p = l_{nail} - c = 32$ mm (figure 14).

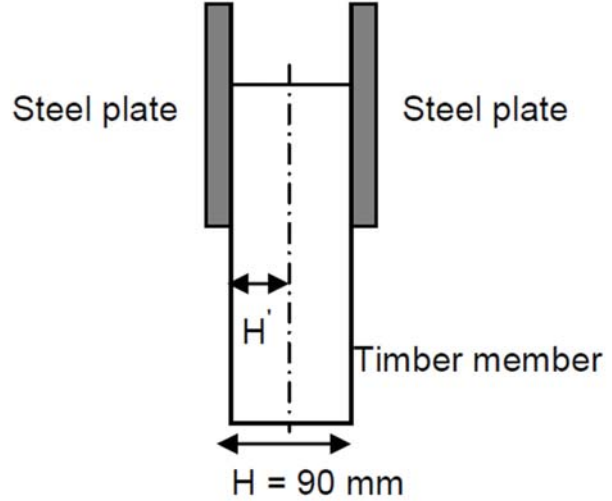
Figure 15: "Apparent" height of timber H' per connection.

For each connection, the "apparent" cross-sectional height of the timber is $H' = 90/2 = 45$ mm (figure 15). Therefore, the ratio $p/H' = 32/45 = 0.7 > 1/2$ so that according to Johnsson (2004), only the tensile strength of the end face will play a role in the resistance of the connection in case of brittle failure.

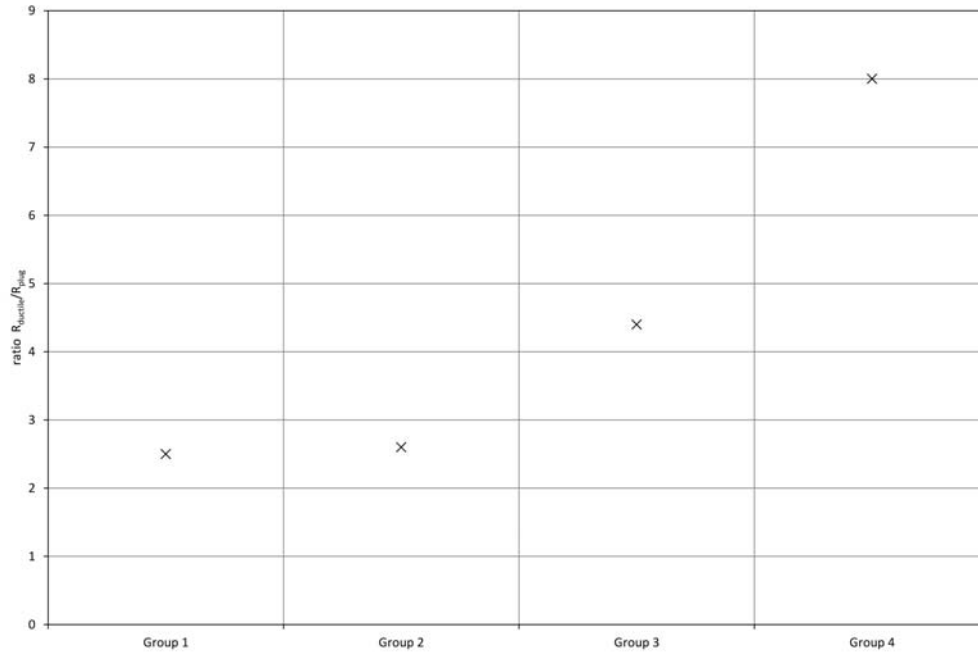
Figure 16: Calculated ratios of $R_{ductile}/R_{plug}$ for each tested group.

if $R_{ductile}/R_{plug} > 1$, the mode of failure would be predicted as brittle. The aim of the experiments was to achieve brittle mode of failure. Therefore, the tested nails patterns were chosen among the configurations which lead to ratios $R_{ductile}/R_{plug} > 1$ (figure 16).

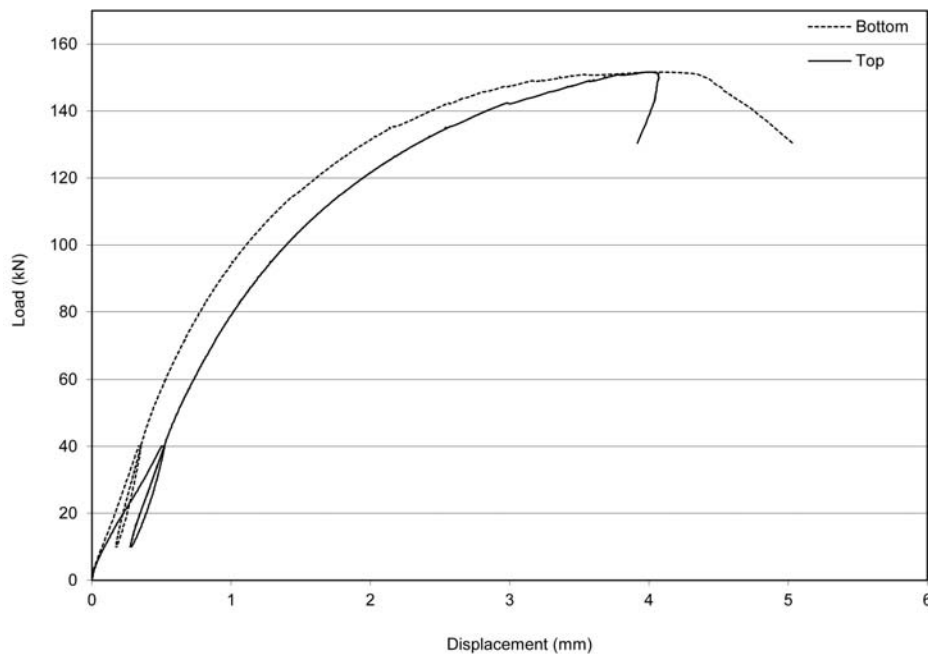
Figure 17: Load-displacement graphs of one specimen of Group 3.

Figure 17 features one of the load-displacement graphs obtained during the experiments. The

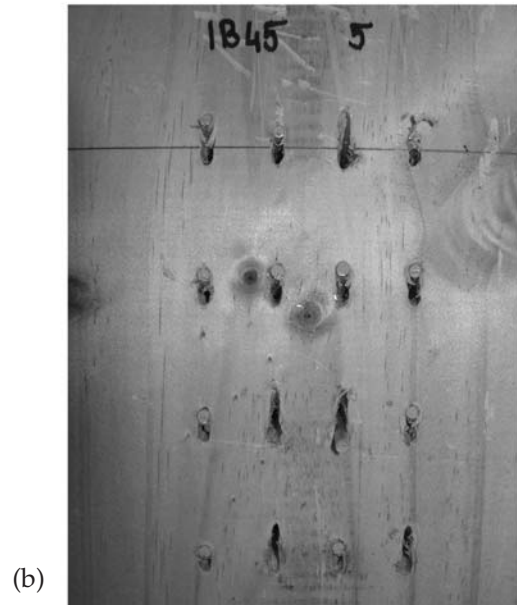
Figure 18: (a) Nails starting to bend and (b) embedment of the nails into the timber (not at scale).

This ductile behaviour was confirmed by the observation of the specimens once tested. The removal of the steel plates showed that the nails have started to bend by forming one plastic hinge (figure 18(a)). The embedment of the nails into the timber for a distance of 3 to 5 mm could also be noticed (figure 18(b)). During the experiments, the noise of some nails breaking could also be heard. The rupturing of the nails happened at random and no particular location of the nails rupturing could be noticed on the nailing patterns. The connection weakened by the loss of those missing nails finally yielded when one steel plate lifted out of the timber member.

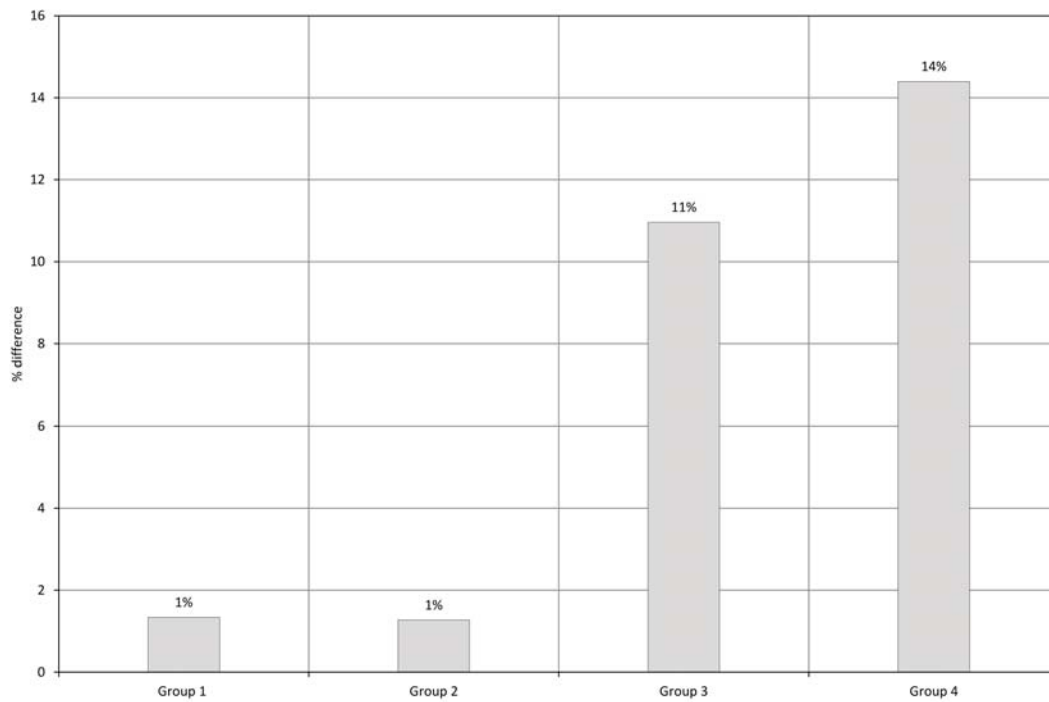
Figure 19: Plot of expected versus experimental ductile failure loads per steel plate.

Results account for negligible percentages of difference experimental results and predicted failure loads for Groups 1 and 2 when minimum spacing respect the recommendations of the EC5 (figure 19). On the other hand, the significant percentage difference obtained for Groups 3 and 4 (respectively 11% and 14%) may due to the fact that Groups 3 and 4 featured smaller minimum spacing than those recommended by the EC5.

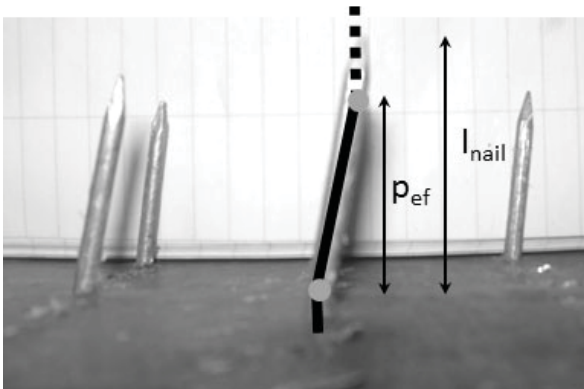
Figure 20: Mode II failure observed on nails.

The predicted mode of failure according to the EC5's equations was the same for all the tested groups: the mode II where the nails would yield in forming one plastic hinges (equation (2)). Visually during the experiments, the nails have started to bend at the junction of the steel plate and the timber member. The formation of the first plastic hinge can be observed. Longer nails may have clearly shown a ductile failure in mode III and confirmed the predictions of the EC5 as did the experimental obtained values of maximum loads at failure (figure 20).
