## Investigating brittle failures in multiple-nail steel-to-timber connections

Anna Duplex, Pierre Quenneville

Anna Duplex, Pierre Quenneville. Investigating brittle failures in multiple-nail steel-to-timber connections. Australian Journal of Civil Engineering, 2012, 10 (2), 10.7158/C11-695.2012.10.2 . hal-01393719

A Duplex<sup>†</sup> and P Quenneville  
Civil Engineering Department, University of Auckland, New Zealand

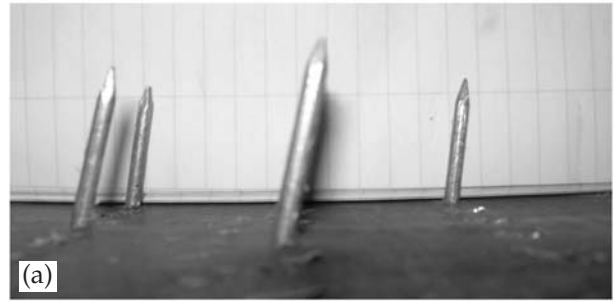
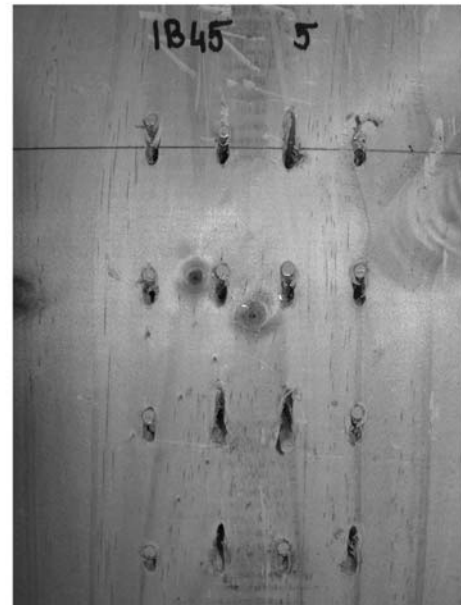
**Figure 18:** (a) Nails starting to bend and (b) embedment of the nails into the timber (not at scale).

This ductile behaviour was confirmed by the observation of the specimens once tested. The removal of the steel plates showed that the nails have started to bend by forming one plastic hinge (figure 18(a)). The embedment of the nails into the timber for a distance of 3 to 5 mm could also be noticed (figure 18(b)). During the experiments, the noise of some nails breaking could also be heard. The rupturing of the nails happened at random and no particular location of the nails rupturing could be noticed on the nailing patterns. The connection weakened by the loss of those missing nails finally yielded when one steel plate lifted out of the timber member.
