AStrion assets for the detection of a main bearing failure in an onshore wind turbine

Xavier Laval, Guanghan Song, Zhong-Yang Li, Pascal Bellemain, Maxime Lefray, Nadine Martin, Alexis Lebranchu, Corinne Mailhes

AStrion has been installed on two wind turbines (WT8 and WT6) owned by VALOREM and exploited by one of its subsidiary, VALEMO. A major fault occurred on December 30th 2015 on the main bearing of the wind turbine WT8. AStrion had already been tested on the similar wind turbine WT6 from the same park ⁽³⁾, but had just proved its good reliability by not raising false alarms when the system was in good operational conditions. The data on both wind turbines were provided by VALEMO in order to test the effectiveness of AStrion to detect the fault. Thus the AStrion features have been used to characterize the fault, also providing other information such as the effect of maintenance operations or sensor problems.

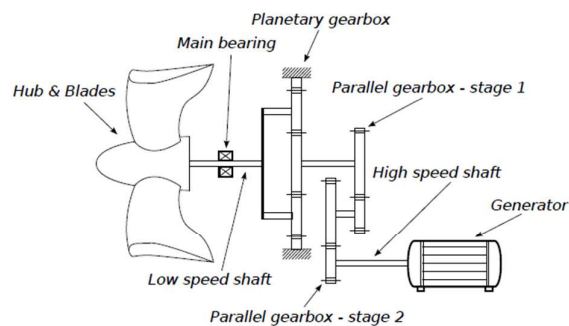
(b) : rotor, main bearing, gearboxes and generator

Figure 2: (a) geographical location of wind turbines WT6 and WT8, and (b) quick overview of the mechanical system

Each wind turbine is composed of a rotor, a main bearing actually composed of two bearings, a planetary gearbox followed by a 2-stage parallel gearbox, and finally the generator. The two gearboxes contained numerous kinematics elements, making the final kinematic chain complex.

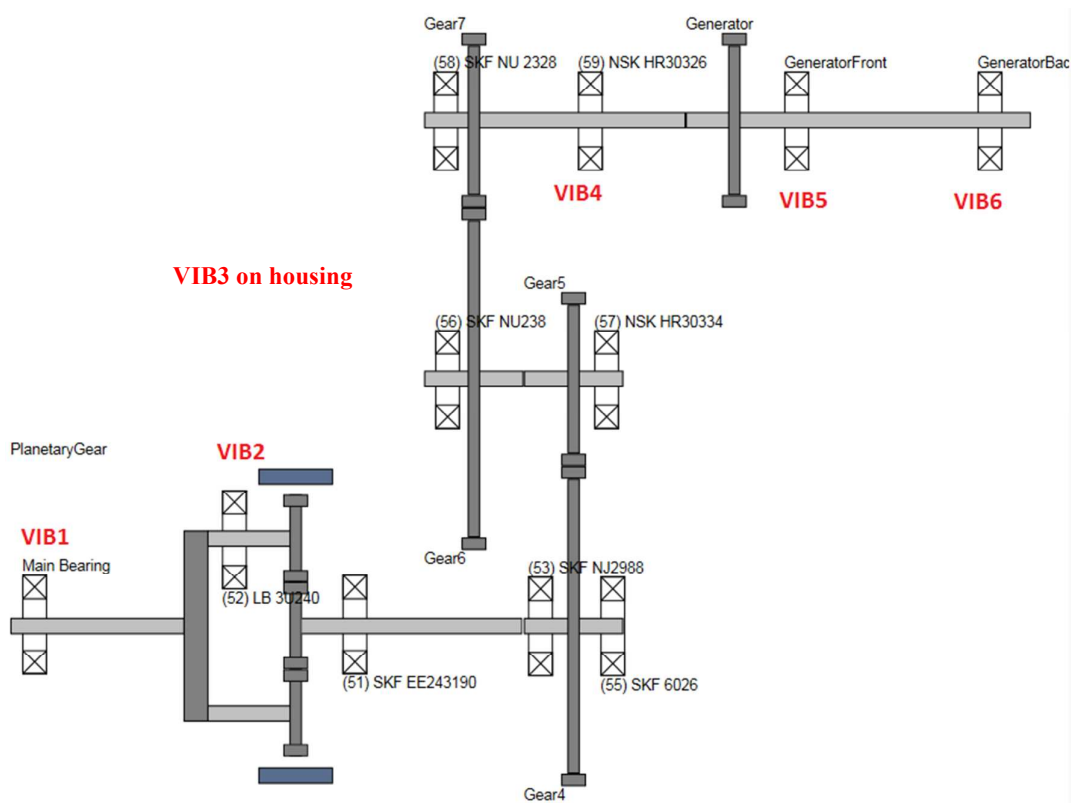
Figure 3: name and location of the 6 accelerometers

The accelerometers are named from vib1 to vib6. Apart from vib3, which is on the housing of the two-stage parallel gearbox, they are located on bearings. The signals are

The 6 accelerometers are located on the system as shown on the kinematic drawing below:

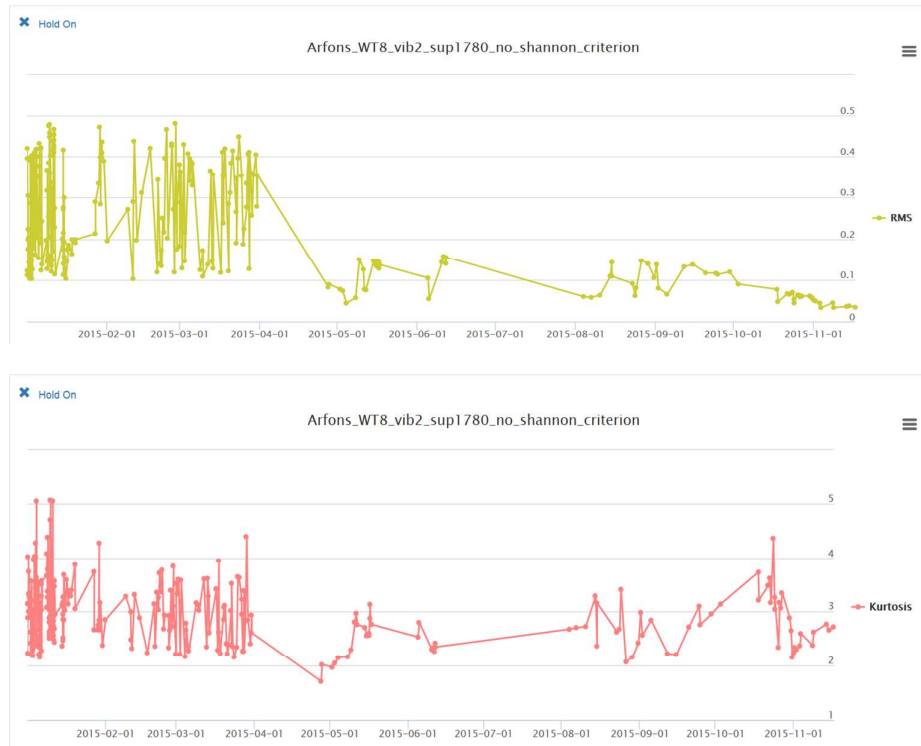
Figure 6: trend of RMS and kurtosis of the dataset signals.

As shown in Figure 6, these standard features do not detect any problems on the system. Their trends show no signs that a major breakdown of the main bearing is about to happen. Actually, the RMS value is even decreasing. Only the RMS and kurtosis are shown here, but other features such as crest factor and skewness have been calculated, and did not provide any more clues.

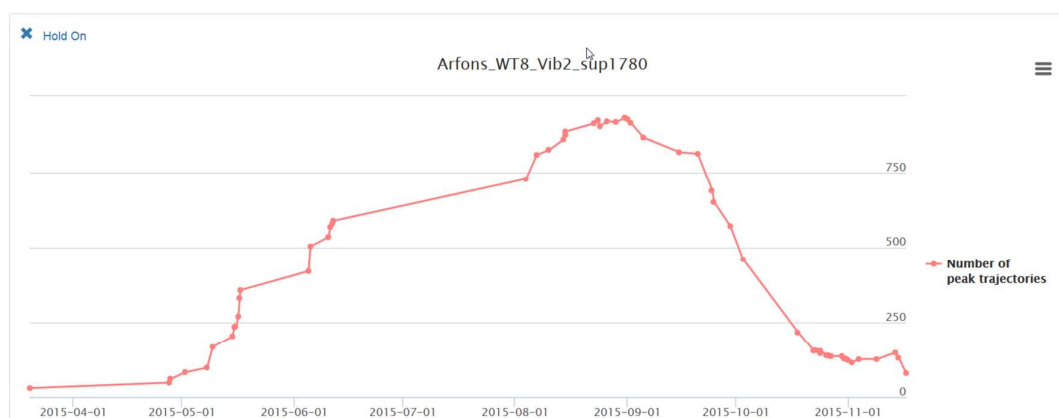
Figure 7: evolution of the trajectory number on WT8

Indeed, according to VALEMO, on September the 20th, a preventive maintenance has been performed on the different mechanical parts. This corresponds exactly to the start of the decrease visible in Figure 7: after this maintenance, the number of trajectories is decreasing rapidly from 800 to 150. This decrease is explainable by looking more closely on the detail of each mechanical component trajectory: nearly every trajectory detected for the bearings disappeared after this greasing. This is very clear on Figure 9. Actually, the only one which does not disappear is a trajectory associated to the faulty main bearing.
