AStrion assets for the detection of a main bearing failure in an onshore wind turbine

Xavier Laval, Guanghan Song, Zhong-Yang Li, Pascal Bellemain, Maxime Lefray, et al.. AStrion assets for the detection of a main bearing failure in an onshore wind turbine. 13th International Conference on Condition Monitoring and Machinery Failure Prevention Technologies (CM2016/MFPT2016), Oct 2016, Paris, France. hal-01399027v1

Journal:	<i>CM 2016 and MFPT 2016</i>
Manuscript ID	Draft
Topic:	CM applications
Date Submitted by the Author:	n/a
Complete List of Authors:	laval, xavier; GIPSA-Lab, Martin, Nadine; GIPSA-Lab, Department Images Signal
Keywords:	Monitoring, Failure diagnosis, wind turbine, AStrion

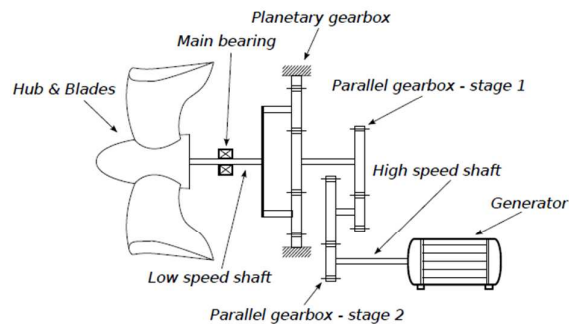
(b) : rotor, main bearing, gearboxes and generator

Figure 2: (a) geographical location of wind turbines WT6 and WT8, and (b) quick overview of the mechanical system

Each wind turbine is composed of a rotor, a main bearing actually composed of two bearings, a planetary gearbox followed by a 2-stage parallel gearbox, and finally the generator. The two gearboxes contained numerous kinematics elements, making the final kinematic chain complex.
