## **AStrion assets for the detection of a main bearing failure in an onshore wind turbine**

Xavier Laval, Guanghan Song, Zhong-Yang Li, Pascal Bellemain, Maxime Lefray, et al.. AStrion assets for the detection of a main bearing failure in an onshore wind turbine. CM 2016 - MFPT 2016 - 13th International Conference on Condition Monitoring and Machinery Failure Prevention Technologies, Oct 2016, Paris, France. hal-01399027v2

AStrion has been installed on two wind turbines (WT8 and WT6) owned by VALOREM and exploited by one of its subsidiary, VALEMO. A major fault occurred on December 30<sup>th</sup> 2015 on the main bearing of the wind turbine WT8. AStrion had already been tested on the similar wind turbine WT6 from the same park <sup>(3)</sup>, but had just proved its good reliability by not raising false alarms when the system was in good operational conditions. The data on both wind turbines were provided by VALEMO in order to test the effectiveness of AStrion to detect the fault. Thus the AStrion features have been used to characterize the fault, also providing other information such as the effect of maintenance operations or sensor problems.

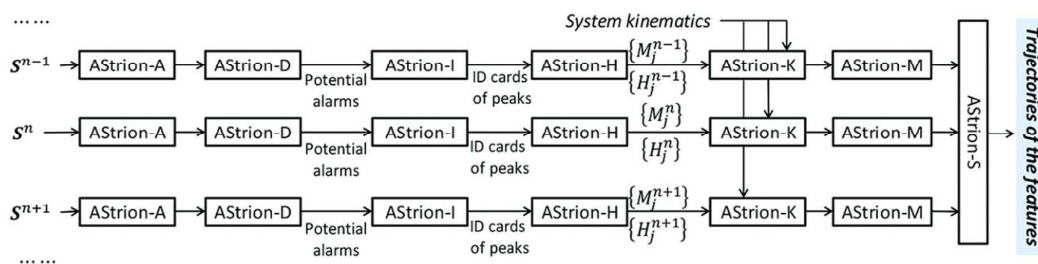
**Figure 1: The modular architecture of AStrion**

Each signal is first submitted to an Angular resampling if needed (AStrion-A), a Data-validation (AStrion-D). Then the peaks are Identified (AStrion-I) and grouped into Harmonics series and sidebands (AStrion-H). These series are then associated to Kinematics elements (AStrion-K) if the system kinematics are known. The sidebands are deModulated to calculate the modulation functions (AStrion-M). Finally, a Survey of trends all the features obtained is performed in time over the signals (AStrion-S). The efficiency of some of these modules (A, D, K and S) will be evaluated in this paper.

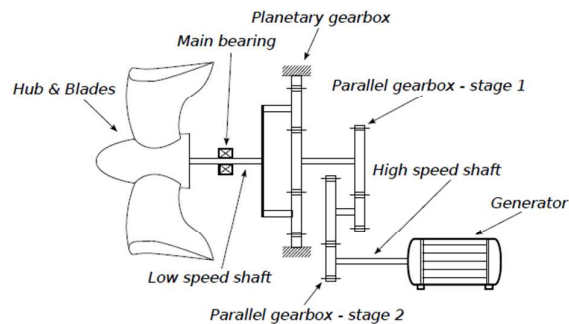
**Figure 2: (a) geographical location of wind turbines WT6 and WT8, and (b) quick overview of the mechanical system**

Each wind turbine is composed of a rotor, a main bearing actually composed of two bearings, a planetary gearbox followed by a 2-stage parallel gearbox, and finally the generator. The two gearboxes contained numerous kinematics elements, making the final kinematic chain complex.

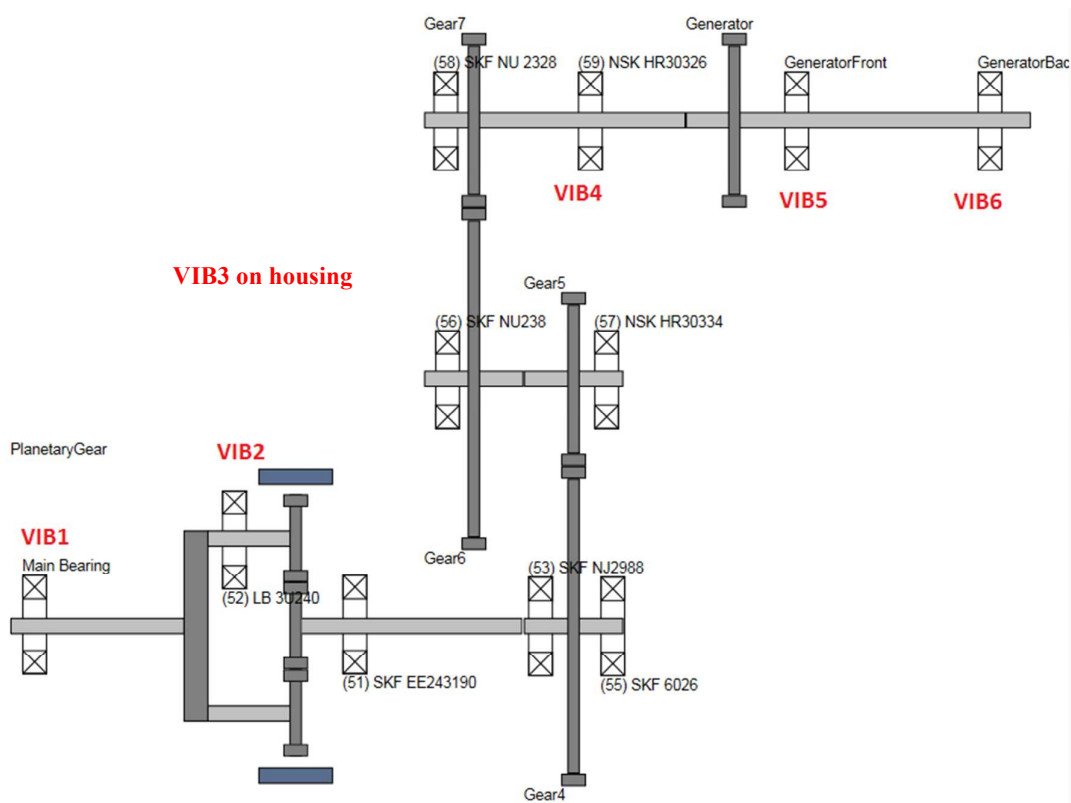
**Figure 3: name and location of the 6 accelerometers**

The accelerometers are named from vib1 to vib6. Apart from vib3, which is on the housing of the two-stage parallel gearbox, they are located on bearings. The signals are

sampled at 25 kHz, and are recorded during 60s until January 19<sup>th</sup>, 40s after January 19<sup>th</sup>.

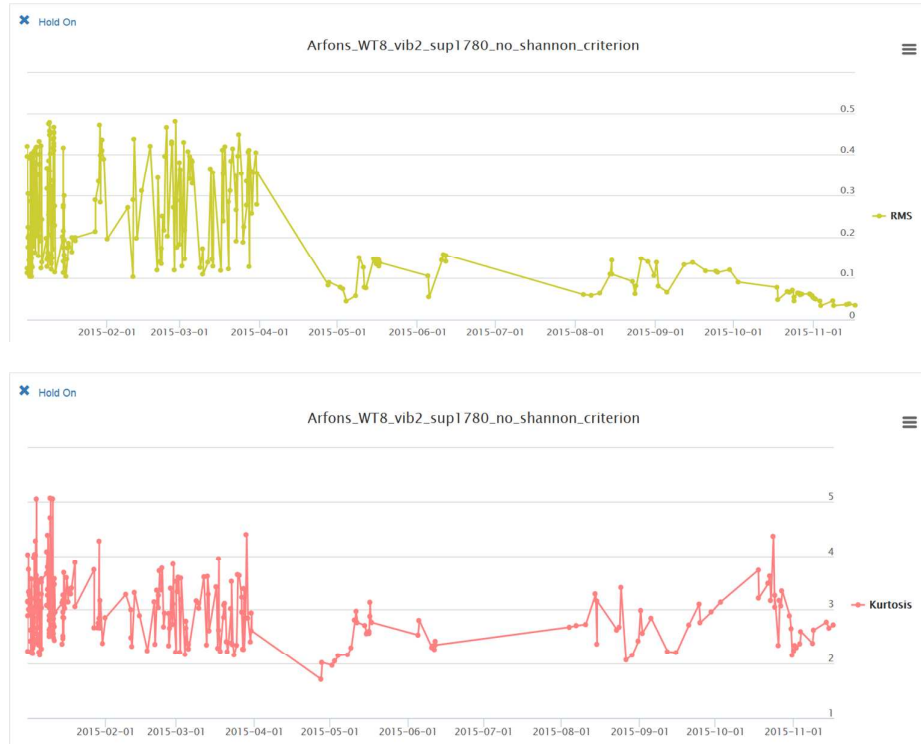
**Figure 6: trend of RMS and kurtosis of the dataset signals.**

As shown in Figure 6, these standard features do not detect any problems on the system. Their trends show no signs that a major breakdown of the main bearing is about to happen. Actually, the RMS value is even decreasing. Only the RMS and kurtosis are shown here, but other features such as crest factor and skewness have been calculated, and did not provide any more clues.

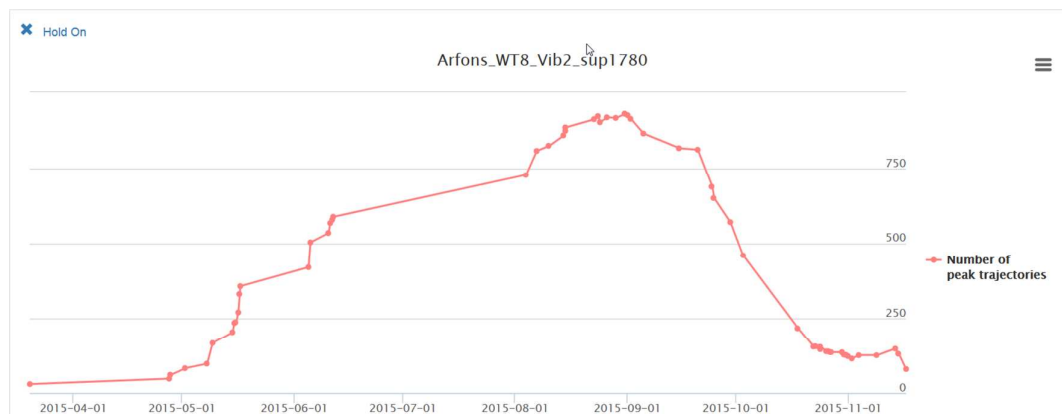
**Figure 7: evolution of the trajectory number on WT8**

Indeed, according to VALEMO, on September the 20<sup>th</sup>, a preventive maintenance has been performed on the different mechanical parts. This corresponds exactly to the start of the decrease visible in Figure 7: after this maintenance, the number of trajectories is decreasing rapidly from 800 to 150. This decrease is explainable by looking more closely on the detail of each mechanical component trajectory: nearly every trajectory detected for the bearings disappeared after this greasing. This is very clear on Figure 9. Actually, the only one which does not disappear is a trajectory associated to the faulty main bearing.

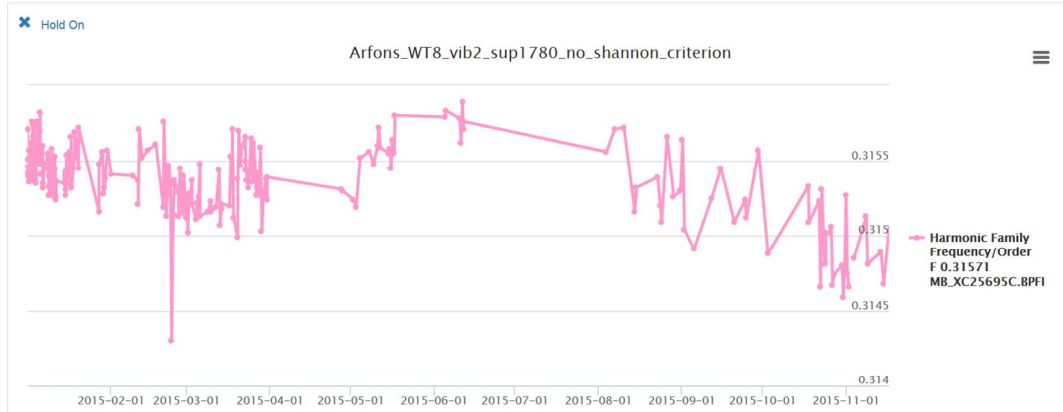
**Figure 8: trend of the main bearing BPF frequency**

In this figure, 2 facts are interesting to note:

- This harmonic family has been detected at nearly every timestamp.
- From August, the frequency value is slowly decreasing (-0.2% at mid-November).

The decreasing of the BPF fundamental frequency is a sign of galling, an advanced state of wearing: the bearing is more and more resisting the rotation. However, it is a hard sign to track, the drop is not very important. When transforming the spectrum into peaks, AStrion applies 5 different spectral analysis methods, with different windows and estimator for each, and then merges the results. This approach makes the spectral analysis efficient to detect slight variations of the fundamental frequency.

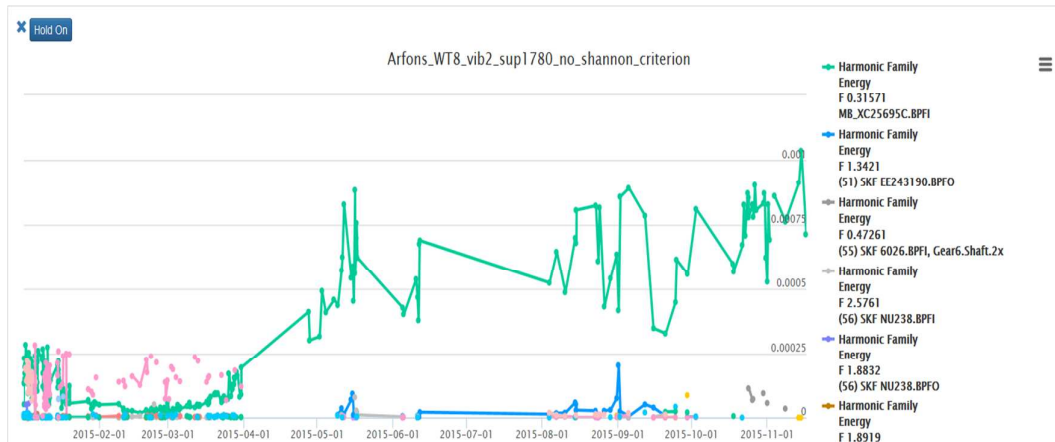
**Figure 9: trend of the energy feature of every harmonic family associated to a bearing. The faulty bearing is in green.**

A huge increase of energy is clearly visible from April. The harmonic family of the faulty bearing BPF1 dominates every other family from there, with a trend to increase.

Furthermore, this figure clearly shows that this harmonic family is the only one which is almost constantly detected by AStrion. The other detected harmonic families disappear, especially after the maintenance of October. This is to be correlated to what was said in Section 3.2.2. Furthermore, AStrion has not detected any trajectory associated to the main bearing BPF1 on the reference wind turbine, WT6. This alone is already a strong sign that something is wrong with the WT8 main bearing. Calculations on signals from early 2014 shows that this trajectory is already the most often detected, though not as much often.
