# Durability Of Mortars With Natural Fillers In Aggressive Environnement

B. Diop, Yannick Mélinge, Laurent Molez, Raoul Jauberthie, A. Bouguerra

B. Diop, Yannick Mélinge, Laurent Molez, Raoul Jauberthie, A. Bouguerra. Durability Of Mortars With Natural Fillers In Aggressive Environnement. Structural Faults and Repair 2008, Jun 2008, Edinburgh, United Kingdom. hal-01421244

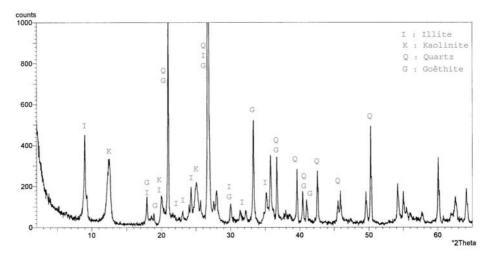
Fig.2. XRD pattern of tuff ( $\lambda k_{\alpha}$  Cu , filtered)

EN 196. The mixture details were the following: aggregate-to-cement ratio was 3.0 and the water-to-cement ratio was 0.5. The cement type used is a normal portland cement – CEM 1 52.5 CP2 manufactured in Saint-Pierre-La-Cour (France). An analysis of the cement type is summarised in Table 1. In the second series of samples, the volcanic tuff, ground below 50μm, replaced partially the cement. An analysis of the volcanic tuff is summarised in Table 2. SEM examinations of this tuff are shown in figure 1. The X-Ray diffraction analysis (figure 2) reveals the presence of illite and kaolin: 2 clay minerals, as well as quartz and goethite.

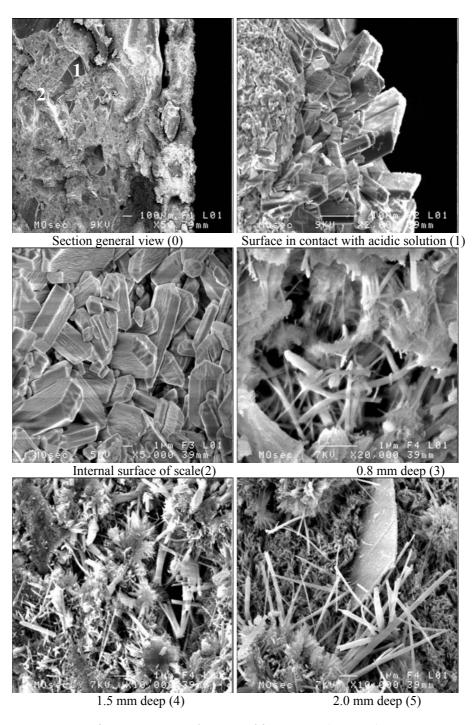
Fig.7. MO Samples stored in H<sub>2</sub>SO<sub>4</sub> (0.25 M)

SEM observations (figure 7) of the sample of normal mortar stored in sulfuric acid (H<sub>2</sub>SO<sub>4</sub> 0.25M) confirm the X-Ray diffraction results. A formation of scale (fig. 7 detail (0)) on the sample surfaces is noted. Such scale induces a penetration of acidic solution deeper in the section. The falling of scales explains the section decreases observed in figure 3. Large prismatic crystals of gypsum cover the surface and fill the pores. Behind this layer, an ettringite front appears. Fine needle like crystals are present to 1.5 mm depth. Portlandite layer are not observed in this area. At 2 mm depth, portlandite is slightly altered (fig. 7, detail (5)). Deeper in, traditional hydrated mineral phases of classic Portland Cement are observed.

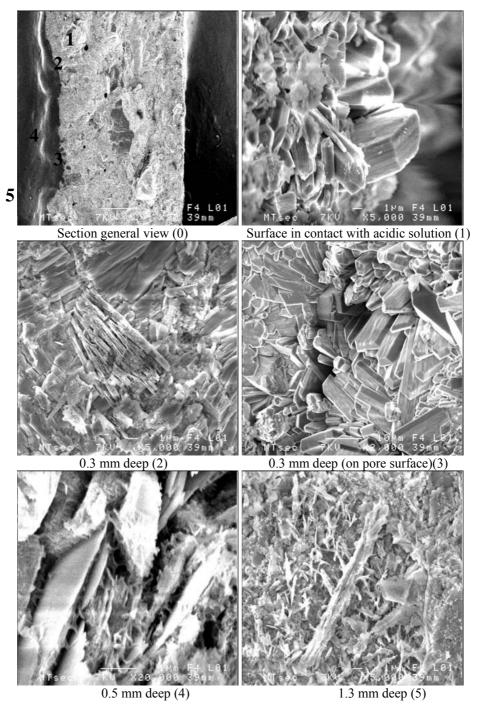
Fig. 8. MT Samples stored in H<sub>2</sub>SO<sub>4</sub> (0.25 M)

SEM observations of the sample of mortar containing tuff and stored in sulfuric acid (H<sub>2</sub>SO<sub>4</sub> 0.25M) are presented on figure 8. Same gypsum mineralization is observed at the sample surface. However, no scale appears (figure 8 detail (3)). At 0.5 mm depth, the portlandite layers are detected and at 1.3 mm the portlandite is less altered. The formation of new mineral phases without spalling explain the expansion of samples (table 4).

The tuff addition induces two type of effect. A pozzolanic effect is due to silica. This effect is limited because of natural tuff alteration. Induced clays bring a filler effect, not interesting regarding strength but reducing the global pore size. Combination of those two effects lead to delay of the sulphatic attack.
