Mechanism of fatigue crack growth in carbon black filled natural rubber

Mechanism of Fatigue Crack Growth in Carbon Black Filled Natural Rubber

J.-B. Le Cam, B. Huneau, E. Verron,* and L. Gornet

ABSTRACT: The present paper deals with the fatigue crack growth in a carbon black filled *cis*-1,4-polyisoprene rubber under relaxing loading conditions. The study focuses on the determination of the scenario of crack growth. For this purpose, an original “microcutting” method is employed to observe microscopic phenomena involved in the growth of the crack with a SEM. It reveals that the cavitation induced by the decohesion between zinc oxides and rubber matrix is the major fatigue damage and that the crack tip is composed of stretched elliptical areas surrounded by highly stretched and crystallized ligaments. Finally, the observations are considered to establish the fatigue crack growth mechanism.

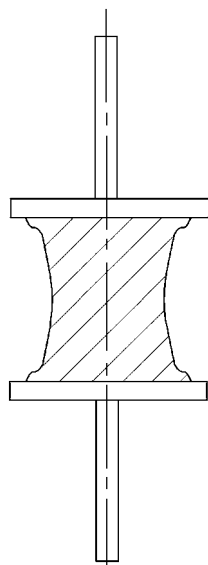
Figure 1. Geometry of the “diabolo” sample.

The sample geometry is similar to the one proposed by Beatty;¹² it is presented in Figure 1. The sample is axisymmetric and is usually called the “diabolo” sample. Its significant radius of curvature leads to a higher local deformation state in its middle than the enforced nominal deformation. Consequently, the predominant fatigue crack is initiated in the lowest diameter section, i.e., at the center of the sample.

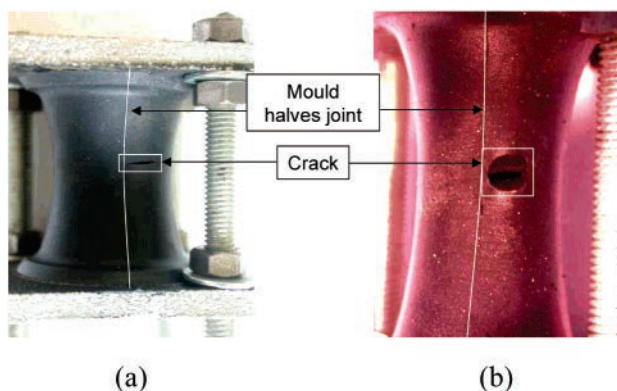
Figure 2. Sample and fatigue crack in the (a) undeformed and (b) deformed configurations.

2.4. Observation Method. The sample is fixed in a rudimentary static tensile apparatus (see Figure 2a), and it is statically stretched to the same ratio than the one enforced during the fatigue test (1.33) in order to open the crack (see Figure 2b). Then, this apparatus is placed in the SEM to observe the crack growth. As mentioned previously, the fatigue test led to initiation and propagation of a crack in the sample, and it involved a fatigue damage in the crack tip vicinity. Thus, the crack tip should be notched to reveal the fatigue damaged zones and to determine their origin. During SEM observations, it is obviously irrelevant to use a laboratory cutting tool to notch the crack. Nevertheless, it is possible to “microcut” the crack tip by imparting in situ a sufficient amount of energy to break cross-links between macromolecules. Two energy sources are used simultaneously: the first one is mechanical and consists of statically stretching the sample to a ratio equal to 1.67, i.e., higher than the level set during the cyclic loading, and the second one consists of locally concentrating the electron beam in the observation zone. In fact, the amount of energy needed to break cross-links cannot easily be determined since the number and nature of cross-links as well as the number of macromolecules in the irradiated zone are not well-known. However, the acquired experience enables us to correctly set the power of the electron beam and to recur experiments. The most favorable zones to perform microcut-

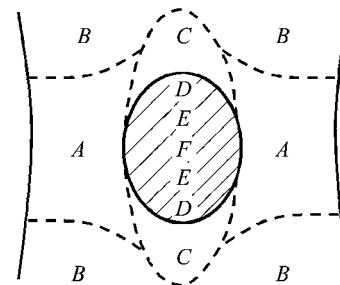
Figure 3. Schematic view of the crack (D–F) and its surroundings (A–C).

3.1. Crack Description. Figure 3 presents a schematic view of the crack and its surroundings. Six different areas are observed in the deformed configuration, i.e., as the sample is stretched to 1.67. Before the occurrence of the crack, there were only two zones: the central zone of the sample, denoted A in the figure, that is the most stretched part of the specimen, and the area situated on both sides of it and denoted B. When the crack occurs, four new zones appear: area C, which corresponds to the parts of area A relaxed during crack opening, and areas D, E, and F that stand for the crack itself. The photomicrographs of the three zones D, E, and F are shown in Figure 4. Area F stands for the crack tip, area D represents the material surfaces that were broken during the previous growth of the crack, and area E is the frontier between the former ones (see Figure 4a). The major difference between surfaces D and F is their stretching level. As shown in Figure 4b, area D is overlaid with wrenchings which are a typical feature of fracture surfaces observed under fatigue loading conditions.^{14,15} Here, the term “wrenchings” refers to highly stretched ligaments which break and shrink. Area F is composed of highly stretched ligaments which delimit elliptical smooth surfaces, and area E contains both wrenchings and ligaments. With regard to these observations, the number and size of ligaments in a zone seem closely related to its stretching level.

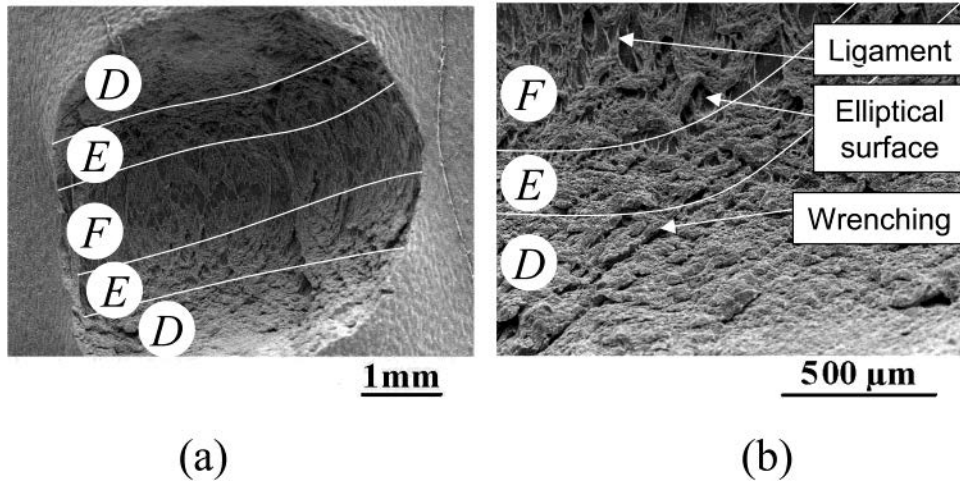
Figure 4. Details of areas D–F for two magnifications.

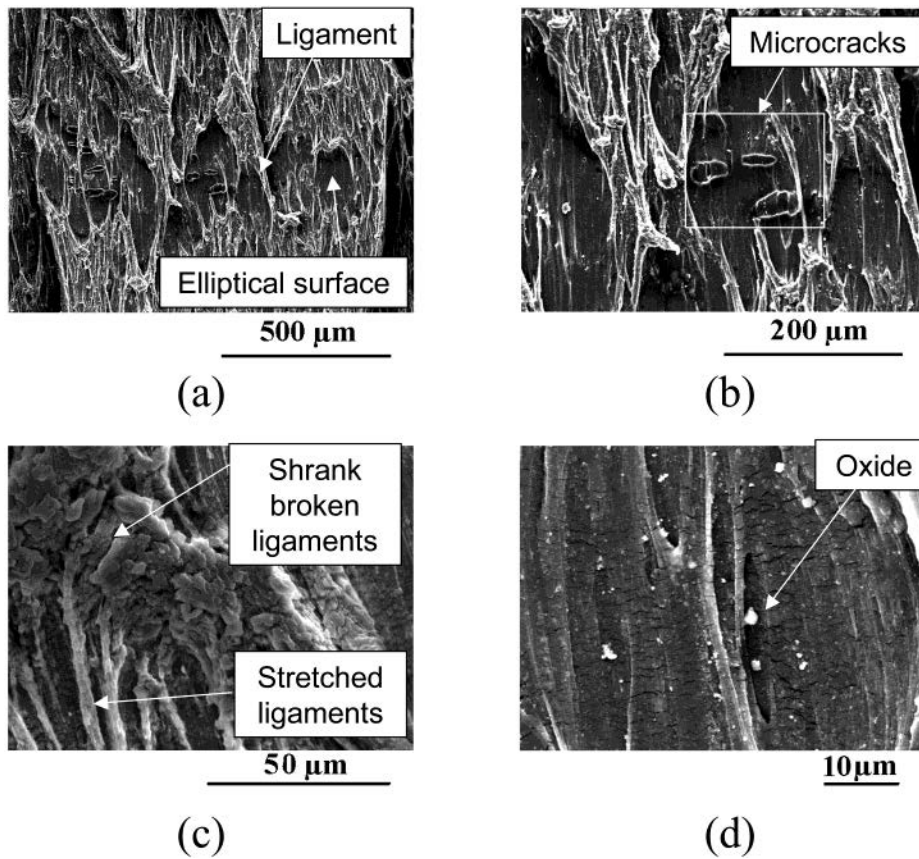
Figure 5. Details of the crack tip for four magnifications.

After this brief description of the crack, the crack tip F, in which our microcutting method will be applied, has to be more precisely examined. Figure 5 shows it for different magnifications. The crack tip is composed of a few hundred micrometers long ligaments which are highly stretched and surround smooth elliptical surfaces (see Figure 5a). Figure 5b–d presents the morphology

of these elliptical surfaces and their surroundings. First, microcracks take place in their middle part; their orientation is perpendicular to the stretch axis (see Figure 5b). The presence of these microcracks shows that the smooth areas are propitious to the propagation of the crack. This property will be used in the following to apply our microcutting method. Moreover, these smooth areas are delimited by ligaments whose extremities are located at their top and bottom. As an example, the photomicrograph in Figure 5c shows the top of any surface. It contains both stretched ligaments and a rough surface that corresponds with broken ligaments which shrank. Finally, using a larger magnification, Figure 5d shows that some zinc oxides are embedded in the relief of smooth elliptical areas. Oxides can be

Some microcracks are generated by microcutting in one of the smooth areas of the crack tip. In fact, these microcracks can be seen as artificial counterparts of the natural microcracks previously described (see Figure

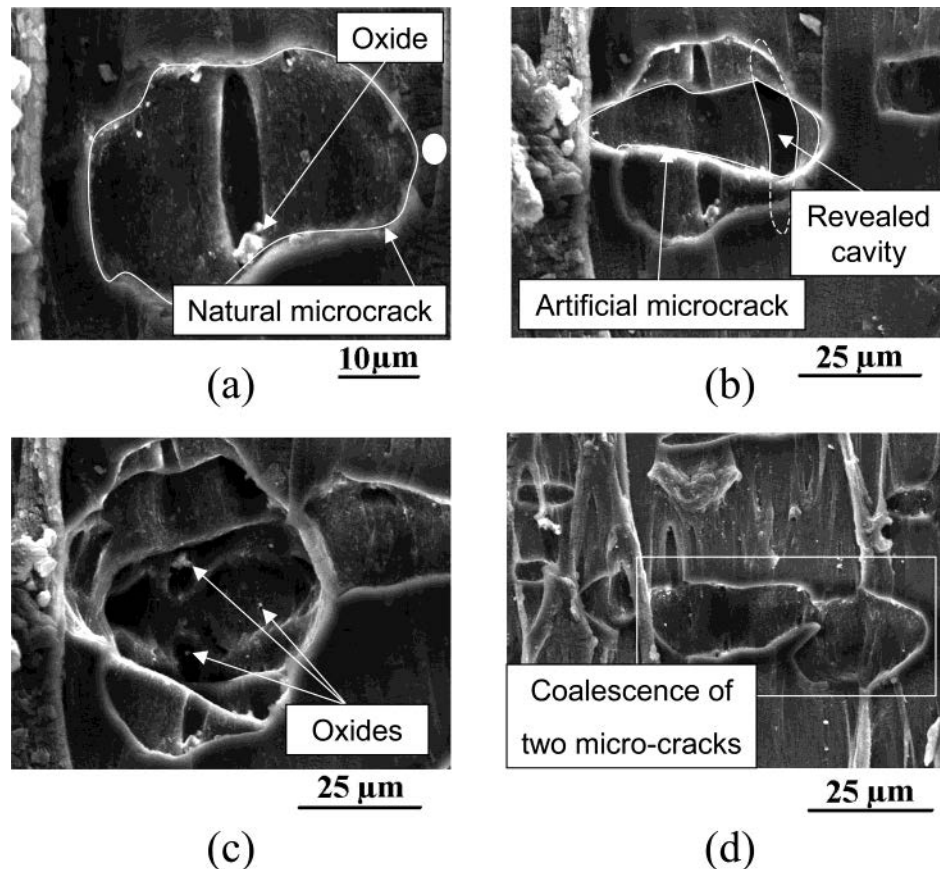
Figure 6. Chronology of the microcut experiment.

5b). Figure 6 presents the chronology of the real-time observation. The observation zone is shown in Figure 6a. It contains a natural microcrack near a ligament. In the middle of this microcrack, a stretched cavity containing an oxide takes place. Then, the electron beam is focused a few seconds beside the microcrack (see the white circle in Figure 6a). It leads to an artificial microcrack which initiates at the beam concentration point, slowly propagates to the other side of the natural microcrack, and stops at the ligament, as shown in Figure 6b. During its propagation, this artificial microcrack revealed a cavity similar to the one observed in the natural microcrack. By continuing to focus the electron beam, new microcracks are propagating in the sample depth and are revealing cavities. Most of these cavities contain oxides (see Figure 6c). Moreover, note that this microcutting can also be used to induce the coalescence of existing microcracks by concentrating the electron beam between them (see Figure 6d). Finally, it should be mentioned that, as the electron beam is focused on ligaments (the SEM power settings being unchanged), they do not break even if they are exposed for a long time. It seems to indicate that the microstructures of ligaments and elliptical areas between them are different. More precisely, this difference might be mainly due to the distribution of the crystallization ratio: the highly stretched ligaments represent the most crystallized zones of the crack tip. These results obtained under fatigue loading conditions are quiet similar to those recently established under static conditions by Trabelsi et al.,¹⁶ who demonstrate that a crystallized zone appears at crack tip of initial cut lengths 0.5 and 1 mm for stretch ratios greater than $\lambda = 1.3$.

This experiment highlights that cavities take place in the vicinity of the crack tip due to decohesion between oxides and rubber matrix. Similarly, Layouni et al.¹⁷ associate the volume change of elastomers under mechanical loading with the decohesion between zinc oxides and matrix. Cavitation in rubber is a well-known phenomenon that was thoroughly studied in the past for static loading conditions.^{18,19} Recently, it has been shown that the number of preexisting microvoids per unit volume strongly correlates with the mechanical performance of elastomers.²⁰ For fatigue loading, only internal crack growth under high hydrostatic pressure has been studied.²¹ Nevertheless, in the present case of relaxing tensile fatigue, the origin of cavitation is not established: is it only a consequence of the stress state at the crack tip, or is it also due to fatigue loading conditions? To answer these questions, a second experiment is carried out. It consists of generating a self-initiated fatigue crack and observing the cavities distribution in the sample.

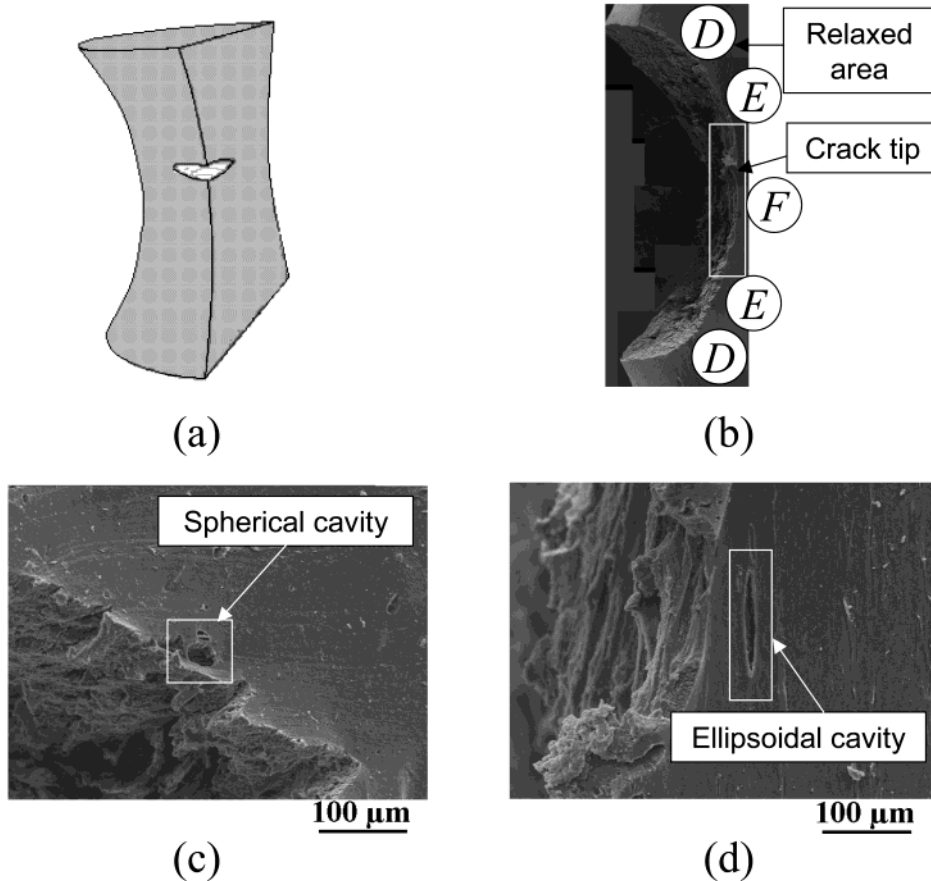
Figure 7. Second experiment: (a) cut sample, (b) global view of the crack, (c) details of relaxed areas, (d) details of the crack tip.

Figure 7 summarizes this second experiment. To observe cavities in the sample, it is cut in its undeformed configuration, as shown in Figure 7a. Afterward, it is stretched using the tensile apparatus presented above and introduced in the SEM. Figure 7b shows the opened crack tip and its surroundings. One can again distinguished relaxed zones with numerous wrenchings at the top and the bottom of the crack, and the most stretched area, i.e., the crack tip, in the middle. Large cavities are observed in both areas near the crack faces, and their shapes highly differ: they are spherical in the relaxed zones (see Figure 7c) and ellipsoidal (due to the stretching level) behind the crack tip (see Figure 7d).

Moreover, it is important to notice that the size of the large spherical cavity in Figure 7c (as compared with the size of an oxide) demonstrates that this cavity grew under cyclic loading. Examining the cut surface of the sample, a large number of cavities are revealed; most of them contain oxide, and their size rapidly decreases with their distance from the crack. From a sufficiently long distance, no more cavities are observed.

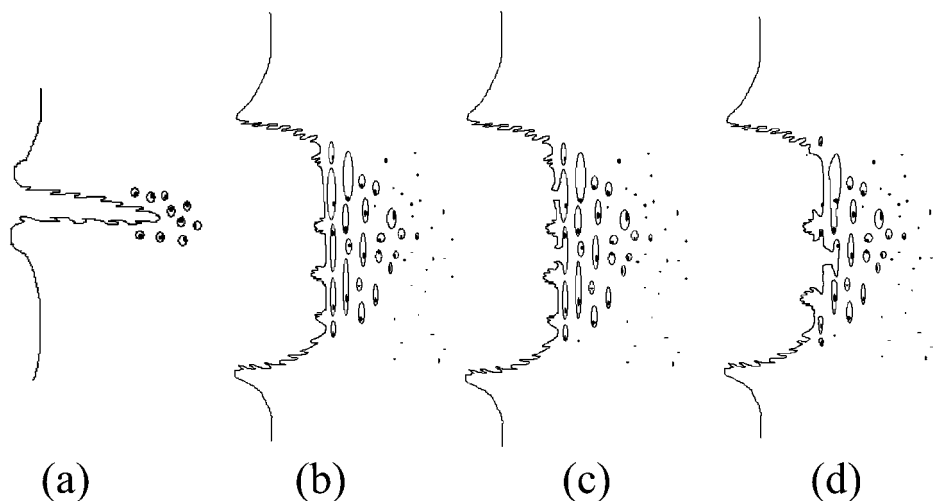
Figure 8. Crack growth mechanism: side view.

3.3. Crack Growth Mechanism. Using the previous observations, the scenario of fatigue crack growth is proposed in this section. It will be described thanks to two chronological sketches which correspond to two views of the phenomenon. Figures 8 and 9 present respectively the side and front views of crack growth. These two views will be used to accurately describe the three-dimensional nature of the phenomenon. It is to note that the chronology of the two figures are different; i.e., the stage of Figure 8a does not correspond to the one of Figure 9a.

The crack growth phenomenon can be seen as the succession of elementary sequences from initiation to final failure. Before examining this elementary sequence, let us recall that both fatigue loading and the stress state in the neighborhood of the crack tip generate cavitation due to the decohesion between oxides and rubber matrix as shown in Figure 8a. The elementary sequence is composed of three steps:

(i) As the crack tip is stretched, elliptical areas take place with ligaments on both sides and wrenchings at the top and bottom. Cavities are situated behind these areas, and their shape is ellipsoidal (see Figure 9a). As shown in Figure 8b, the wall that separates the crack tip and cavities is thin, such that it can be considered as a membrane.

(ii) This membrane tears and reveals most of the cavities situated behind it (see Figure 8c). The corresponding microcracks propagate perpendicularly to the crack growth direction (see Figure 9b).

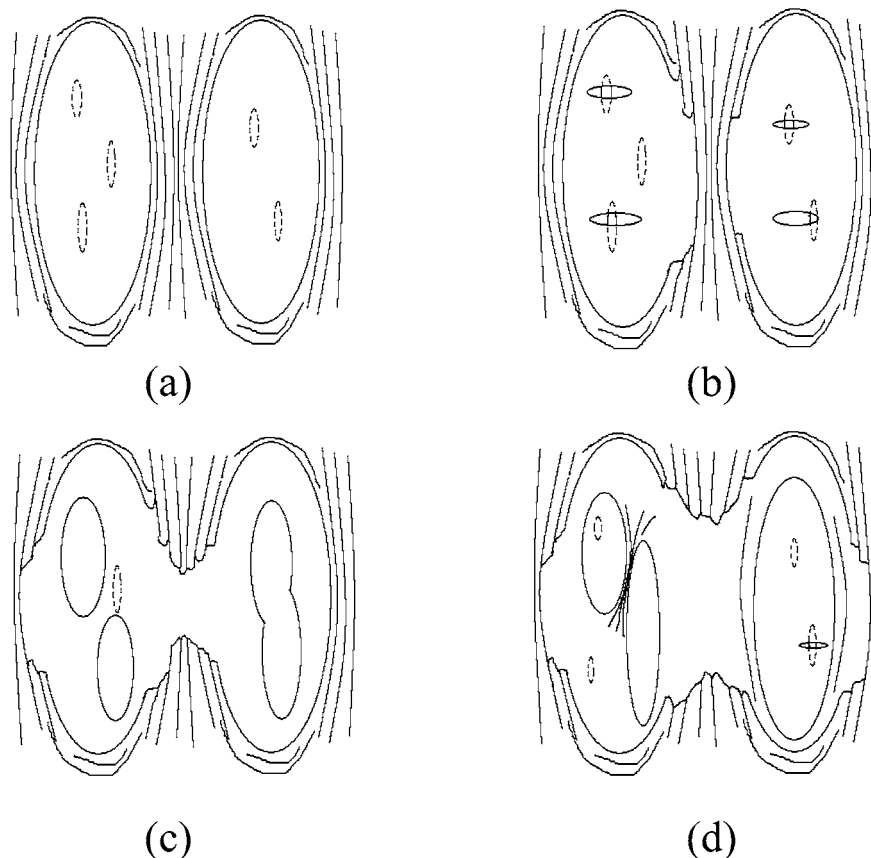
Figure 9. Crack growth mechanism: front view. Hidden parts are represented by dotted lines.

(iii) Then, microcracks grow and eventually coalesce until the destruction of the elliptical areas. Moreover, ligaments break and relax to form the wrenchings which lie at the top and bottom of these elliptical zones (see Figure 9c). This fracture may be due to the fatigue of ligaments or/and to the new stress state in ligaments generated by their neighborhood. Schematically, the crack tip breaks, the crack grows, and the processus restarts at (i) (see Figure 8d). It should be noted that the coalescence of microcracks can be limited with the result that the elliptical zones are not completely destroyed and that ligaments occur between microcracks, the consequence being the formation of several new elliptical areas (see Figure 9d).
