A New NDT Method for the study of composite bonded repair

A NEW NDT METHOD FOR THE STUDY OF COMPOSITE BONDED REPAIR

Keywords: composite materials, bonded repair, infrared thermography, joint response

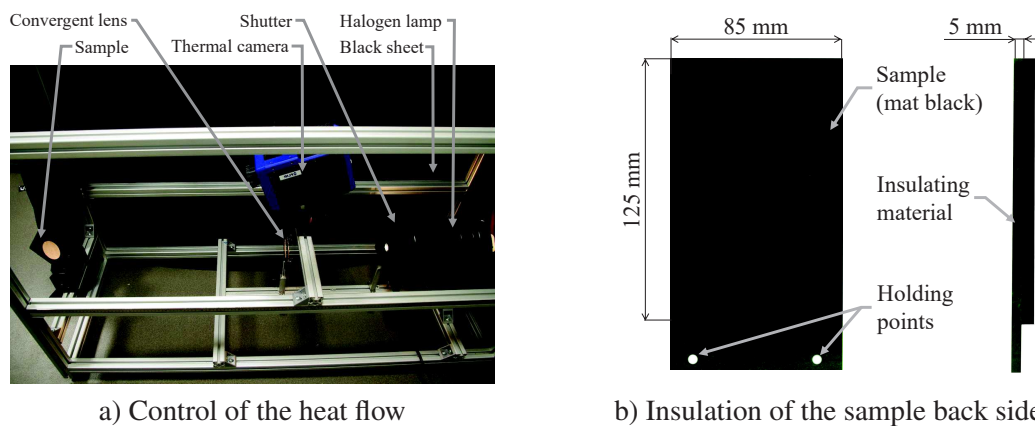
Figure 1. Specific experimental device

The new bench is designed to better control the thermal stimulation and boundary conditions (Figure 1 a). Indeed, it allows to generate a homogeneous heat flow by the use of a convergent optical lens which transforms the initial divergent light delivered by the halogen lamp (maximum power of 1000 W) into a parallel light beam. Furthermore the sample is pasted on an insulating polymer reticulated foam (Airex[®] C70) and the assembly is held at the foam bottom (Figure 1 b)). This avoids heat sinks and thermally insulates the back face of the sample. To precisely control the position of the thermal stimulation, each element (lamp, shutter, lens and camera) is placed into a rigid metallic support. Since the thermal camera optical axis should be orthogonal to the sample surface, the sample is tilted relative to the light source (forming an angle of 25°), which makes the heat impacted area elliptical in shape whose dimensions are fixed by the lens diameter and the inclination angle (namely the minor axis 65 mm and major axis 72 mm long). At last, all samples are painted in mat black to consider the emissivity of carbon ($\epsilon = 0.98$) and the bench is entirely covered with a black sheet to limit most of environment disturbances.

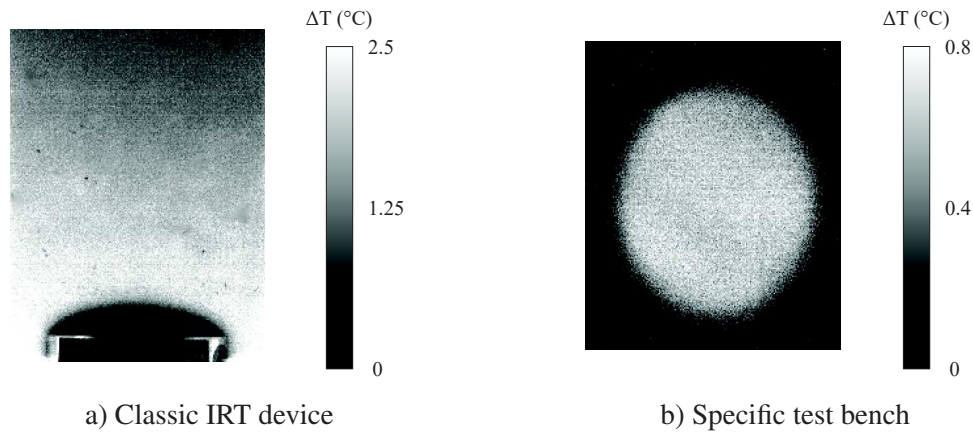
Figure 2. Surface temperature variation on an Inconel plate for a classic IRT device and the specific test bench, after a step heat load of 3 s

Compared with conventional device, the improvement obtained with this new experimental configuration is presented on the Figure 2 for the same material (Inconel), thermal load (step heat load), equipment (lamp, IR camera) and distances (lamp-sample, sample-camera). Even if the optical system reduces globally the amount of heat flow received by the sample, this new configuration enables a significant improvement in terms of load distribution, providing namely an homogeneous intensity on a delimited elliptical area. An other significant advantage is that such loading configuration and boundary conditions of the thermal problem can be physically taken into account by a numerical model.

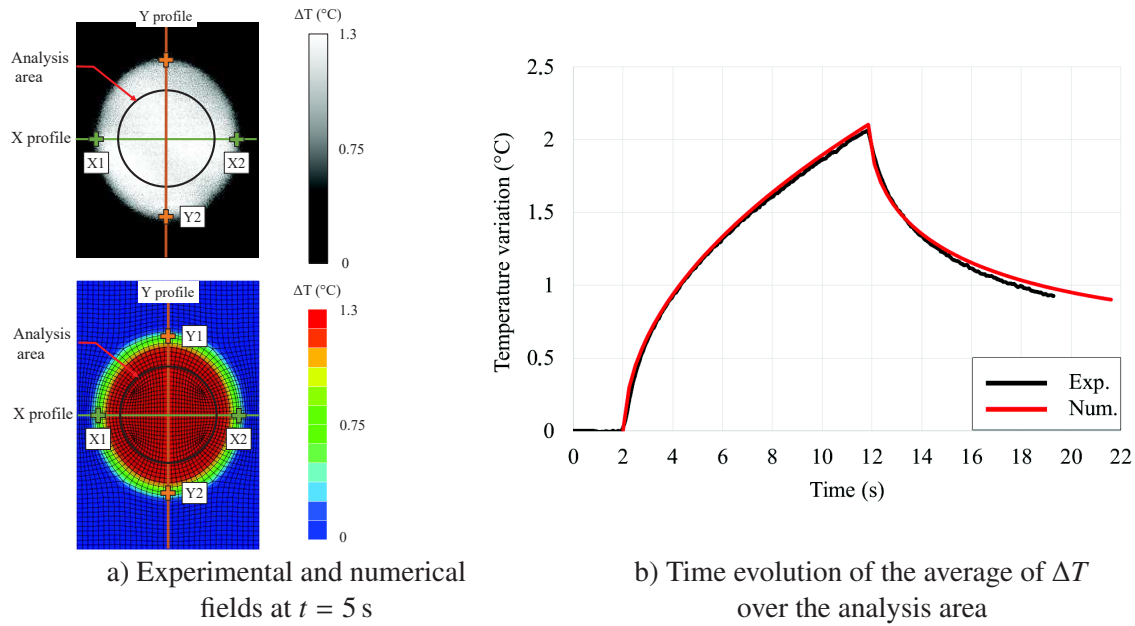
Figure 3. Surface temperature variation ΔT for a $[0/90/0]_6$ composite

Same study is next set up for a virgin (not repaired) composite laminate composed of 18 plies of M10 epoxy resin and T300 fibers with $[0/90/0]_6$ stacking sequence (thickness of 4.7 mm). The numerical modelling for such a case integrates the transversely isotropic behavior of CFRP plies and their specific orientation. Also, simulated response corresponds to the heat load intensity φ_{id} identified previously on the Inconel material. If the model is able to capture the global non linear behavior of the composite under these thermal conditions, note that the transverse conductivity λ_t of composite ply has been calibrated to match the time evolution of the average thermal variation over the central analysis area (Figure 3). To check the adequation of the model, is shown on Figure 4 the spatial distribution of surface temperature variation ΔT through temperature profiles at different steps (middle and end of heating phase and middle of cooling phase). Since simulations are in good agreement with measurements, this allows to validate the experimental set up and related modelling.

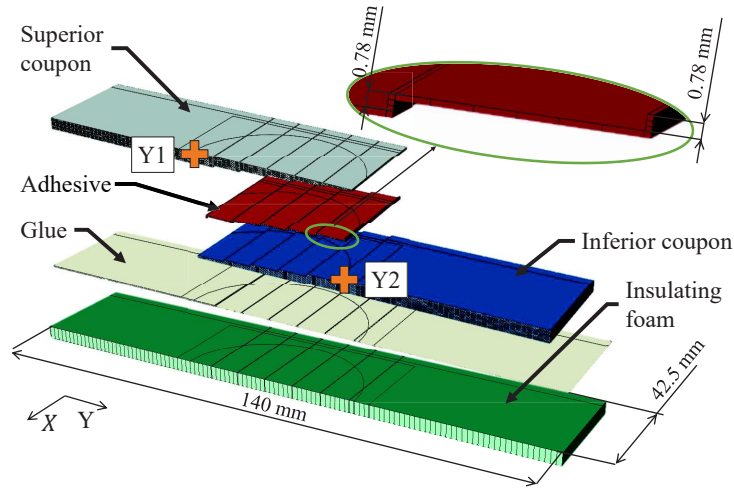
Figure 5. Constitutive parts of the FE model for the study of repaired assembly (Y-axis corresponds to 0° ply direction)

Two coupons of the composite laminate studied previously have been machined by water jet and bonded to form repaired assemblies with a step lap geometry. Precisely, the repaired assembly is composed of five steps with a length of 12 mm and a thickness of 0.78 mm (Figure 5). A structural epoxy adhesive (ST1035) with a thickness of 0.3 mm is used to bond the two elementary parts and polymerized by means of a heating bench. As for the virgin materials, repaired assemblies are painted in mat black and pasted on the reticulated foam. Afterwards, they are thermally solicited under same conditions using the specific experimental device. The studied assembly is placed such that the elliptical heating area covers along Y axis both repaired and virgin parts of the laminate. Regarding the numerical modelling, same approach as for section 3 has been implemented. Given to the complexity of the geometry, a supplementary work was however necessary to ensure a perfect coincidence between the mesh nodes and thus to respect the perfect thermal contact assumption between parts. Note finally that some adhesive film goes up to the surface during the bonding procedure (Figure 5), which was taken into account in the numerical model and allows to calibrate the missing properties of the adhesive film.

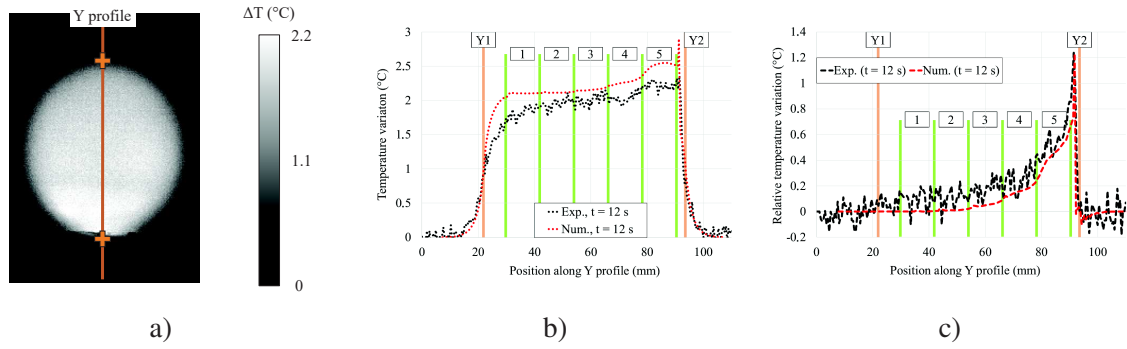
Surface temperature variations ΔT for $[0/90/0]_6$ composite repaired assembly are illustrated on Figure 6a and 6b. We observe on the temperature profile along Y-axis that the most important temperature elevation is near point Y2 (at the shallowest step, Figure 6b). This can be explained by the poor thermal effusivity ($\sqrt{\lambda\rho C_p}$) of the adhesive film (less than those of the composite material) which behaves as a barrier for the heat load. Indeed, the more the deep of the joint becomes important (that is far from Y2), the more the temperature elevation decreases. For this reason, it is not possible to distinguish clearly on ΔT profiles the specific response of the joint.

Figure 6. Surface temperature variation for a $[0/90/0]_6$ composite repaired assembly at $t = 12$ s : experimental ΔT field (a), experimental and numerical ΔT (b) and $\Delta_2 T$ (c) temperature profiles along Y-axis. Limits of steps are indicated by green lines (respective depths : 3.9 mm (1), 3.12 mm (2), 2.34 mm (3), 1.56 mm (4), 0.78 mm (5))

where the variations ΔT related to the repaired assembly and to the virgin material are both obtained in the same conditions (load and boundary conditions) and at the same time. Such a post processing allows to avoid edge effects relative to the convergent lens and to highlight the thermal response of the glue joint. The good agreement between experimental and numerical results on ΔT_2 is illustrated on Figure 6c. With the new experimental procedure (and current light source), it is thus possible to highlight the three shallowest steps, that is to access to the joint standing at a maximum inspection depth of 2.34 mm. Such result is consistent with detection limits generally encountered by IRT for similar properties contrast (using for instance Teflon inserts as artificial defects).

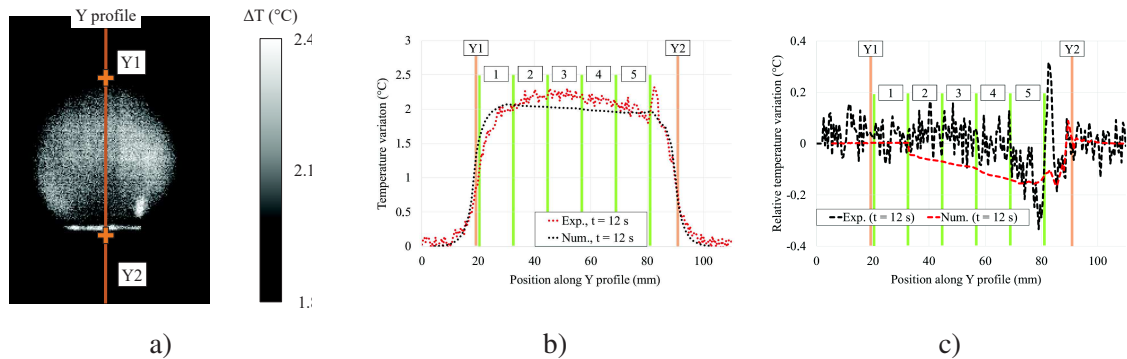
Figure 7 presents the first experimental results. We observe a maximum temperature elevation ΔT near the deepest step, equal to the case of bonded repair without additive. The minimum temperature elevation ΔT is located at the shallowest step which confirms the predicted conductive behaviour of the epoxy adhesive with additives. Note also that a local temperature elevation on ΔT field (at the right bottom of the assembly, Figure 7a) can be attributed to the presence of a disbond. The numerical modelling is this time again based on the same assumptions and uses the effective physical and thermal properties of the joint with additives. The model is able to capture the global tendency of the variation of ΔT_2 (Figure 7c) and allows to inspect the joint response at a depth of 3.9 mm. These results are thus very encouraging, providing a full confidence with the numerical modelling and allowing to validate the assumptions taken into consideration.

Figure 7. Surface temperature variation for a $[0/90/0]_6$ composite repaired assembly with boron nitride inside the glue joint at $t = 12$ s : experimental ΔT field (a), experimental and numerical ΔT (b) and $\Delta_2 T$ (c) temperature profiles along Y-axis
