Lime Treatment: New Perspectives for the use of Silty and Clayey Soils in Earthen Hydraulic Structures

G. Herrier, D. Puiatti, C. Chevalier, M. Froumentin, Stéphane Bonelli, et al.. Lime Treatment: New Perspectives for the use of Silty and Clayey Soils in Earthen Hydraulic Structures. 9th ICOLD European Club Symposium, Apr 2013, Venice, Italy. pp.10. hal-01548437

Lime treatment : new perspectives for the use of silty and clayey soils in earthen hydraulic structures

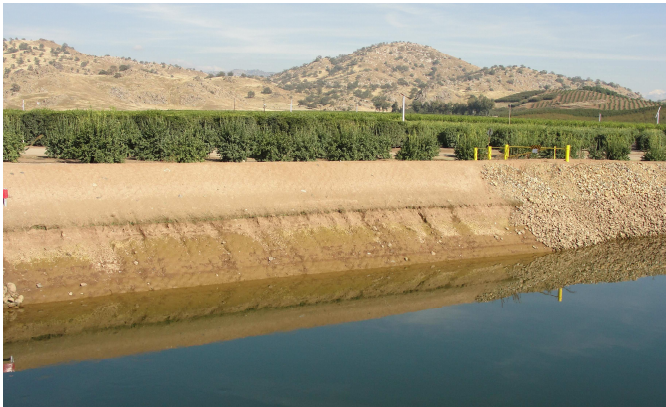
Figure 1: Lime-treated section of the Friant-Kern Canal (taken in November 2010) on the left part; the right part consist of original, untreated slope covered with gravel.

Several evaluations of the results have been performed, no new slips, slides or sloughs have occurred. The viability and economical benefits of the solution were obvious. A recent visit (Figure 1) showed that the sheepfoot roller imprint was still visible both above and below the water surface, 35 years after the job [8]. The picture was taken during a maintenance phase, when the water level was below the normal one, one can see minor erosion along the water level, due to departure of small rocks or “untreated clay balls”, not mixed efficiently with lime due to the poor mixing quality at these ages. The maintenance operations are very limited on this section, considering the lime-treated part is durable and is significantly cost-saving.

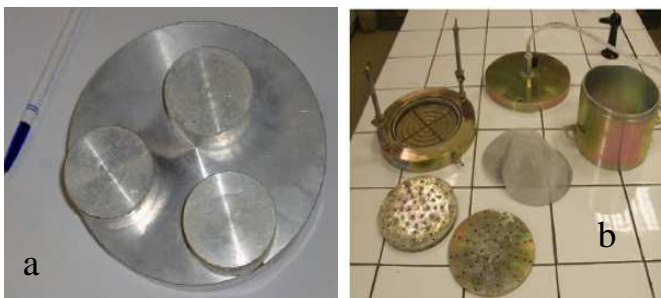
Figure 2: Kneading compaction tool (a) and permeameter (b).

- classical Proctor dynamic compaction, to 95% of the OPN dry density ;
- kneading compaction, performed with a specific tool, simulating the geometry and surface ratios of a sheepfoot roller (Figure 2a) [10]. The specimens were compacted to the same final density as that of the Normal Proctor method. In

The permeability tests were performed at LRPC Angers (France), according to the XP CEN ISO/TS 17892-11 Standard. The samples were directly compacted in the permeameters (Figure 2b). The set-up was similar to CBR moulds except that they were equipped with inox grids and pierced plates for the water entrance and exit. The permeability measurements were performed after 28 days curing at constant water content (after compaction), after 28d curing + 2 months immersion period and 28d curing + 5 months immersion. The following results were highlighted:

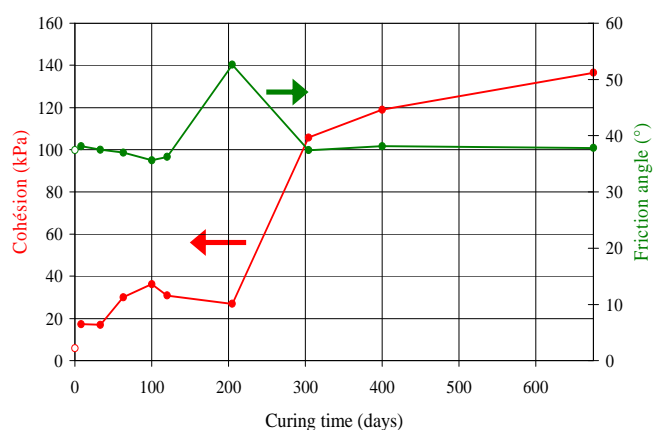
Figure 5: Evolution of the shear resistance parameters with time (treated silt from Soumagne, Belgium, PI=16). The white points at $t=0$ are related to the untreated specimen.

[11]. Consolidated undrained triaxial tests were performed on samples of 3.6cm diameter and 7.2cm height, beforehand saturated. The untreated first silt (Soumagne soil) parameters are $c'=5.8\text{kPa}$ and $\phi'=37.4^\circ$. The values obtained after treatment and at several curing times are reported on the Fig. 5. The friction angle stays stable with time, whereas the cohesion rises significantly: after 2 years, the c' value was multiplied by 25. Similar results were obtained with the silt from Marche-les-Dames (PI=11), which shows a c' value equal to 500 kPa at 450 days after treatment. The range of measured cohesion values was well above common stresses met on small hydraulic structures.

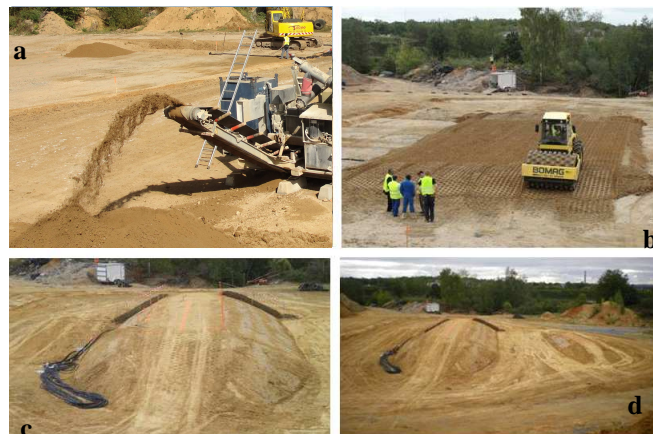
Figure 11: Lime-treated material production (a), application and compaction with a sheepfoot roller (b), global view of the lime-treated dike (c) and of the two dikes (lime-treated and untreated, on the right) (d).

- after lime and soil mixing, the final materials must be humid, e.g. wet of optimum conditions. In the case of Marche-les-Dames soil that means that water must be added to obtain a final moisture content above 18 %, once treated.
 - the compaction must be performed with kneading operations (sheepfoot roller). The objective in terms of density level is to reach at least 95 % of the maximal dry density (17.3 kN/m³). The equipment used for lime treatment was a mobile soil mixing plant, able to precisely control the lime dosage through a continuous weighing of soil passing through the band, and offers a regular addition of water directly in the mixing bell. The particle size of the treated soil is very fine and ranges between 0 and 20 mm.
- The compaction equipment is a VP5 sheepfoot roller, according the French Standard NF P 98-736 (Figure 11b).

The 2.5% lime treatment with a controlled water addition in the mobile mixing plant, produced a granular, fine material at a humidity level above OMC. This material was transported directly to the jobsite, and then taken by a shovel for the placement of 50 cm thick layers prior to compaction. The compaction step was performed with a kneading compactor in 6 passes at a speed of 3 km/h, producing a final thickness of 30 cm for each layer. Finally, the embankment was constructed in 6 layers, giving a total height of 1.80 m (Figure 10b). Pictures of each step can be viewed in Figure 11.
