G. Herrier, D. Puiatti, C. Chevalier, M. Froumentin, Stéphane Bonelli, et al.. Lime Treatment: New Perspectives for the use of Silty and Clayey Soils in Earthen Hydraulic Structures. 9th ICOLD European Club Symposium, Apr 2013, Venice, Italy. pp.10. hal-01548437

Lime treatment : new perspectives for the use of silty and clayey soils in earthen hydraulic structures

Real-scale experimental dikes were built in September 2011, to verify the correspondence between lab results and the real-scale realization.

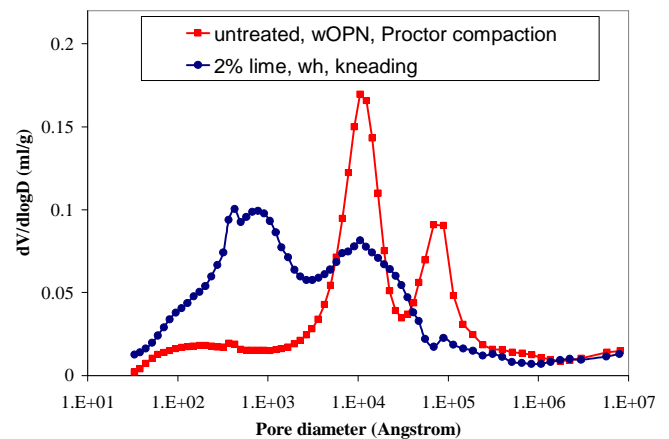
Figure 3: Mercury intrusion porosimetry of untreated (red curve) and lime-treated (blue curve) samples, as a function of water content and compaction procedure (silty soil from Moulin de Laffaux, France, $PI=12.7$).

and kneading compaction, the amount of pores $>3\mu\text{m}$ was strongly reduced in favour of the smallest pore size (Figure 3), that is in favour of very small pores that do not affect the permeability. As a conclusion, the placement method is far more important than final density in the control of permeability.

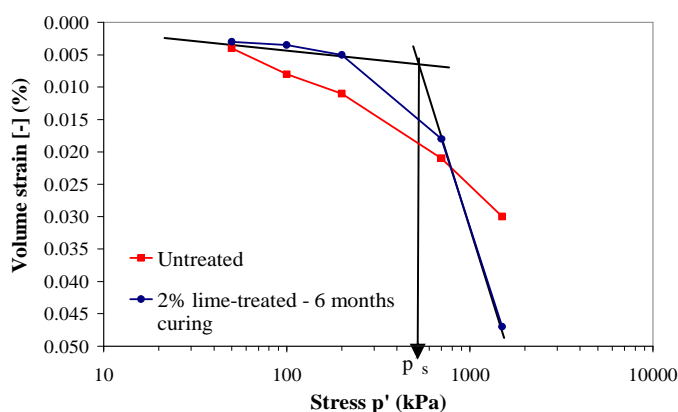
Figure 4: Isotropic compression of untreated and lime-treated silty soil from Moulin de Laffaux, PI=12.7 (6 month curing).

Isotropic compression tests were performed on the same silt as the one used for permeability (Figure 4). The volume strain of the untreated sample is function of the logarithm of isotropic stress ($\log p'$), which means that the yield strength is below the smallest applied stress. Once treated with 2% lime and after 6 months, 2 slopes can be distinguished on the graph, separated by the yield strength between 400 and 500 kPa.

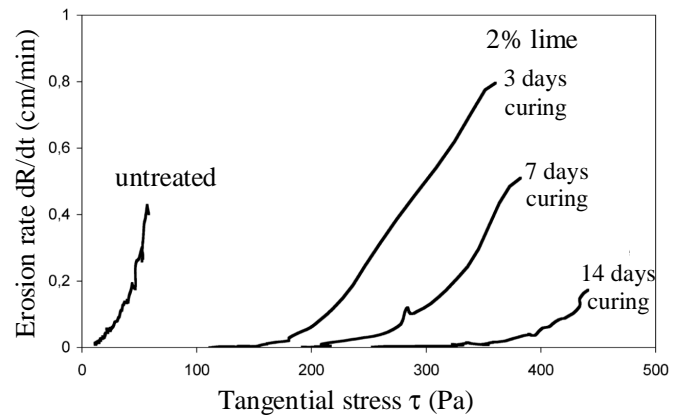
Figure 7: Hole Erosion Test: erosion rate vs tangential stress for untreated and 2% lime-treated clayey silt from a Camargue dike (PI= 11).

erosion rates vs tangential stress are reported in Fig. 7 for untreated specimen, and 2% lime-treated after 3 curing periods.

After 14 days curing, the critical stress was increased by a factor 20, and the erosion coefficient divided by 10. The device didn't allow the erosion initiation of the 28 days cured samples. HET results can be used to estimate the threshold water velocity that induces erosion (Fig. 8). For untreated clayey silt, the erosion threshold correspond to a water velocity of 2 m/s, whereas for lime-treated material, the value rises up to 10 m/s. These results are important elements for the problematic of internal erosion, main origin of hydraulic earthworks failures [14],[15].

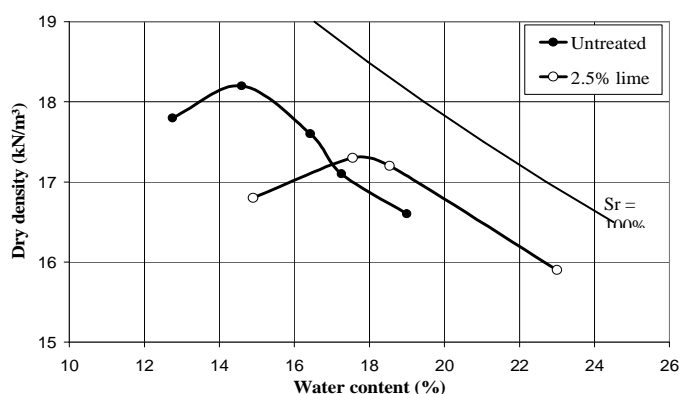
Figure 9: Standard Proctor compaction curves of untreated and 2.5 % Proviacal® DD-treated soil from Marche-les-Dames (Belgium).

The changes induced by the lime treatment on the compaction behavior of the soil are illustrated in Figure 1. The optimal moisture content for Standard Proctor compaction of untreated soil is $\rho_d=18.2\text{ kN/m}^3$ at $w_{OMC}=14.5\%$. It is known that lime treatment leads to a displacement of the w_{OMC} towards higher moisture contents and a reduction of the maximal dry density: the specific compaction characteristics of the Marche-les-Dames silty soil treated with 2.5 % quicklime are $\rho_d=17.3\text{ kN/m}^3$ at $w_{OMC}=17.8\%$ (Figure 9).

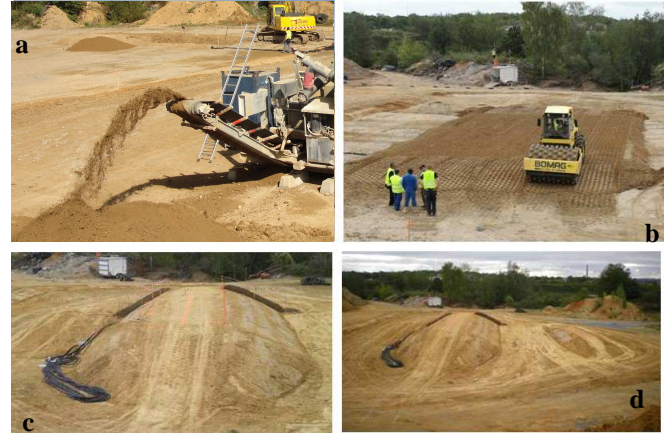
Figure 11: Lime-treated material production (a), application and compaction with a sheepfoot roller (b), global view of the lime-treated dike (c) and of the two dikes (lime-treated and untreated, on the right) (d).

- after lime and soil mixing, the final materials must be humid, e.g. wet of optimum conditions. In the case of Marche-les-Dames soil that means that water must be added to obtain a final moisture content above 18 %, once treated.
 - the compaction must be performed with kneading operations (sheepfoot roller). The objective in terms of density level is to reach at least 95 % of the maximal dry density (17.3 kN/m³). The equipment used for lime treatment was a mobile soil mixing plant, able to precisely control the lime dosage through a continuous weighing of soil passing through the band, and offers a regular addition of water directly in the mixing bell. The particle size of the treated soil is very fine and ranges between 0 and 20 mm.
- The compaction equipment is a VP5 sheepfoot roller, according the French Standard NF P 98-736 (Figure 11b).

The 2.5% lime treatment with a controlled water addition in the mobile mixing plant, produced a granular, fine material at a humidity level above OMC. This material was transported directly to the jobsite, and then taken by a shovel for the placement of 50 cm thick layers prior to compaction. The compaction step was performed with a kneading compactor in 6 passes at a speed of 3 km/h, producing a final thickness of 30 cm for each layer. Finally, the embankment was constructed in 6 layers, giving a total height of 1.80 m (Figure 10b). Pictures of each step can be viewed in Figure 11.
