Lime Treatment: New Perspectives for the use of Silty and Clayey Soils in Earthen Hydraulic Structures

G. Herrier, D. Puiatti, C. Chevalier, M. Froumentin, Stéphane Bonelli, J.J. Fry

G. Herrier, D. Puiatti, C. Chevalier, M. Froumentin, Stéphane Bonelli, et al.. Lime Treatment: New Perspectives for the use of Silty and Clayey Soils in Earthen Hydraulic Structures. 9th ICOLD European Club Symposium, Apr 2013, Venice, Italy. pp.10. hal-01548437

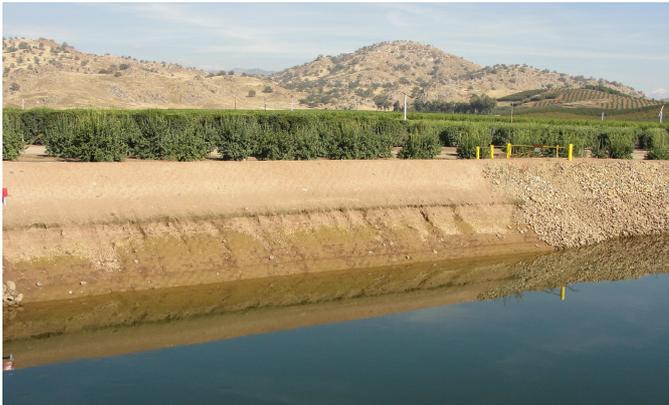
Figure 1: Lime-treated section of the Friant-Kern Canal (taken in November 2010) on the left part; the right part consist of original, untreated slope covered with gravel.

Several evaluations of the results have been performed, no new slips, slides or sloughs have occurred. The viability and economical benefits of the solution were obvious. A recent visit (Figure 1) showed that the sheepfoot roller imprint was still visible both above and below the water surface, 35 years after the job [8]. The picture was taken during a maintenance phase, when the water level was below the normal one, one can see minor erosion along the water level, due to departure of small rocks or “untreated clay balls”, not mixed efficiently with lime due to the poor mixing quality at these ages. The maintenance operations are very limited on this section, considering the lime-treated part is durable and is significantly cost-saving.

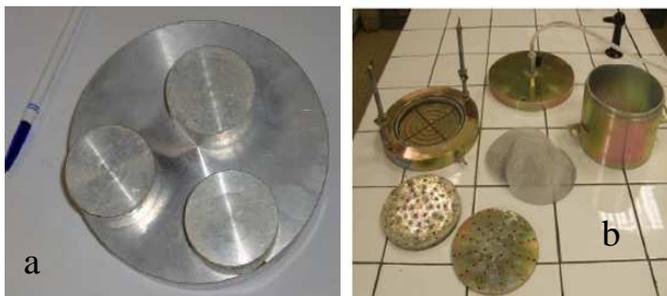
Figure 2: Kneading compaction tool (a) and permeameter (b).

- classical Proctor dynamic compaction, to 95% of the OPN dry density ;
- kneading compaction, performed with a specific tool, simulating the geometry and surface ratios of a sheepfoot roller (Figure 2a) [10]. The specimens were compacted to the same final density as that of the Normal Proctor method. In

The permeability tests were performed at LRPC Angers (France), according to the XP CEN ISO/TS 17892-11 Standard. The samples were directly compacted in the permeameters (Figure 2b). The set-up was similar to CBR moulds except that they were equipped with inox grids and pierced plates for the water entrance and exit. The permeability measurements were performed after 28 days curing at constant water content (after compaction), after 28d curing + 2 months immersion period and 28d curing + 5 months immersion. The following results were highlighted:

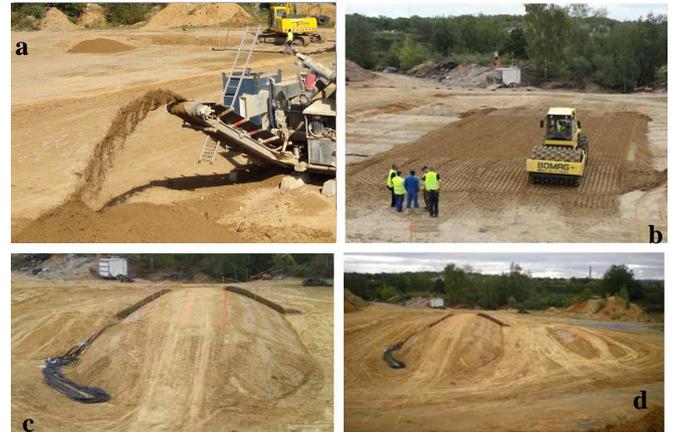
Figure 11: Lime-treated material production (a), application and compaction with a sheepfoot roller (b), global view of the lime-treated dike (c) and of the two dikes (lime-treated and untreated, on the right) (d).

- after lime and soil mixing, the final materials must be humid, e.g. wet of optimum conditions. In the case of Marche-les-Dames soil that means that water must be added to obtain a final moisture content above 18 %, once treated.
 - the compaction must be performed with kneading operations (sheepfoot roller). The objective in terms of density level is to reach at least 95 % of the maximal dry density (17.3 kN/m³). The equipment used for lime treatment was a mobile soil mixing plant, able to precisely control the lime dosage through a continuous weighing of soil passing through the band, and offers a regular addition of water directly in the mixing bell. The particle size of the treated soil is very fine and ranges between 0 and 20 mm.
- The compaction equipment is a VP5 sheepfoot roller, according the French Standard NF P 98-736 (Figure 11b).

The 2.5% lime treatment with a controlled water addition in the mobile mixing plant, produced a granular, fine material at a humidity level above OMC. This material was transported directly to the jobsite, and then taken by a shovel for the placement of 50 cm thick layers prior to compaction. The compaction step was performed with a kneading compactor in 6 passes at a speed of 3 km/h, producing a final thickness of 30 cm for each layer. Finally, the embankment was constructed in 6 layers, giving a total height of 1.80 m (Figure 10b). Pictures of each step can be viewed in Figure 11.
