## Resistance to erosion of lime treated soils for application to coastal dikes

# Resistance to erosion of lime treated soils and perspectives for coastal dikes

Keywords: lime treatment, soil, erosion, dike

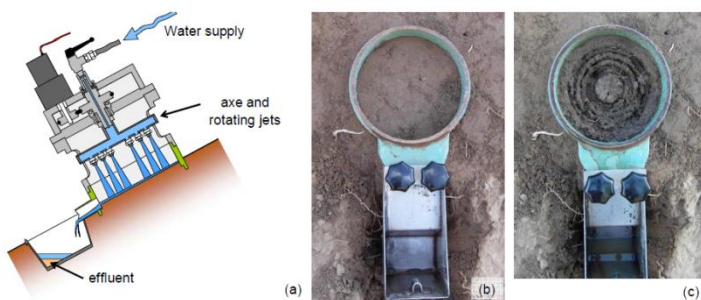
Figure 1. Mobile jets erosion (MoJET) test set-up: (a) Schematic diagram of eroding unit. Image of eroding unit in field (b) before and (c) after test

The MoJET is made up of one mechanical part, named “eroding unit” with 6 rotating water jets, a water supply tank with the possibility of pressurization, and a few additional parts (pump, flowmeter etc.). The eroding unit projects water jets with 0.5 mm diameter nozzles (Fig. 1a) perpendicular to the soil. The mould is placed on a 10% slope (6 degrees) (Fig. 1.a and 1.b). The outfall ring is inserted around the mould while directing the outfall towards the downstream side of the slope into the top of the measurement container. The ground is then subjected to the action of the water jets with the following test parameters:

After the test, the soil sample generally shows gullies located where the water jets impact its surface (Fig. 1c).

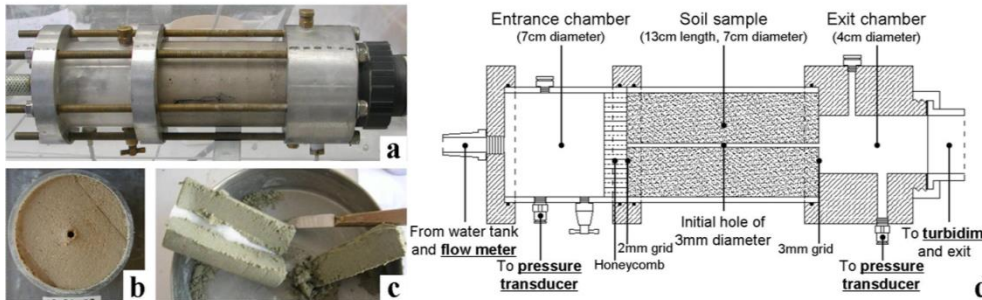
Figure 2. Experimental set-up and soil sample treatment. (a) Image of eroding unit. (b) Sample before test with 3mm diameter hole. (c) Cut sample after test with wax mold. (d) Drawing of eroding unit. Sensor are indicated in bold and underlined characters.

The HET device has three parts: an upstream water tank, an eroding unit where the sample is located and a downstream water exit. The erosion unit is depicted in figure 2 along with the measuring instruments. The soil sample is prepared in a cylindrical Plexiglas mold. The dimensions are 7cm in diameter and 15cm in length (volume: 500 cm<sup>3</sup>), and vertically drilled. The diameter of the initial hole is 3 or 5mm. After bringing water to the system and especially in the sample, the air pressure in the upstream water reservoir is raised gradually until the desired pressure difference is reached. This pressure difference is kept constant after the erosion occurred. During the test, from the increase of head charge to the decrease, the data collected by flow meter (flow rate  $Q$ ), pressure transducers (pressure drop  $\Delta P$ ) and turbidimeter (turbidity  $T$ ) are stored on a computer using a data-logger. The acquisition frequency is generally 1 Hz. These measurements and data on initial and final radii allow us to calculate erosion curves (interpretation method detailed in Pham (2008) and Haghighi et al. (2012a)) i.e. the relationship between the two following physical quantities:

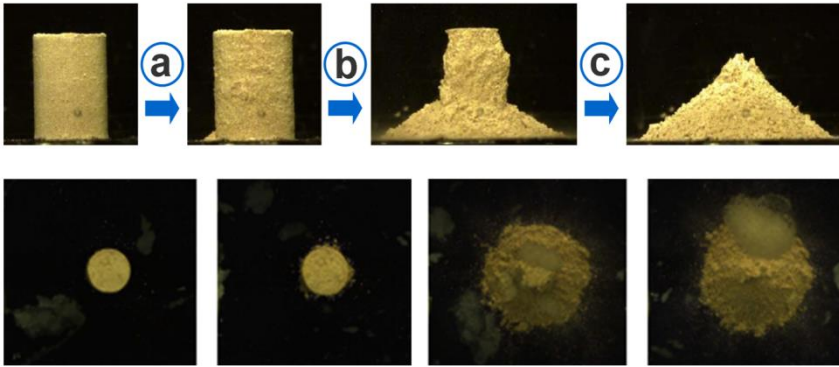
Figure 4. General behavior of a specimen

The general behavior of the soil specimens, after being placed in water, is almost the same but with different characteristics for different soil textures. This behavior can be divided into two different phases: (a) hydration and (b-c) dispersion. Nevertheless detailed characteristics (height of swelling, disaggregation time, etc.) vary between different soil textures.

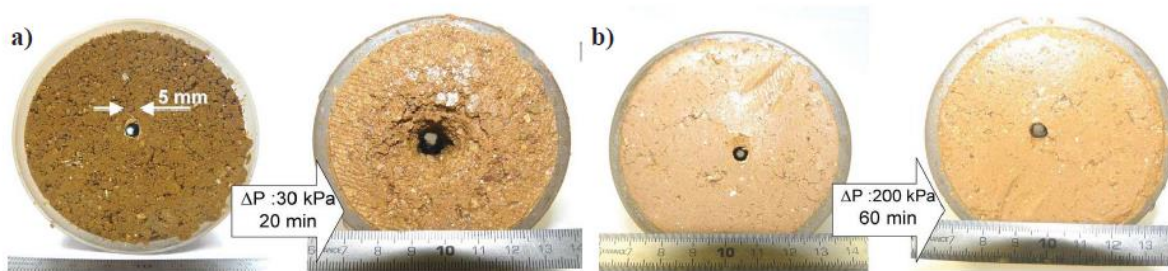
Figure 5: Typical HET results on materials. (a) Untreated silt before and after test (pressure difference of 30KPa during 20 minutes), (b) treated silt before and after test (pressure difference of 200KPa during 60 minutes).

Regarding HET tests, the critical shear stress cannot be measured for treated soil: for the silty treated soil it is higher than 800Pa, being at least 2 times greater than shear stress for untreated silt.

Images of an example of an untreated silt sample and a treated one are given on figure 5.

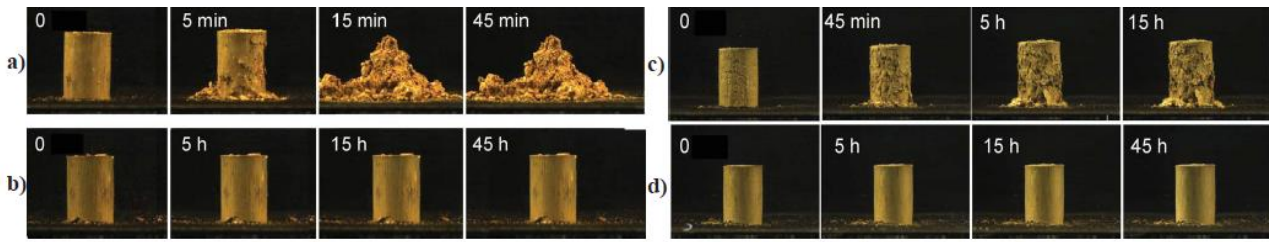
Figure 6: Evolution of the geometry of ECT soil specimen during test.  
(a) Untreated silty soil, (b) treated silty soil, (c) untreated clayey soil, (d) treated clayey soil.

Treated soils therefore are virtually water insensitive according to ECT tests. The swelling is very low and crumbling almost nonexistent (Figure 6).

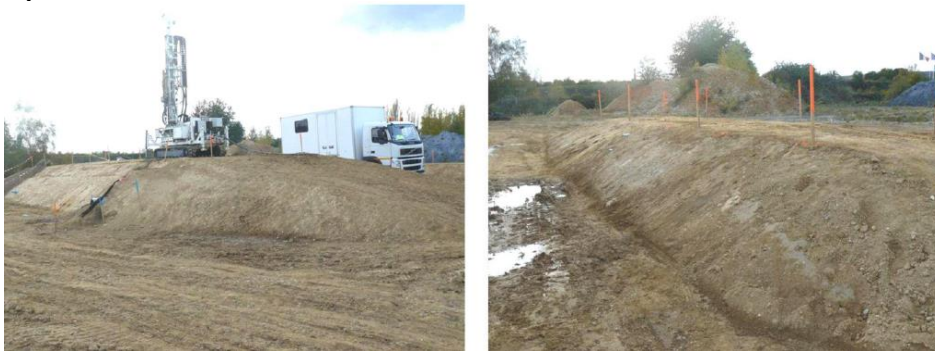
Figure 7. View of the experimental dry dikes built at the Rouen Experimentation and Research Center: on left the lime treated dike and on right the untreated dike

In this section, in situ and laboratory tests performed with soil from two full-scale experimental hydraulic structures built in the Rouen CER (Experimentation and Research Center) are presented (Charles et al. 2012). The structures were two dry dikes built with silty soil from “Marche-les-Dames”(Belgium), one had been treated with 2.5% lime and the other was untreated. The treatment was performed using a mobile mixing plant. Materials were compacted in the wet state, at 17% water content ( $w_{OPN}+2\%$ ) in the case of the untreated silt structure, and at 19.4% ( $w_{OPN}+1.6\%$ ) in the case of the treated soil structure. Pictures of the two dikes are presented in figure 7. The treated soil homogenization was guaranteed throughout the production using the mixing plant, and its compaction was performed by a sheepfoot roller (kneading compaction). Consequently, laboratory conditions of preparation are well reproduced in situ.

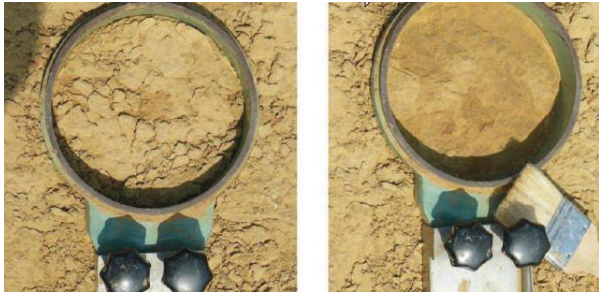
Figure 8: On left the flaky crust which appeared between 28 and 180 days after the construction. On right, this crust is removed using a brush

Tests were performed in situ 28, 180 and 368 days after the building. In most cases, two repeatability tests were carried out for each configuration (soil constitution, protocol and curing time). Tests were performed under temperate climate (15°C mean at 28 days, 20°C mean at 180 days and 15°C mean after 365 days) and without intense rainfalls. Nevertheless, dikes spent winter without superficial protection and at 180 days, a few millimeters of flaky crust had appeared on the free surface of the lime treated dike (**Erreur ! Source du renvoi introuvable.**). That crust was not there after 28 days curing. The two

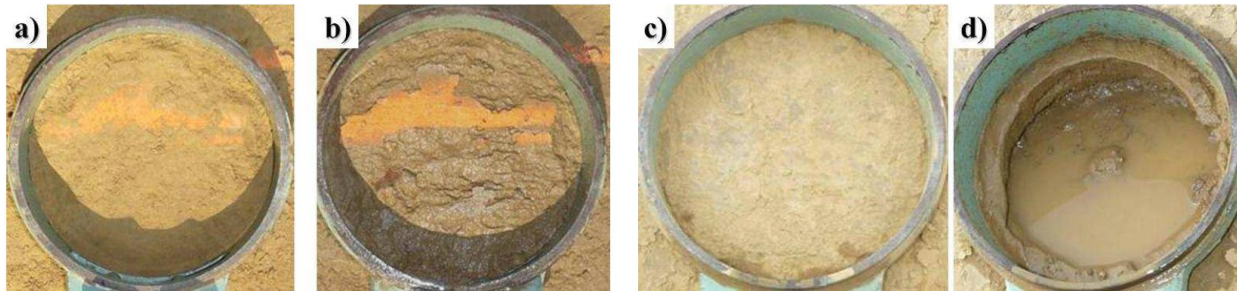
Figure 9. Soil surfaces before and after normal protocol MoJET tests, 28 days after the construction. Soil treated before test (a) and after test (b); untreated soil before test (c) and after test (d).

Figure 9 shows treated and untreated dike surfaces after tests using the normal protocol. First, we note a large difference in erosion depth and water penetration between tests performed on the treated and untreated dike. Because of the very low permeability of treated dikes, the water stream around the mould and the infiltration depth were only a few millimeters. Removing the superficial layer, the soil water content below was still the same as before solicitation.

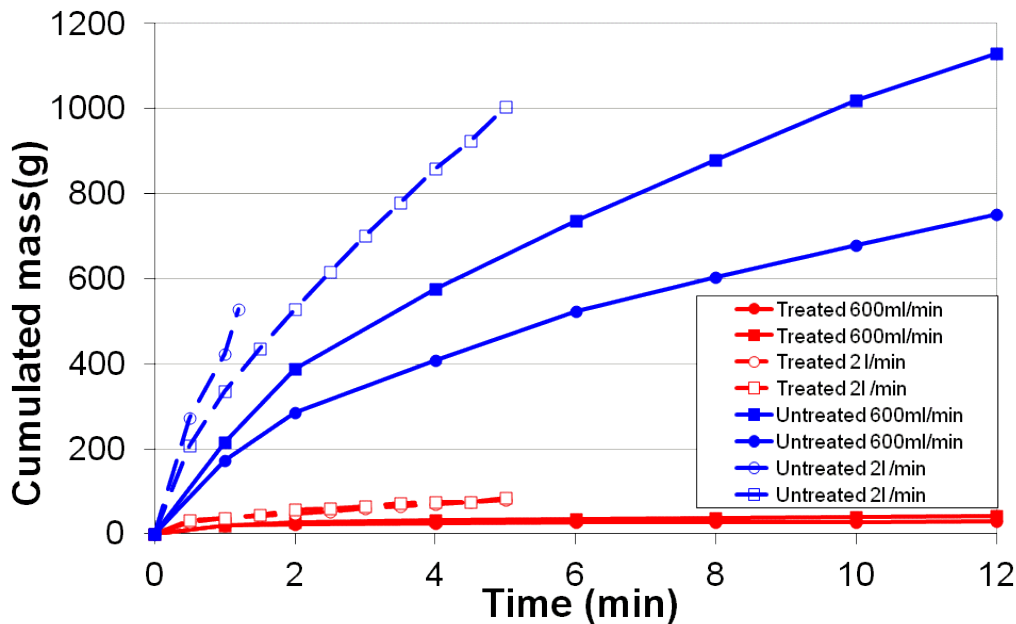
Figure 10. Cumulated mass versus time for the tests 28 day after the construction

Results from the 28 curing days test program are shown in figure 10. The repeatability tests are also plotted. The total eroded mass with the classical protocol is on average 900g for the natural soil, against 35g for the lime treated soil. With the modified protocol these values reach 1000 and 80g.

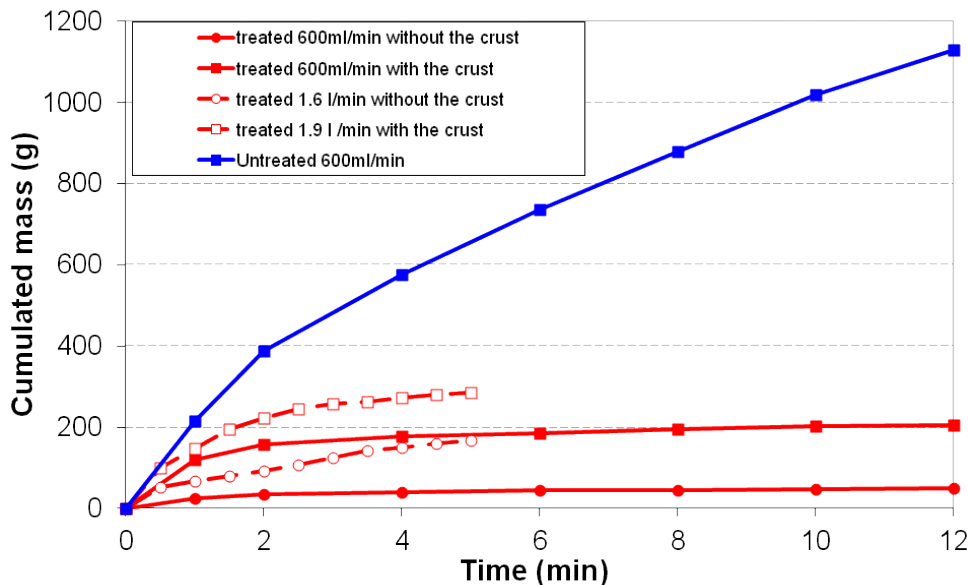
Figure 11 : Effect of the flaky crust on the eroded mass for the tests 180 day after the construction

The test performed on the natural soil dike gave the same results at 28 and 180 curing days. For the soil treated dike, systematic differences were observed in the eroded masses with and without the flaky crust (

Figure 11). The crust showed a low resistance to erosion and was eroded during the 2 first minutes of the test. After the crust was removed the erosion rate from the two layers became similar. Apart from this difference, the results followed similar trends between 28 and 180 days: 1130g natural soil eroded and 40g treated soil eroded in the configuration without the flaky layer, using the classical protocol (600mL/min).

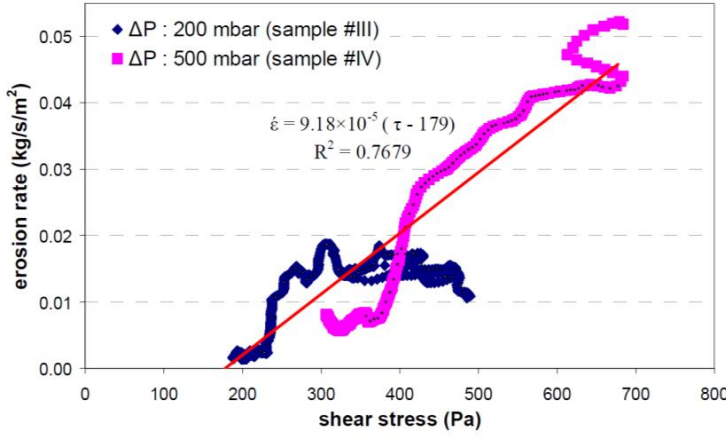
$$\tau_c = 179 \text{ Pa} \quad k_{er} = 9.18 \times 10^{-5} \text{ s/m}$$

Figure 12 Tests result performed with core sampling from the untreated dike, with 20 and 50 mbar hydraulic solicitations

For this test, soil was sampled from the two dikes 28, 180 and 365 days after the construction, using a PVC cutting edge in the case of the natural construction (500mm long and 80mm external diameter), and a double envelope core drill on the treated embankment. Samples were cut (diameter 68mm, height 150mm) and sealed in a mould using silicone gel to avoid parasitic erosion between the sample and the mould. Two tests were performed using untreated 28 days curing soil, of which one with 20kPa hydraulic solicitation and the other with 50kPa hydraulic solicitation. Experimental curves are given in Figure 12. The critical shear stress for natural soil is about 180Pa.

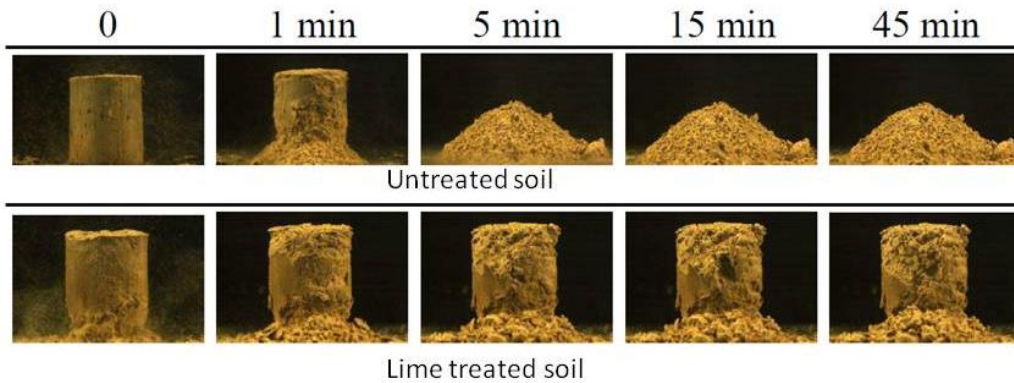
Figure 13. Representative tests results for cores sampled in the treated dike (down), and untreated (above) after 28 days of curing. No evolution observed beyond 45 minutes.

For the test after 28 days of curing, the typical visual aspect of the sample geometrical evolution is presented in figure 14. Final morphology is reached after 10 minutes of immersion. Contrary to lab rebuilt soil, samples taken from the treated dike present very low water sensitivity. They crumble slowly and less intensively than the untreated samples. Moreover, the aggregates which come off are bigger than those from the untreated soil.
