Resistance to erosion of lime treated soils for application to coastal dikes

Resistance to erosion of lime treated soils and perspectives for coastal dikes

Keywords: lime treatment, soil, erosion, dike

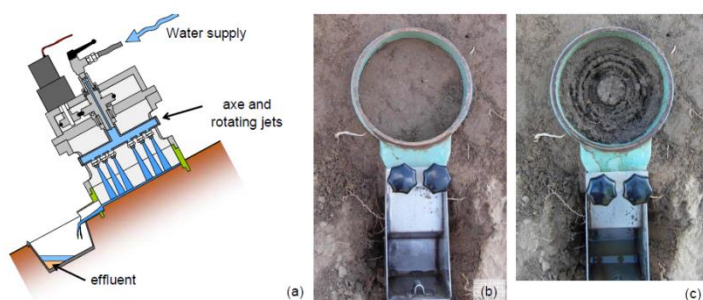
Figure 1. Mobile jets erosion (MoJET) test set-up: (a) Schematic diagram of eroding unit. Image of eroding unit in field (b) before and (c) after test

The MoJET is made up of one mechanical part, named “eroding unit” with 6 rotating water jets, a water supply tank with the possibility of pressurization, and a few additional parts (pump, flowmeter etc.). The eroding unit projects water jets with 0.5 mm diameter nozzles (Fig. 1a) perpendicular to the soil. The mould is placed on a 10% slope (6 degrees) (Fig. 1.a and 1.b). The outfall ring is inserted around the mould while directing the outfall towards the downstream side of the slope into the top of the measurement container. The ground is then subjected to the action of the water jets with the following test parameters:

After the test, the soil sample generally shows gullies located where the water jets impact its surface (Fig. 1c).

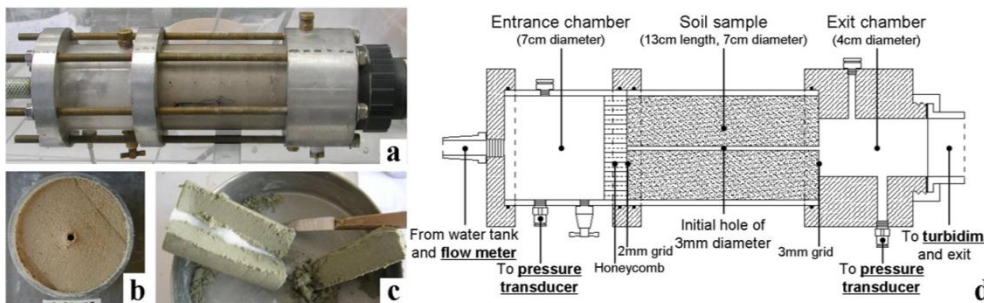
Figure 2. Experimental set-up and soil sample treatment. (a) Image of eroding unit. (b) Sample before test with 3mm diameter hole. (c) Cut sample after test with wax mold. (d) Drawing of eroding unit. Sensor are indicated in bold and underlined characters.

The HET device has three parts: an upstream water tank, an eroding unit where the sample is located and a downstream water exit. The erosion unit is depicted in figure 2 along with the measuring instruments. The soil sample is prepared in a cylindrical Plexiglas mold. The dimensions are 7cm in diameter and 15cm in length (volume: 500 cm³), and vertically drilled. The diameter of the initial hole is 3 or 5mm. After bringing water to the system and especially in the sample, the air pressure in the upstream water reservoir is raised gradually until the desired pressure difference is reached. This pressure difference is kept constant after the erosion occurred. During the test, from the increase of head charge to the decrease, the data collected by flow meter (flow rate Q), pressure transducers (pressure drop ΔP) and turbidimeter (turbidity T) are stored on a computer using a data-logger. The acquisition frequency is generally 1 Hz. These measurements and data on initial and final radii allow us to calculate erosion curves (interpretation method detailed in Pham (2008) and Haghghi et al. (2012a)) i.e. the relationship between the two following physical quantities:

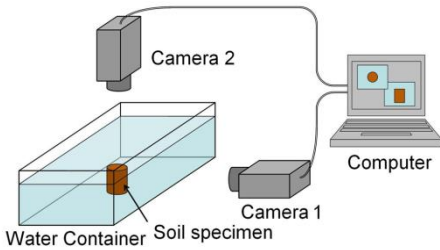
Figure 3. General layout of the experimental setup

The aim of this experimental method is to quantify the disaggregating geometry of an immersed unsaturated soil specimen as a function of time (Haghghi et al., 2012b). With this purpose in mind, a soil specimen of 15 mm in diameter and 20 mm high is placed in a large water container and monitored by two digital cameras (Figure 2).

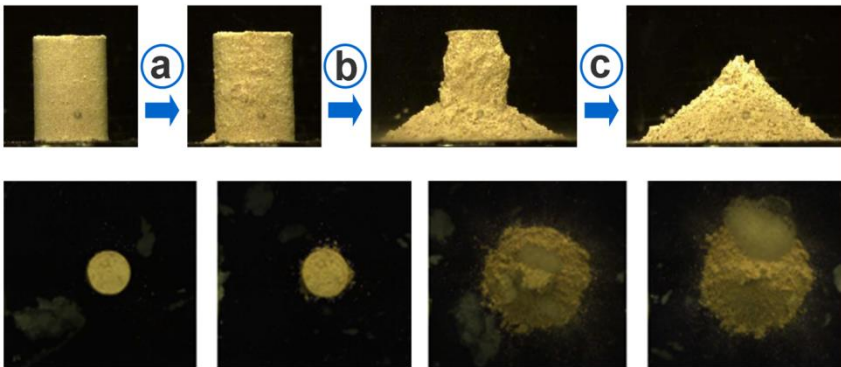
Figure 4. General behavior of a specimen

The general behavior of the soil specimens, after being placed in water, is almost the same but with different characteristics for different soil textures. This behavior can be divided into two different phases: (a) hydration and (b-c) dispersion. Nevertheless detailed characteristics (height of swelling, disaggregation time, etc.) vary between different soil textures.

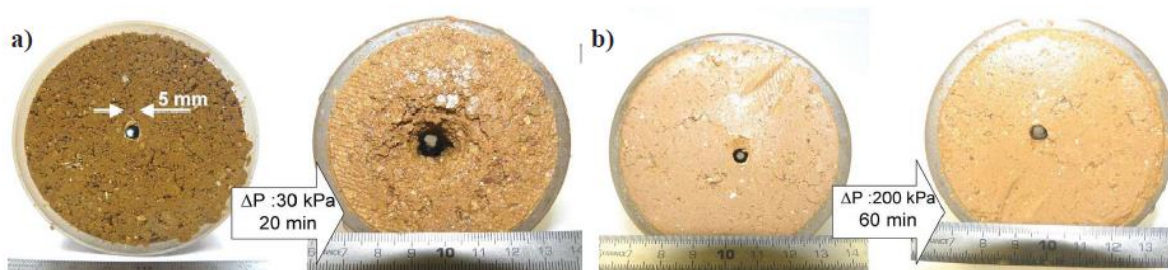
Figure 5: Typical HET results on materials. (a) Untreated silt before and after test (pressure difference of 30KPa during 20 minutes), (b) treated silt before and after test (pressure difference of 200KPa during 60 minutes).

Regarding HET tests, the critical shear stress cannot be measured for treated soil: for the silty treated soil it is higher than 800Pa, being at least 2 times greater than shear stress for untreated silt.

Images of an example of an untreated silt sample and a treated one are given on figure 5.

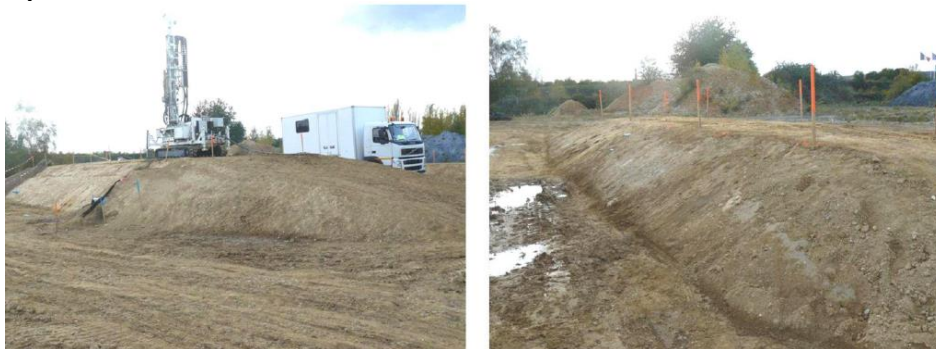
Figure 7. View of the experimental dry dikes built at the Rouen Experimentation and Research Center: on left the lime treated dike and on right the untreated dike

In this section, in situ and laboratory tests performed with soil from two full-scale experimental hydraulic structures built in the Rouen CER (Experimentation and Research Center) are presented (Charles et al. 2012). The structures were two dry dikes built with silty soil from “Marche-les-Dames”(Belgium), one had been treated with 2.5% lime and the other was untreated. The treatment was performed using a mobile mixing plant. Materials were compacted in the wet state, at 17% water content (wOPN+2%) in the case of the untreated silt structure, and at 19.4% (wOPN+1.6%) in the case of the treated soil structure. Pictures of the two dikes are presented in figure 7. The treated soil homogenization was guaranteed throughout the production using the mixing plant, and its compaction was performed by a sheepfoot roller (kneading compaction). Consequently, laboratory conditions of preparation are well reproduced in situ.

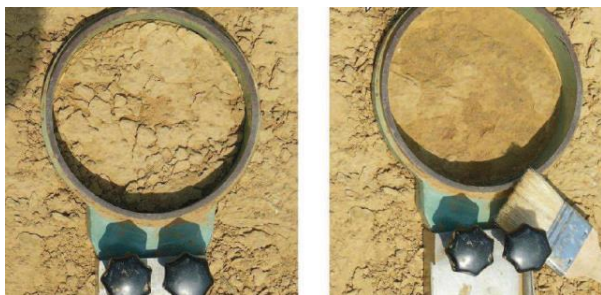
Figure 8: On left the flaky crust which appeared between 28 and 180 days after the construction. On right, this crust is removed using a brush

Tests were performed in situ 28, 180 and 368 days after the building. In most cases, two repeatability tests were carried out for each configuration (soil constitution, protocol and curing time). Tests were performed under temperate climate (15°C mean at 28 days, 20°C mean at 180 days and 15°C mean after 365 days) and without intense rainfalls. Nevertheless, dikes spent winter without superficial protection and at 180 days, a few millimeters of flaky crust had appeared on the free surface of the lime treated dike (**Erreur ! Source du renvoi introuvable.**). That crust was not there after 28 days curing. The two

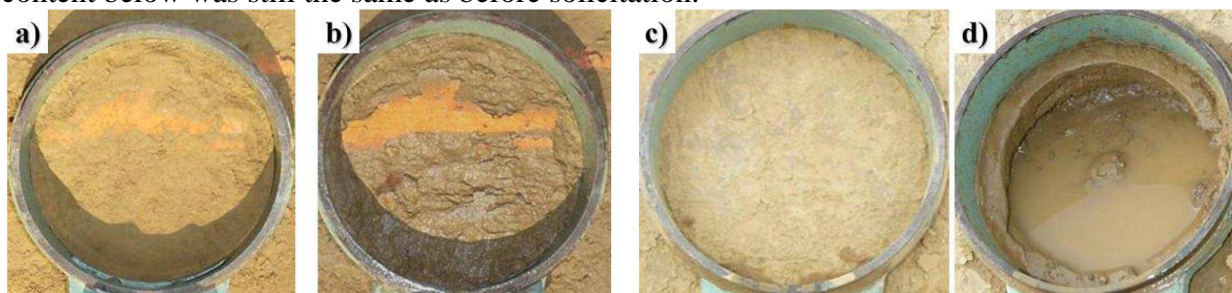
Figure 9. Soil surfaces before and after normal protocol MoJET tests, 28 days after the construction. Soil treated before test (a) and after test (b); untreated soil before test (c) and after test (d).

Figure 9 shows treated and untreated dike surfaces after tests using the normal protocol. First, we note a large difference in erosion depth and water penetration between tests performed on the treated and untreated dike. Because of the very low permeability of treated dikes, the water stream around the mould and the infiltration depth were only a few millimeters. Removing the superficial layer, the soil water content below was still the same as before solicitation.

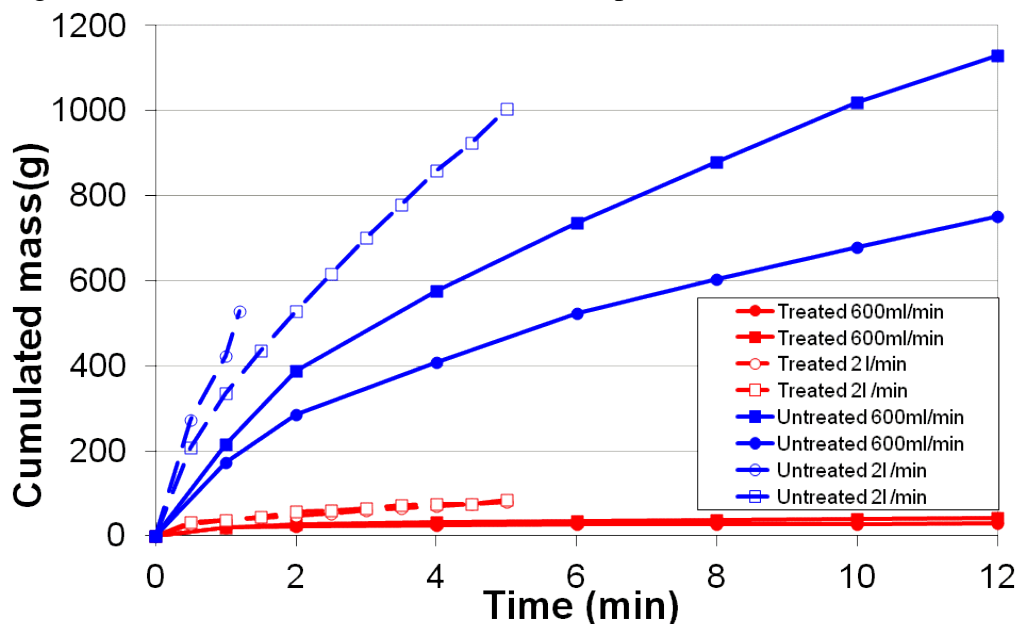
Figure 10. Cumulated mass versus time for the tests 28 day after the construction

Results from the 28 curing days test program are shown in figure 10. The repeatability tests are also plotted. The total eroded mass with the classical protocol is on average 900g for the natural soil, against 35g for the lime treated soil. With the modified protocol these values reach 1000 and 80g.

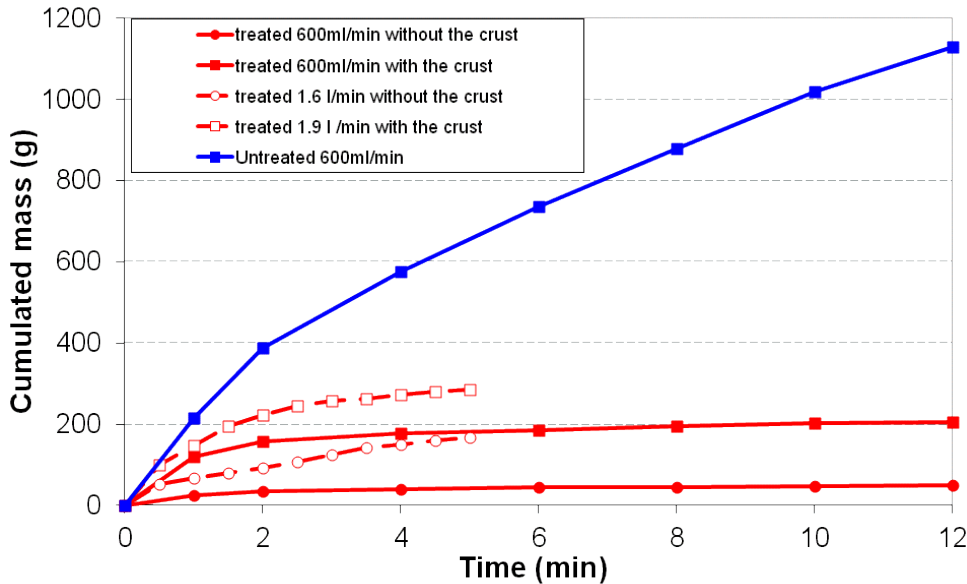
Figure 11 : Effect of the flaky crust on the eroded mass for the tests 180 day after the construction

The test performed on the natural soil dike gave the same results at 28 and 180 curing days. For the soil treated dike, systematic differences were observed in the eroded masses with and without the flaky crust (

Figure 11). The crust showed a low resistance to erosion and was eroded during the 2 first minutes of the test. After the crust was removed the erosion rate from the two layers became similar. Apart from this difference, the results followed similar trends between 28 and 180 days: 1130g natural soil eroded and 40g treated soil eroded in the configuration without the flaky layer, using the classical protocol (600mL/min).

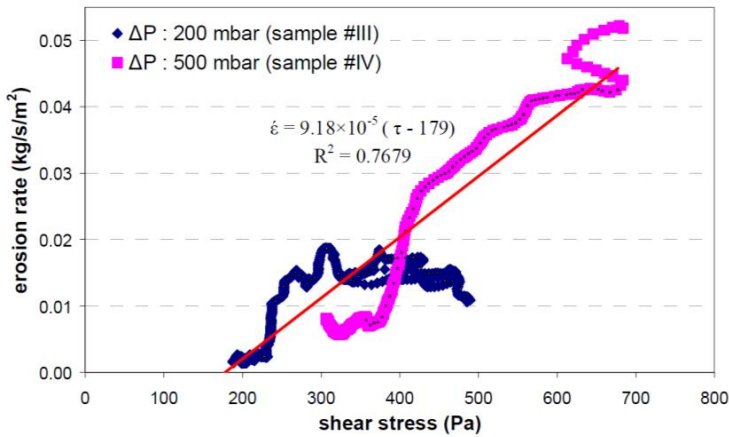
$$\tau_c = 179 Pa \quad k_{er} = 9.18 \times 10^{-5} s / m$$

Figure 12 Tests result performed with core sampling from the untreated dike, with 20 and 50 mbar hydraulic solicitations

For this test, soil was sampled from the two dikes 28, 180 and 365 days after the construction, using a PVC cutting edge in the case of the natural construction (500mm long and 80mm external diameter), and a double envelope core drill on the treated embankment. Samples were cut (diameter 68mm, height 150mm) and sealed in a mould using silicone gel to avoid parasitic erosion between the sample and the mould. Two tests were performed using untreated 28 days curing soil, of which one with 20kPa hydraulic solicitation and the other with 50kPa hydraulic solicitation. Experimental curves are given in Figure 12. The critical shear stress for natural soil is about 180Pa.

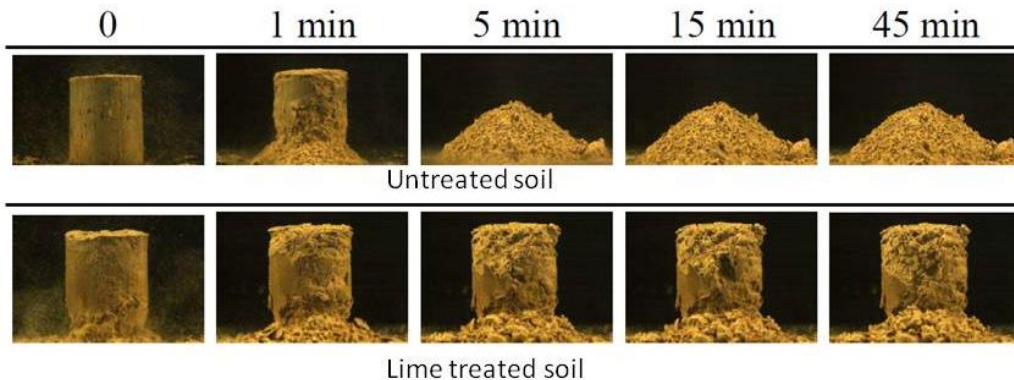
Figure 13. Representative tests results for cores sampled in the treated dike (down), and untreated (above) after 28 days of curing. No evolution observed beyond 45 minutes.

For the test after 28 days of curing, the typical visual aspect of the sample geometrical evolution is presented in figure 14. Final morphology is reached after 10 minutes of immersion. Contrary to lab rebuilt soil, samples taken from the treated dike present very low water sensitivity. They crumble slowly and less intensively than the untreated samples. Moreover, the aggregates which come off are bigger than those from the untreated soil.
