Behavior of pre-cracked deep beams with composite materials repairs

M Boumaaza, A. Bezazi, H Bouchelaghem, N Benzennache, Sofiane Amziane, F. Scarpa

M Boumaaza, A. Bezazi, H Bouchelaghem, N Benzennache, Sofiane Amziane, et al.. Behavior of pre-cracked deep beams with composite materials repairs. Structural Engineering and Mechanics, 2017, 63 (5), pp.575-583. <10.12989/sem.2017.63.5.575>. <hal-01631559>

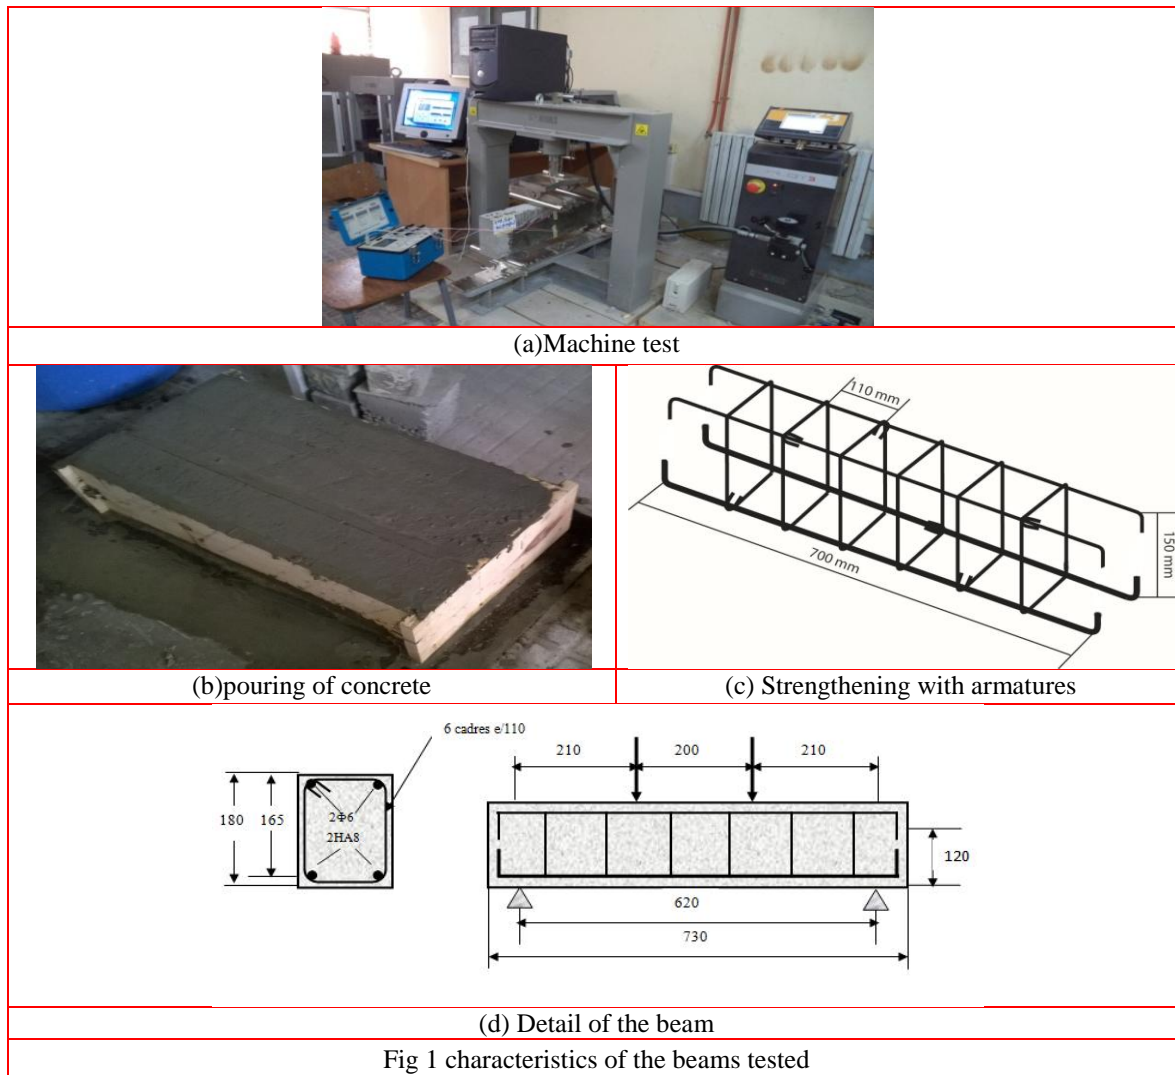
Fig 1 characteristics of the beams tested

The experimental tests have been carried out on deep beams whose ratio between the distance of between the application of the point loads and the support at the height of the beam is small (only 1.3) so that shear failure is predominantly. These investigations are useful to identify the contribution of the GFRP in terms of strength gain and failure modes. The tests were conducted in accordance with the ASTM C78-00 (2004) using a four-point bending device with a capacity of 150 kN (Fig. 1 (a)).

The manufacturing of the beams was performed at the Laboratory of Civil Engineering and Hydraulics (LGCH) of Guelma University. In order to characterize the compressive strength In order to characterize the concrete, six cylindrical and cubic specimens having dimensions of 160x320 and 150x150 mm² respectively were also produced. After 24 hours the specimens are removed from the mould and stored in tanks of water at ambient temperature up to 28 days. The beams have 730 mm long and width and height of 100 mm and 180 mm respectively, they are reinforced by two HA8 bars in the tensioned zone and by two HA6 bars in the compressed one. For vertical steel (steel frames), 6 mm of diameter rods in mild steel and spaced by 110 mm have been used (Fig.1 (b)-(d)).

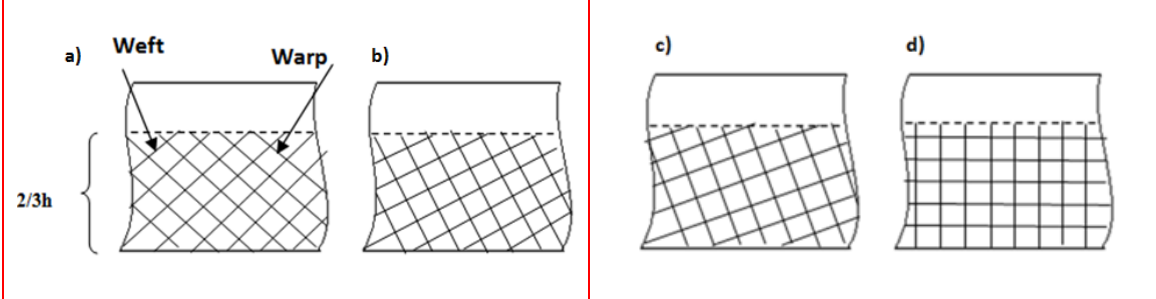
Fig. 2 Reinforcement with U shape patch following orientations a) +45/-45 b) 30/60 c)20/70 d) 0/90.

To better understand the behaviour of the reinforced concrete beams preloaded and repaired by glass bidirectional fiber fabrics (GFRP), a testing program was established by using two specific rehabilitation methods. The activities related to the first series of tests have focused on strengthening or repairing by using a continuous configuration of the reinforcement consisting in GFRP with a U-shaped recovery system following orientations (0/90, 20/70, 30/60 et +45/-45) (Fig. 2).

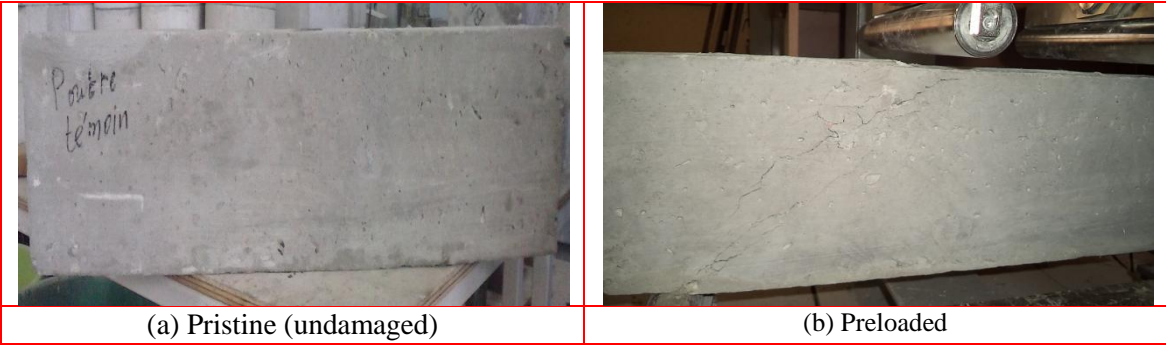
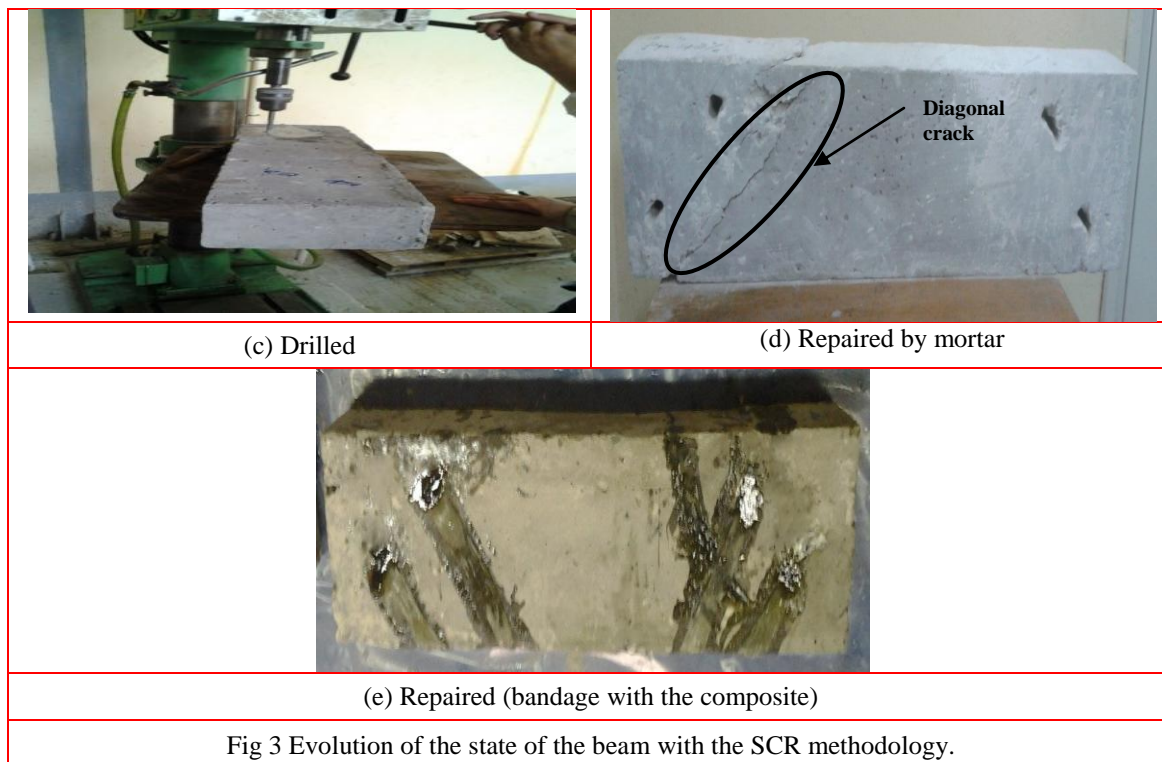
The second series of tests consists in placing reinforcements made from composite materials according to the new proposed procedure. The composite patches are placed as to intersect the cracks produced by the shear force in order to improve the brittle failure mode of the reinforced concrete. In this way the glass fibers of the composite are loaded along their longitudinal direction (tensile) and therefore maximizing the strength of the system. This method uses a composite constituted by strands of unidirectional glass fibers impregnated in polyester resin and applied as a wrapping system on the beam by bonding.

After drilling the holes the damaged beams have been repaired using mortar concrete. This repair was performed in order to improve the aesthetics and the surface finish before the bonding of the composites (see Fig. 3 (d) and (e)). The various reinforcements were arranged to intercept the diagonal cracks as accurately as possible. To facilitate the setting of the unidirectional fabric with the resin in the holes, the fibers are interlaced and centered in each hole. It is necessary that the holes are very clean before the resin filling. As the load is symmetric, it is important to note that the non-cracked parts of the beam are also repaired in the same manner to avoid the appearance of new diagonal cracks.

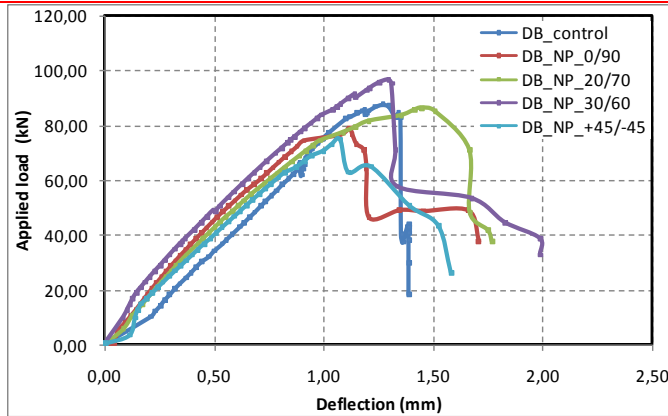
Fig. 4 Force-deflection curves of non preloaded beams obtained for the orientations (0/90,20/70,30/60 and +45/-45)

The results obtained show that the stiffness of the beams is increased by the bonding of the composite patch. The best performance is obtained for the beam reinforced with the stacking of (+30/-60) (see Fig. 4). The ultimate strength of the control beam is 87.6kN with a deflection equal to 1.27 mm. Based on the orientation of the reinforcement, the ultimate load of the beam (DB_NP_30 / 60) is increased by 10.5% compared to the reference beam (DB_control). This gain at the ultimate load is accompanied by a reduction in ductility, resulting in a decrease of the deflection by approximately 12.4% compared to the beam (DB_NP_20 / 70). This value is in good agreement with the results obtained by Bouchelaghem *et al.* (2011 a, b) for cylindrical specimens. The beams have diagonal cracks having an average orientation 34 °. The orientation of the composite fibers should be perpendicular to the cracks in order to sew them. The solicitation in the composite of the beam (DB_NP_30 / 60) presents a lesser shear effect as that of the beam (DB_NP_20 / 70) due to the difference of the directions respectively which is in the order of 4 and 14 ° to the direction of the crack (34 °) obtained experimentally after preloading. This is why the beam (DB_NP_30/60) has a higher ultimate strength compared to the beam (DB_NP_20/70).

The orientation of the fibers has a great influence on the behavior of test pieces due to the difference in rigidity which characterizes the first phase of the curves.

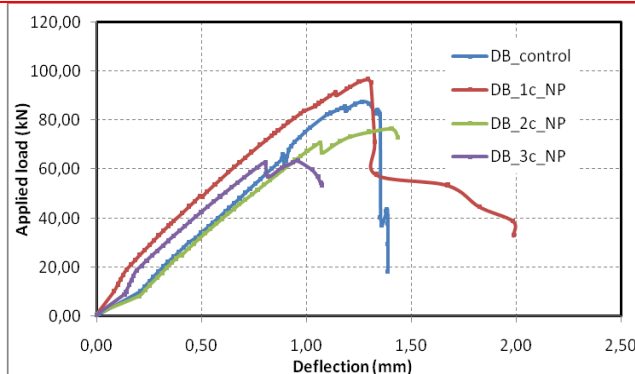
Fig. 5 Force/deflection curves of STV1 reinforced non-preloaded beams.

The beams considered in this case belong to the non-preloaded and preloaded cases reinforced with the composite STV1 patches with different thicknesses. Figure 5 shows the load history of the non-preloaded reinforced beams with one, two and three composite plies compared to the analogous behavior of the control beam.

The load drop occurring on the curves of figure 5 shows a sudden drop in resistance due to delamination of the composite. The analysis of the results shows that the rate of improvement of the ultimate strength of the beams reinforced by one ply is in the order of 10.5% compared to a control beam, whereas the application of one or two plies of the fabric PRFG leads to decreases in strength in the order of 12.5 and 27.6% respectively. The strengthening of deep beams appears therefore to be governed by the first ply only, and this is in good agreement with previous works from (Bousselham and Chaallal 2006 Contamine et al. 2013). It was also noticed that the beams bonded by three layers of STV1 show a more stable deflection behavior compared to the case of beams strengthened by one and two layers. The beams reinforced by one and three plies showed however a greater stiffness than the control beam (Sundarraja and Ganesh Prabhu 2011). In addition, it was observed that the beam reinforced by a ply STV1 showed a greater rigidity than the control beam and the beams reinforced by two and three plies which confirms the work of (Kreit 2012). The absence of bearings in the test setup explains the brittle behavior of the deep beams.

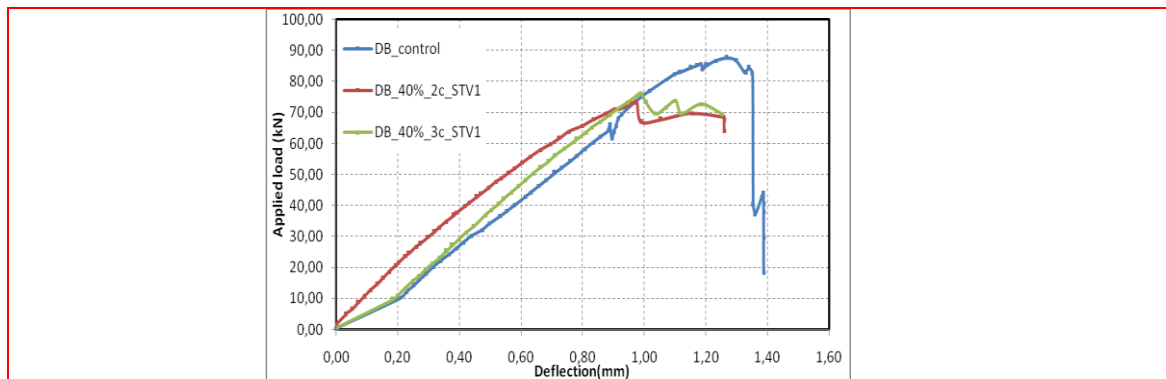
Fig. 6 Force/displacement curves charge / deflection of the beams preloaded at 40% of the ultimate load and then repaired by the STV1 patch.

with U shape are shown in Fig. 6. The preloaded and then repaired beams using one or two plies showed a less brittle behavior, with a reduction of the resistance respectively in the order of 15.3 and 12.3% ,76% and 78% for deflection respectively for specimens repaired by two and three plies and a stiffness increase compared to the control beam. These beams still show some residual compliance that provides lower brittleness compared to the control beam. The composite repairs do not appear however to provide a significant influence to the resistance of the beams. The resistance of the beam (DB-40% -3c-STV1) is greater than the resistance of the beam (DB - 3c-NP) due to the deformations of the most remote zones of compression concrete which have reached their limits near the loading area after the crushing of the concrete compression (Figs. 4, 5 and 6). Preloaded beams then repaired by U-shaped composite STV1 showed a higher rigidity than that of the control beam. The STV1 reinforcing with U-shape does not prevent diagonal cracks to appear.

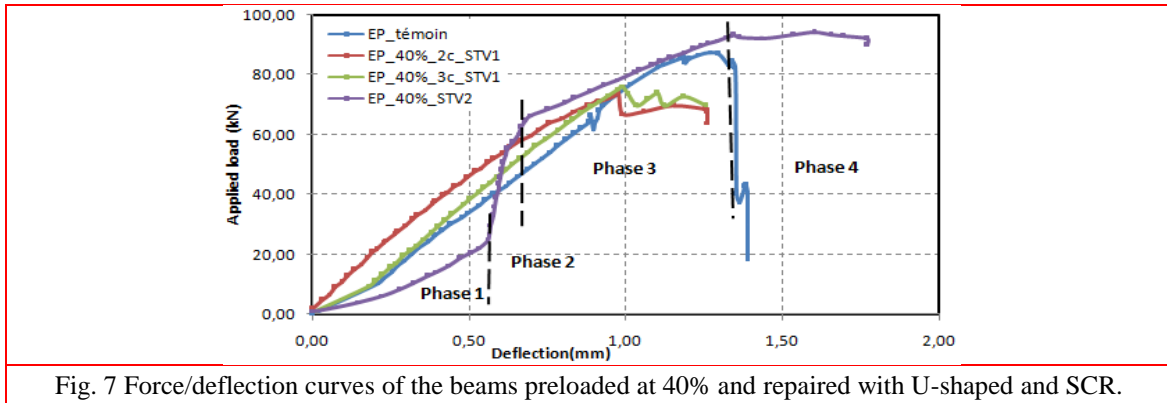
Fig. 7 Force/deflection curves of the beams preloaded at 40% and repaired with U-shaped and SCR.

The analysis of the results obtained on the beam preloaded at 40% of its ultimate load and then repaired following the new SCR method (wrapping in the cracked zone) using the composite STV2 (DB_40%_STV2) allowed an increase of the load capacity of 7.1% and a more ductile behavior with an increase in the deflection of the order of 26% compared to the control concrete beam as shown in (Fig. 7). The load deflection behavior of this beam is quite different from the others and can be divided into four phases. During the first part of the curve it is possible to notice a, **nonlinear elastic behavior nonlinear behavior** dominated by the concrete until a load of 25 kN, **Phase 1 represent the concrete behavior which its rigidity has decreased significantly due to the cracked concrete for the preloaded beam (EP_40%_STV2) comparatively of the other tested beams** followed by a very significant increase of the stiffness (increase in the slope) in the second phase until a value of 67 kN. The stiffness increase is due to the contribution of the composite patch that possesses very good tensile properties. During the third phase the curve segment is equivalent to the other curves with a slight higher increase due to the significant contribution of the composite to the resistance to shearing forces, which is characterized by a drop in stiffness followed by a quasi-plateau in the fourth phase. The latter behavior can be explained by the appearance of vertical cracks **and a sudden shear failure mode caused by the shear force, by a ductile one by bending, and therefore leading to failure mode change from brutal due to the shear to a ductile one due to bending.**

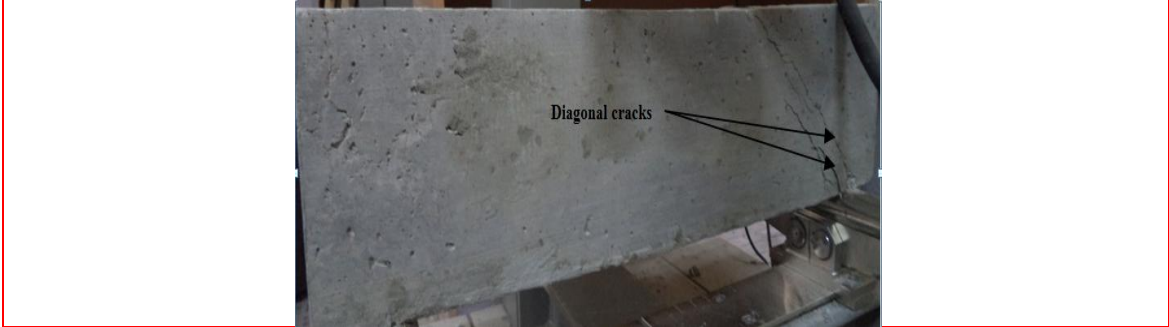
Fig. 8 Failure mode of the control beam.

Figure 8 shows that the control beam subjected to 4-point bending underwent shear failure. The reasons behind the particular failure type are two folds:

The parallel diagonal cracks created in the vicinity of the supports are located around the position of the application of the point load, and may appear on both sides and propagate with increasing load values at an angle of approximately 40°. Only the large and dominant crack progresses to reach the application point of the concentrated load where the failure of the beam is obtained only in one side. This behavior is typical of deep beams and also in good agreement with previous works carried out on beams with different and large sizes (Sayed 2014, Baggio 2014 *et al.* Boussselham *et al.* 2006).

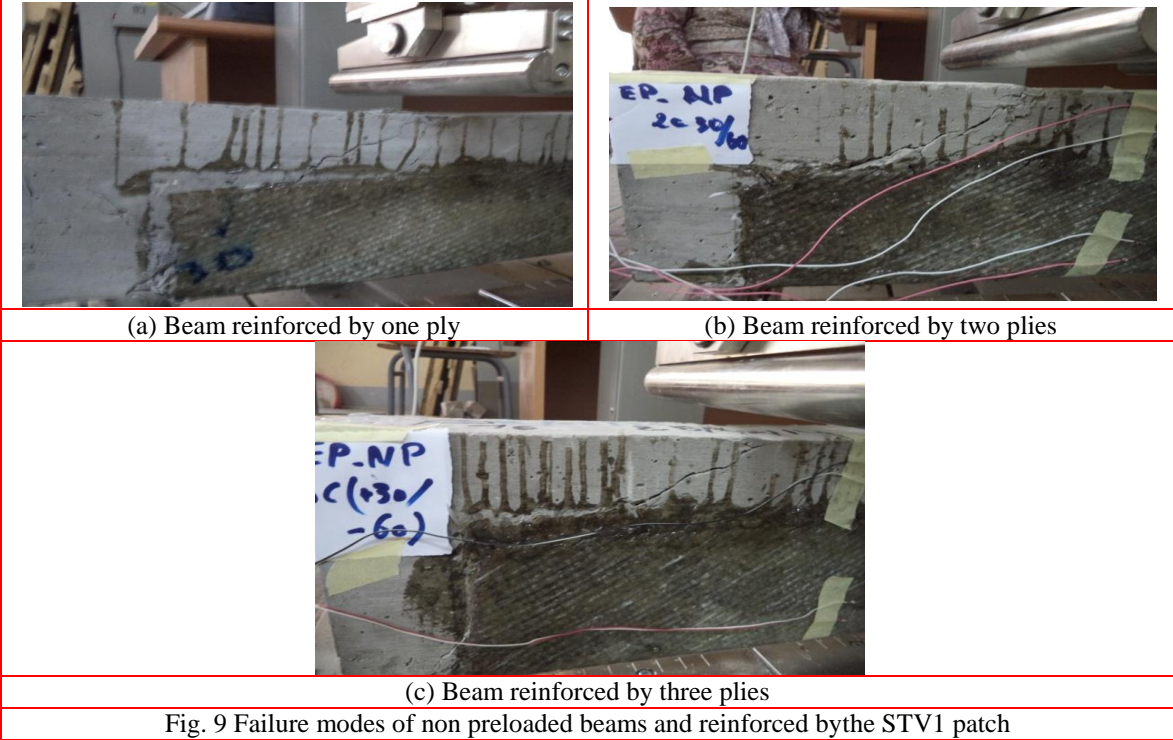
Fig. 9 Failure modes of non preloaded beams and reinforced bythe STV1 patch

The failure mode observed in the case of the beams non-preloaded and reinforced with one, two or three composites plies of U-shaped patches was shear failure, similar to the one found in the control beam. During the tests one crack was heard followed by the delamination of the composite. In beams reinforced by one and two plies two cracks there after appeared, however only a single crack was evident for the beam reinforced by three plies **due to the amount of composites is rather large** (Figs. 9 (a) - (c)). Shear cracks could be observed in the part of the beam covered by the composite with the U-shape.

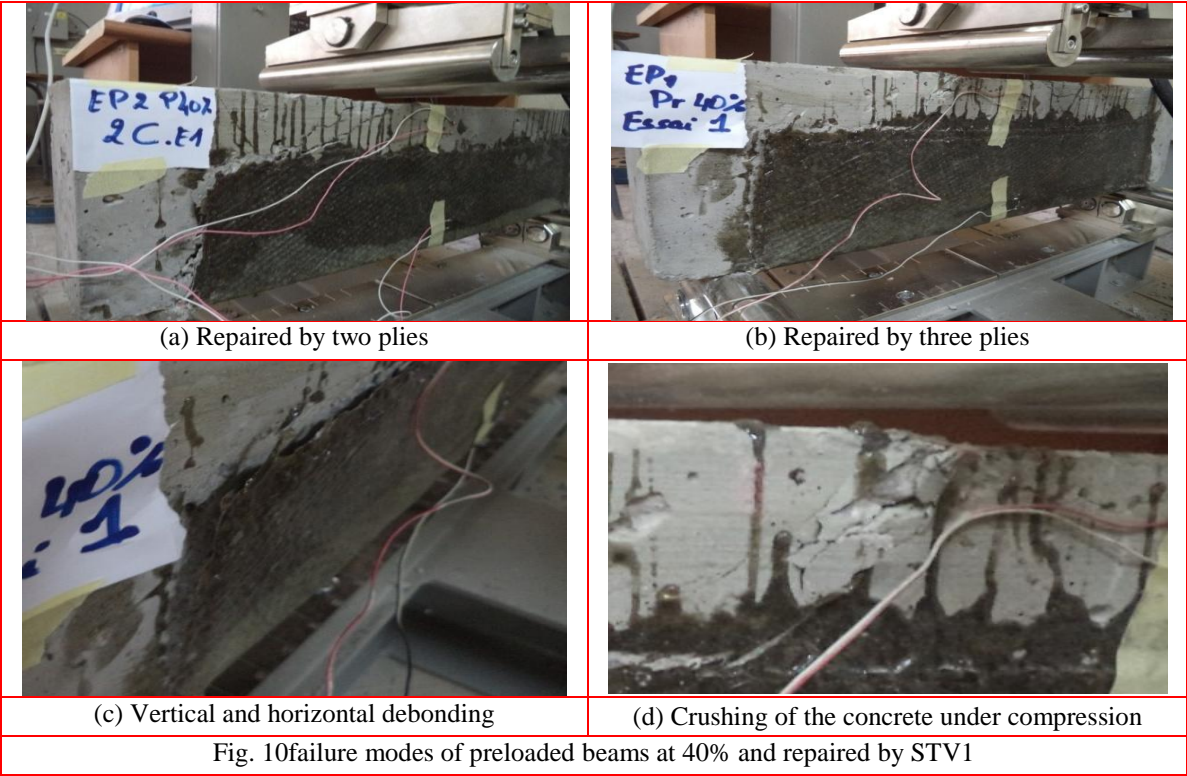
The failure mode of the beams preloaded at 40% and then repaired by two and three plies is similar to the one present in the control beam and the non preloaded STV1-reinforced one as shown in Fig. 10 (a). However, for the beam preloaded at 40% and then repaired by three plies with large composite

mass a delamination between the composite and the concrete in the horizontal and vertical direction was obtained (Figs.10(b)-(c)), followed by the deformations on the concrete in highly compressed zones that have reached their limits near to the loading point (Fig. 10 (d)).

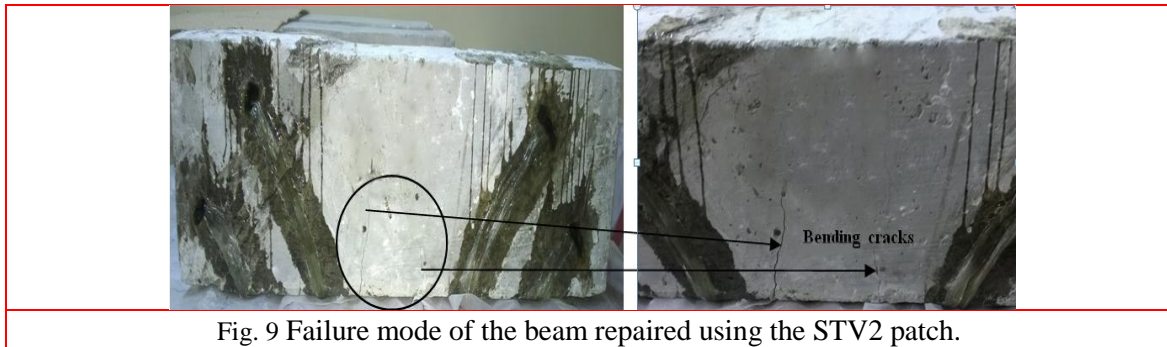
Fig. 9 Failure mode of the beam repaired using the STV2 patch.

The beam belonging to the B series preloaded and then repaired using the STV2 composite failed by bending due to the appearance of vertical cracks following the formation of a bearing, therefore preventing the shear crack to appear and to develop. The experimental results of the SCR-rehabilitated beam have therefore showed the desired type of failure mode, which is the bending one (Fig. 9). Similar results were also observed by other researchers in previous investigations of reinforced concrete beams strengthened with composite materials using the ETS method by inserting FRP rods into the shear zone of the beam (Chaallal *et al.* . 2011b, Breveglieri *et al.* 2014, Mofidi and Chaallal 2014). Therefore the repair of the beams by bonding with U-shaped continuous fabric does not allow to "sew" the cracks. This is explained by the fact that the series B where the composite is subjected until its rupture, however in the series A the appearance of the delamination (composite/concrete) which does not permit to reach the ultimate strength of the composite. In addition, in the new method (SCR) the strands are continue for few turns banding the cracks, however in the U-shaped (EB), the composite is bonded in the surface only. The SCR method permit to don't have the delamination problem by the use of adequate fiber orientation (perpendicular to shear cracks), leading to tensile in the fiber direction, permitting a maximal resistance and then a rational use of the composite until its ultimate strength. Strengthening or repairing the beams using the new method has leads to change the failure mode from a fragile rupture by shear to a ductile one by bending..
