Behavior of pre-cracked deep beams with composite materials repairs

M Boumaaza, A. Bezazi, H Bouchelaghem, N Benzennache, Sofiane Amziane, et al.. Behavior of pre-cracked deep beams with composite materials repairs. Structural Engineering and Mechanics, 2017, 63 (5), pp.575-583. 10.12989/sem.2017.63.5.575 . hal-01631559

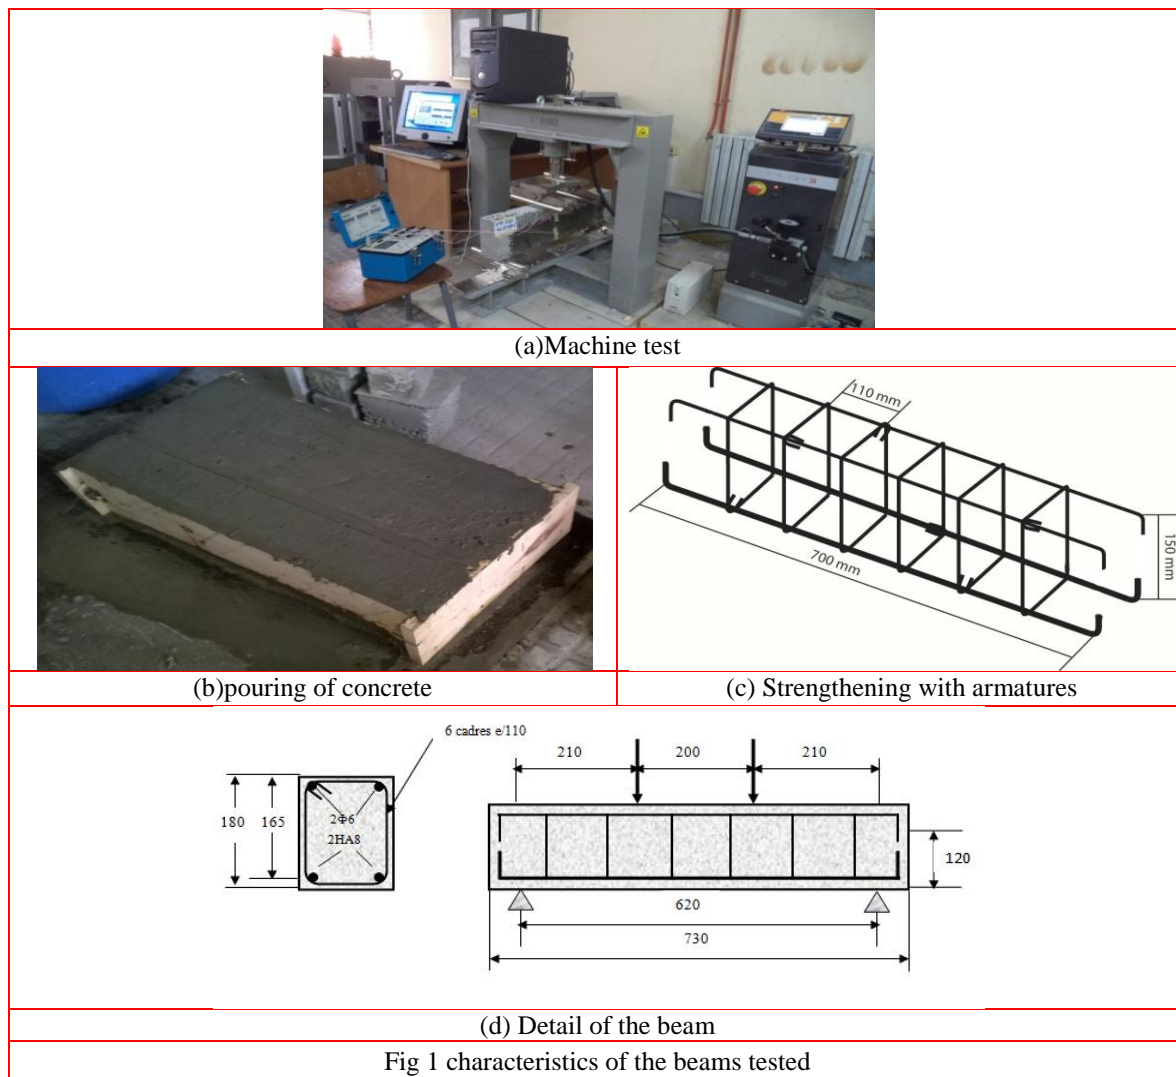
The experimental tests have been carried out on deep beams whose ratio between the distance of between the application of the point loads and the support at the height of the beam is small (only 1.3) so that shear failure is predominantly. These investigations are useful to identify the contribution of the GFRP in terms of strength gain and failure modes. The tests were conducted in accordance with the ASTM C78-00 (2004) using a four-point bending device with a capacity of 150 kN (Fig. 1 (a)).

The manufacturing of the beams was performed at the Laboratory of Civil Engineering and Hydraulics (LGCH) of Guelma University. In order to characterize the compressive strength In order to characterize the concrete, six cylindrical and cubic specimens having dimensions of 160x320 and 150x150 mm² respectively were also produced. After 24 hours the specimens are removed from the mould and stored in tanks of water at ambient temperature up to 28 days. The beams have 730 mm long and width and height of 100 mm and 180 mm respectively, they are reinforced by two HA8 bars in the tensioned zone and by two HA6 bars in the compressed one. For vertical steel (steel frames), 6 mm of diameter rods in mild steel and spaced by 110 mm have been used (Fig.1 (b)-(d)).

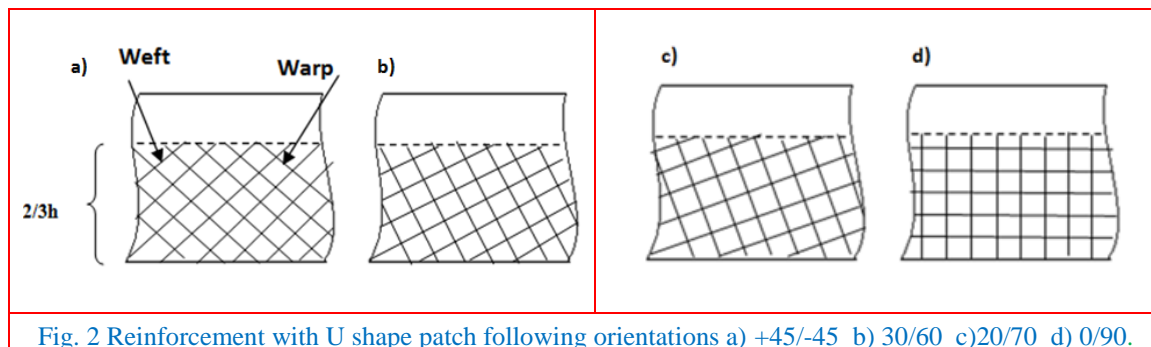
To better understand the behaviour of the reinforced concrete beams preloaded and repaired by glass bidirectional fiber fabrics (GFRP), a testing program was established by using two specific rehabilitation methods. The activities related to the first series of tests have focused on strengthening or repairing by using a continuous configuration of the reinforcement consisting in GFRP with a U-shaped recovery system following orientations (0/90, 20/70, 30/60 et +45/-45) (Fig. 2).

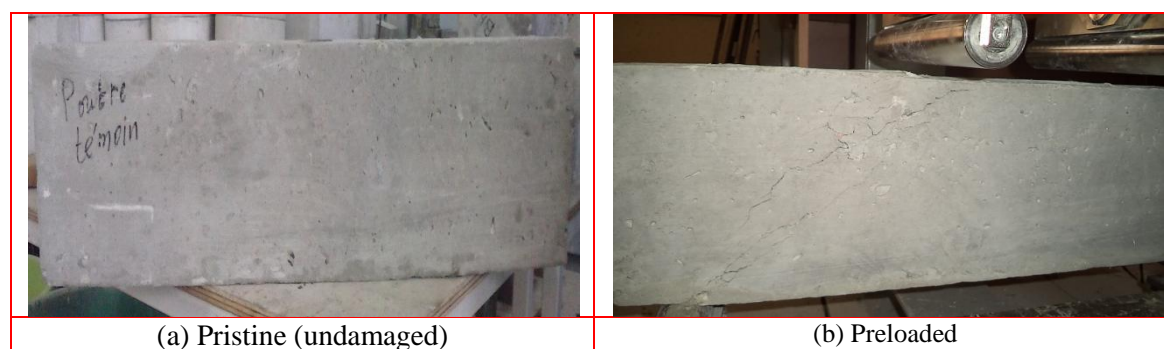
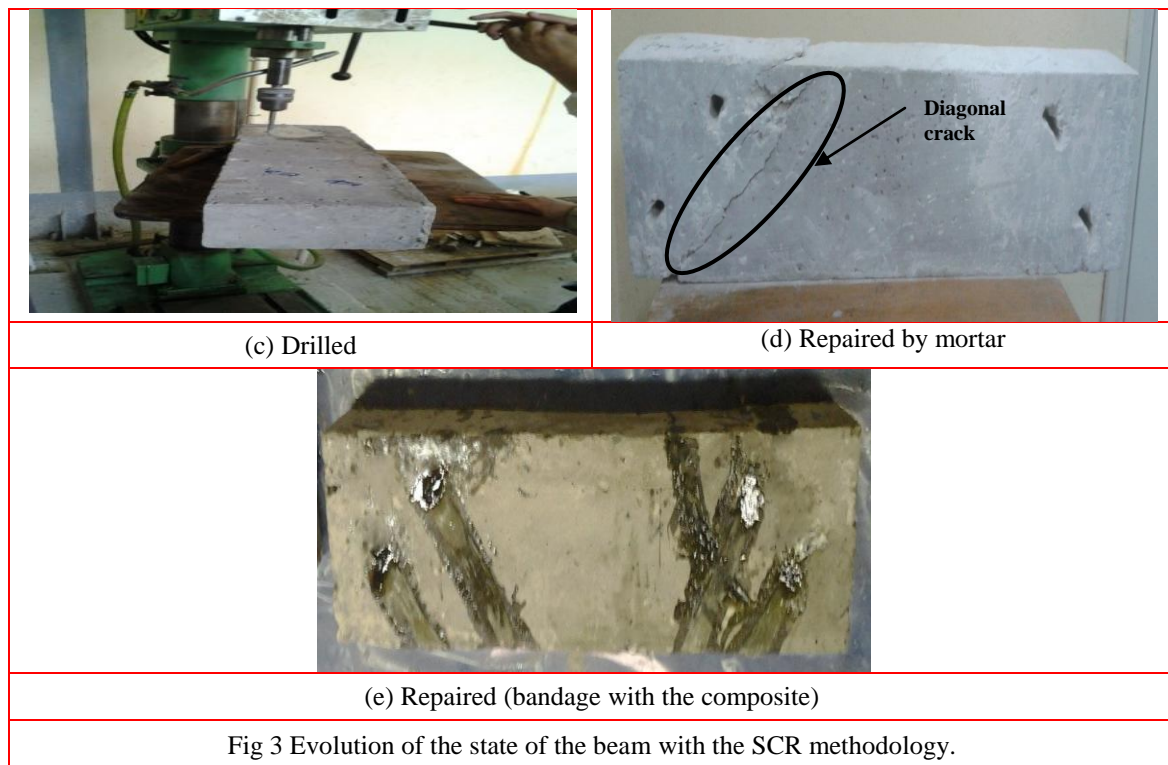
The second series of tests consists in placing reinforcements made from composite materials according to the new proposed procedure. The composite patches are placed as to intersect the cracks produced by the shear force in order to improve the brittle failure mode of the reinforced concrete. In this way the glass fibers of the composite are loaded along their longitudinal direction (tensile) and therefore maximizing the strength of the system. This method uses a composite constituted by strands of unidirectional glass fibers impregnated in polyester resin and applied as a wrapping system on the beam by bonding.

After drilling the holes the damaged beams have been repaired using mortar concrete. This repair was performed in order to improve the aesthetics and the surface finish before the bonding of the composites (see Fig. 3 (d) and (e)). The various reinforcements were arranged to intercept the diagonal cracks as accurately as possible. To facilitate the setting of the unidirectional fabric with the resin in the holes, the fibers are interlaced and centered in each hole. It is necessary that the holes are very clean before the resin filling. As the load is symmetric, it is important to note that the non-cracked parts of the beam are also repaired in the same manner to avoid the appearance of new diagonal cracks.

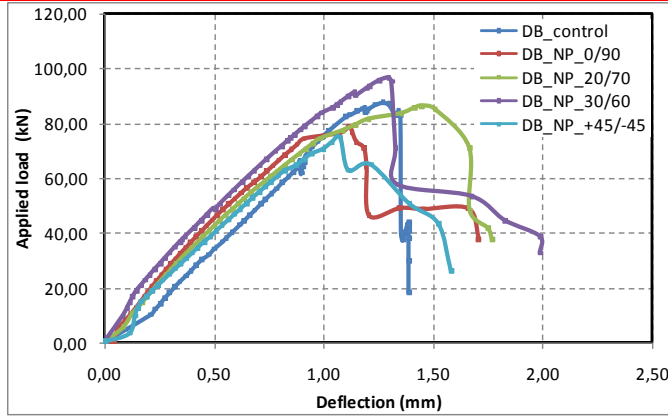
Fig. 4 Force-deflection curves of non preloaded beams obtained for the orientations (0/90,20/70,30/60 and +45/-45)

The results obtained show that the stiffness of the beams is increased by the bonding of the composite patch. The best performance is obtained for the beam reinforced with the stacking of (+30/-60) (see Fig. 4). The ultimate strength of the control beam is 87.6kN with a deflection equal to 1.27 mm. Based on the orientation of the reinforcement, the ultimate load of the beam (DB_NP_30 / 60) is increased by 10.5% compared to the reference beam (DB_control). This gain at the ultimate load is accompanied by a reduction in ductility, resulting in a decrease of the deflection by approximately 12.4% compared to the beam (DB_NP_20 / 70). This value is in good agreement with the results obtained by Bouchelaghem *et al.* (2011 a, b) for cylindrical specimens. The beams have diagonal cracks having an average orientation 34 °. The orientation of the composite fibers should be perpendicular to the cracks in order to sew them. The solicitation in the composite of the beam (DB_NP_30 / 60) presents a lesser shear effect as that of the beam (DB_NP_20 / 70) due to the difference of the directions respectively which is in the order of 4 and 14 ° to the direction of the crack (34 °) obtained experimentally after preloading. This is why the beam (DB_NP_30/60) has a higher ultimate strength compared to the beam (DB_NP_20/70).

The orientation of the fibers has a great influence on the behavior of test pieces due to the difference in rigidity which characterizes the first phase of the curves.

Because of this reason, the (+30/-60) orientation is adopted in the following steps of this work, i.e. all other beams of the series A were repaired using the external bonding with two or three plies of GFRP and only using the (+30/-60) orientation.

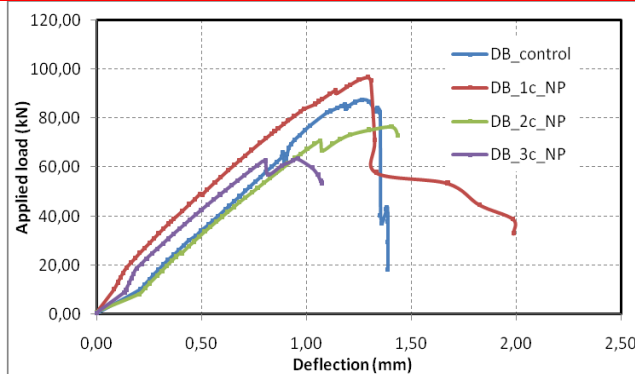
Fig. 5 Force/deflection curves of STV1 reinforced non-preloaded beams.

The beams considered in this case belong to the non-preloaded and preloaded cases reinforced with the composite STV1 patches with different thicknesses. Figure 5 shows the load history of the non-preloaded reinforced beams with one, two and three composite plies compared to the analogous behavior of the control beam.

The load drop occurring on the curves of figure 5 shows a sudden drop in resistance due to delamination of the composite. The analysis of the results shows that the rate of improvement of the ultimate strength of the beams reinforced by one ply is in the order of 10.5% compared to a control beam, whereas the application of one or two plies of the fabric PRFG leads to decreases in strength in the order of 12.5 and 27.6% respectively. The strengthening of deep beams appears therefore to be governed by the first ply only, and this is in good agreement with previous works from (Bousselham and Chaallal 2006 Contamine et al. 2013). It was also noticed that the beams bonded by three layers of STV1 show a more stable deflection behavior compared to the case of beams strengthened by one and two layers. The beams reinforced by one and three plies showed however a greater stiffness than the control beam (Sundarraja and Ganesh Prabhu 2011). In addition, it was observed that the beam reinforced by a ply STV1 showed a greater rigidity than the control beam and the beams reinforced by two and three plies which confirms the work of (Kreit 2012). The absence of bearings in the test setup explains the brittle behavior of the deep beams.

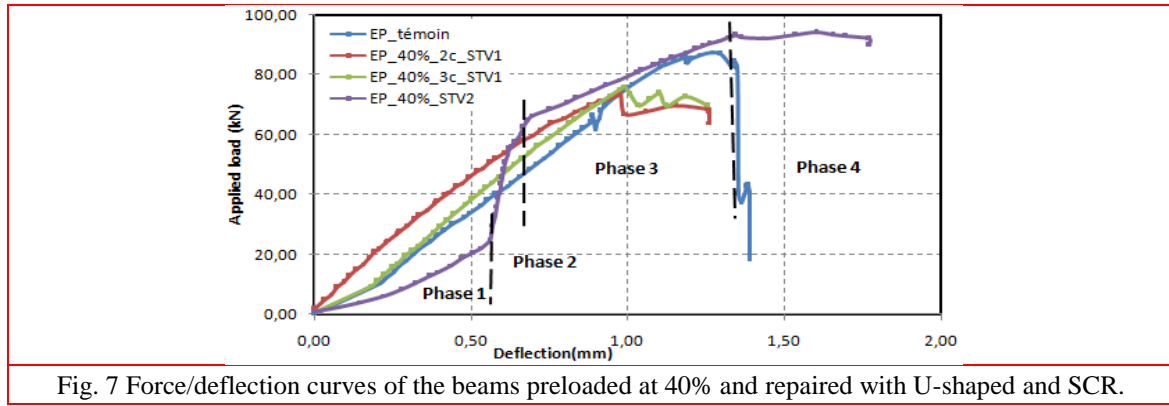
Fig. 7 Force/deflection curves of the beams preloaded at 40% and repaired with U-shaped and SCR.

The analysis of the results obtained on the beam preloaded at 40% of its ultimate load and then repaired following the new SCR method (wrapping in the cracked zone) using the composite STV2 (DB_40%_STV2) allowed an increase of the load capacity of 7.1% and a more ductile behavior with an increase in the deflection of the order of 26% compared to the control concrete beam as shown in (Fig. 7). The load deflection behavior of this beam is quite different from the others and can be divided into four phases. During the first part of the curve it is possible to notice a, **nonlinear elastic behavior** **nonlinear behavior** dominated by the concrete until a load of 25 kN, **Phase 1 represent the concrete behavior which its rigidity has decreased significantly due to the cracked concrete for the preloaded beam (EP_40%_STV2) comparatively of the other tested beams** followed by a very significant increase of the stiffness (increase in the slope) in the second phase until a value of 67 kN. The stiffness increase is due to the contribution of the composite patch that possesses very good tensile properties. During the third phase the curve segment is equivalent to the other curves with a slight higher increase due to the significant contribution of the composite to the resistance to shearing forces, which is characterized by a drop in stiffness followed by a quasi-plateau in the fourth phase. The latter behavior can be explained by the appearance of vertical cracks **and a sudden shear failure mode caused by the shear force, by a ductile one by bending, and therefore leading to failure mode change from brutal due to the shear to a ductile one due to bending.**

Table 3 lists the loads attained at failure for the two repair types, namely the U-shaped one (with 2 and 3 plies) and the SCR approach. The table lists the type of composite, the gain or loss of load capacity, defined as $[1 - (\text{load after repair} / \text{load of control concrete})] \times 100\%$, and a summary of the final failure type for each beam. Beams rehabilitated with composites having a U-shape with two and three plies use 74% and 143% more composite material respectively, compared to the new SCR method proposed. The results of the tests are very positive with an increase of 7.1% and 26% of the ultimate load and deflection of the rehabilitated SCR beams compared to the beam control, while the rehabilitated beams by the patches (two and three plies) with U-shape bring reductions of 16.1% and 13.1% for the ultimate load, and 23% and 22% for the deflection.

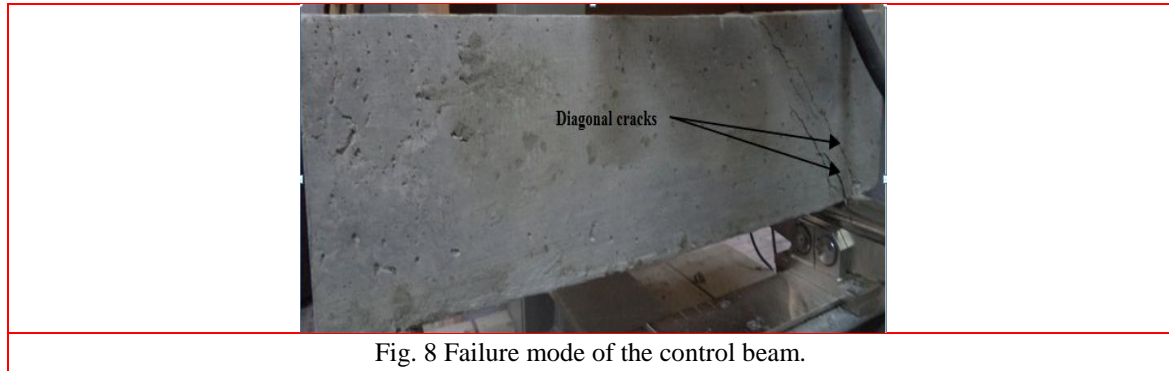
Figure 8 shows that the control beam subjected to 4-point bending underwent shear failure. The reasons behind the particular failure type are two folds:

The parallel diagonal cracks created in the vicinity of the supports are located around the position of the application of the point load, and may appear on both sides and propagate with increasing load values at an angle of approximately 40° . Only the large and dominant crack progresses to reach the application point of the concentrated load where the failure of the beam is obtained only in one side. This behavior is typical of deep beams and also in good agreement with previous works carried out on beams with different and large sizes (Sayed 2014, Baggio 2014 *et al.* et Bousselham *et al.* 2006).

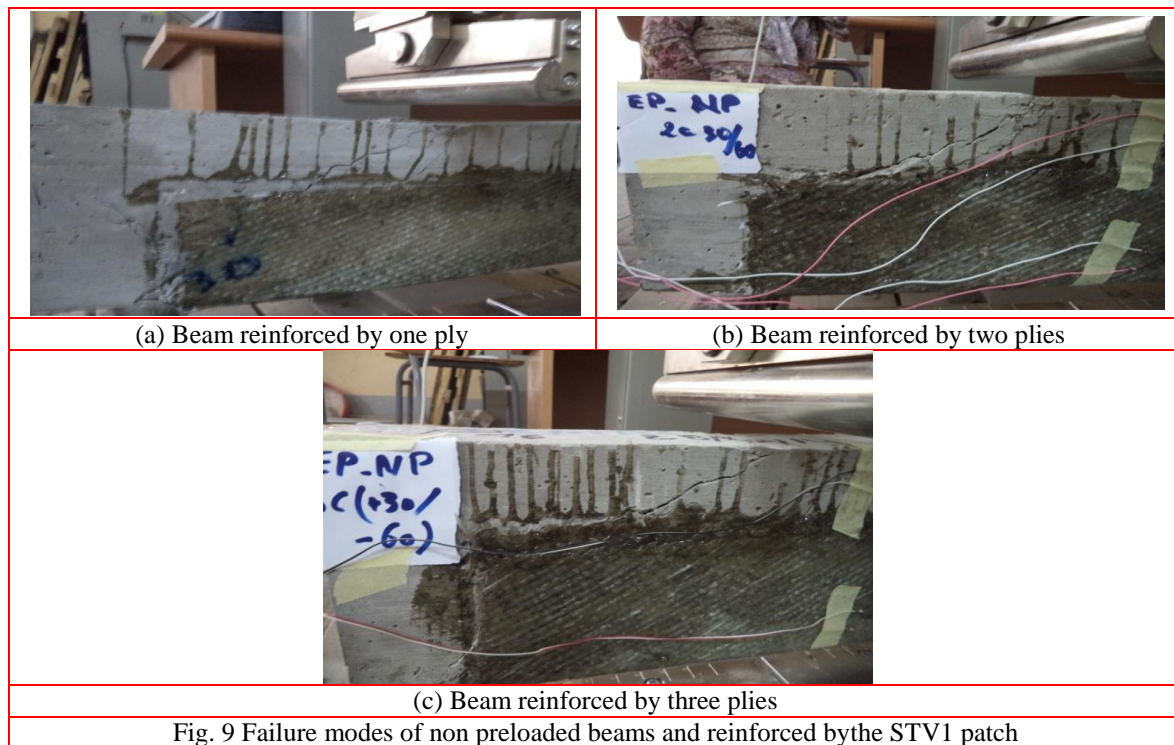
The failure mode observed in the case of the beams non-preloaded and reinforced with one, two or three composites plies of U-shaped patches was shear failure, similar to the one found in the control beam. During the tests one crack was heard followed by the delamination of the composite. In beams reinforced by one and two plies two cracks there after appeared, however only a single crack was evident for the beam reinforced by three plies **due to the amount of composites is rather large** (Figs. 9 (a) - (c)). Shear cracks could be observed in the part of the beam covered by the composite with the U-shape.

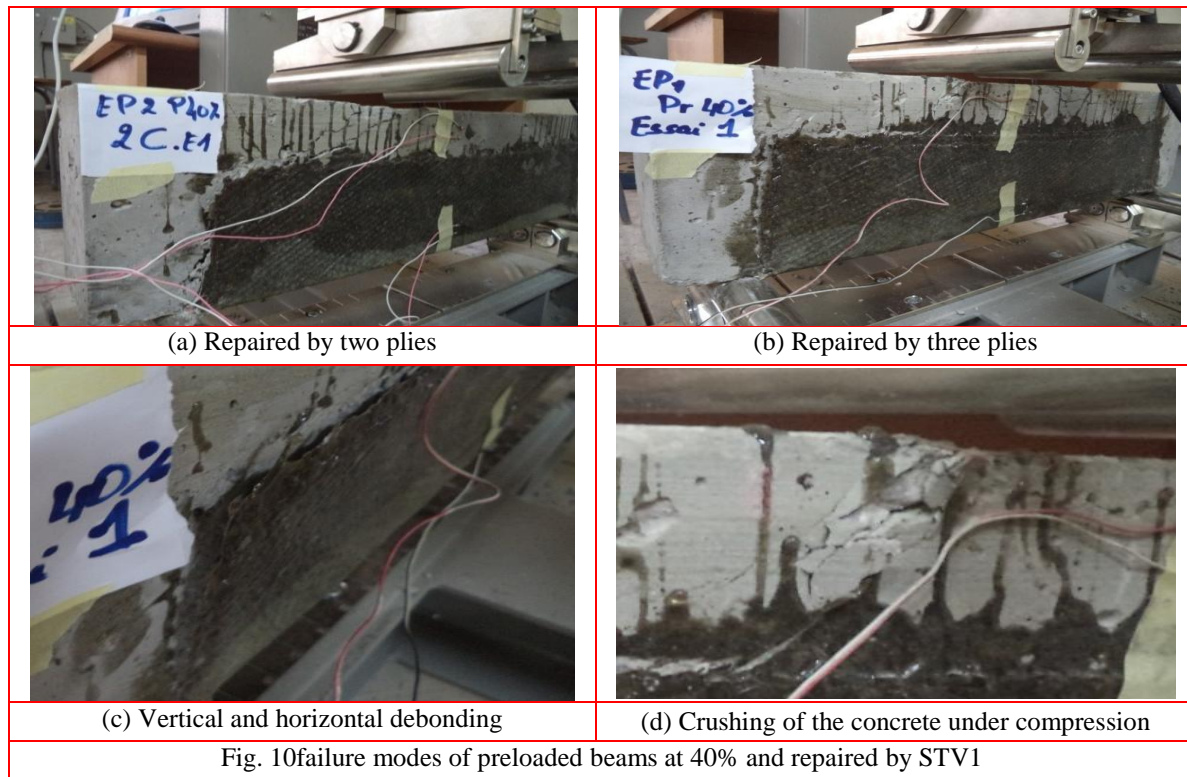
The failure mode of the beams preloaded at 40% and then repaired by two and three plies is similar to the one present in the control beam and the non preloaded STV1-reinforced one as shown in Fig. 10 (a). However, for the beam preloaded at 40% and then repaired by three plies with large composite

mass a delamination between the composite and the concrete in the horizontal and vertical direction was obtained (Figs.10(b)-(c)), followed by the deformations on the concrete in highly compressed zones that have reached their limits near to the loading point (Fig. 10 (d)).

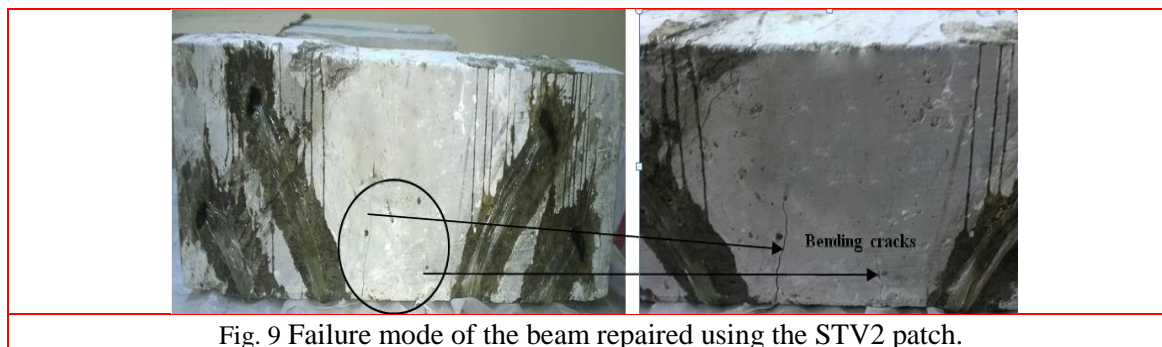
Fig. 9 Failure mode of the beam repaired using the STV2 patch.

The beam belonging to the B series preloaded and then repaired using the STV2 composite failed by bending due to the appearance of vertical cracks following the formation of a bearing, therefore preventing the shear crack to appear and to develop. The experimental results of the SCR-rehabilitated beam have therefore showed the desired type of failure mode, which is the bending one (Fig. 9). Similar results were also observed by other researchers in previous investigations of reinforced concrete beams strengthened with composite materials using the ETS method by inserting FRP rods into the shear zone of the beam (Chaallal *et al.* 2011b, Breveglieri *et al.* 2014, Mofidi and Chaallal 2014). Therefore the repair of the beams by bonding with U-shaped continuous fabric does not allow to "sew" the cracks. This is explained by the fact that the series B where the composite is subjected until its rupture, however in the series A the appearance of the delamination (composite/concrete) which does not permit to reach the ultimate strength of the composite. In addition, in the new method (SCR) the strands are continue for few turns banding the cracks, however in the U-shaped (EB), the composite is bonded in the surface only. The SCR method permit to don't have the delamination problem by the use of adequate fiber orientation (perpendicular to shear cracks), leading to tensile in the fiber direction, permitting a maximal resistance and then a rational use of the composite until its ultimate strength. Strengthening or repairing the beams using the new method has leads to change the failure mode from a fragile rupture by shear to a ductile one by bending..
