Safety problems and difficulties in using public spaces with modern tramways: the example of Marseilles

Elisa Maitre. Safety problems and difficulties in using public spaces with modern tramways: the example of Marseilles. 8th Young Researchers' Seminar 2017 - ECTRI-FEHRL-FERSI, May 2017, Berlin, Germany. 16 p. hal-01658471

SAFETY PROBLEMS AND DIFFICULTIES IN USING PUBLIC SPACES WITH MODERN TRAMWAYS: THE EXAMPLE OF MARSEILLES

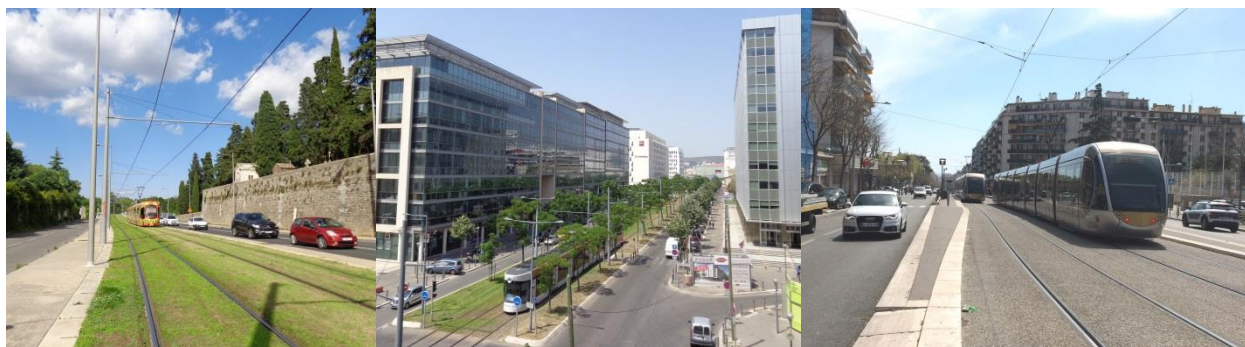
Fig. 1 Examples of modern tram layouts with dedicated tram lanes in three French cities

Modern tram layouts in France are usually based on dedicated lanes and contribute to the redistribution of the whole public space. These tram lanes take on various forms (tram lanes in a lateral, bilateral, axial or elevated position, with or without borders, with or without different surfacing). For example, the tram systems in Montpellier, Nice or Marseille, are inserted in exclusive lanes for the major part of their networks.

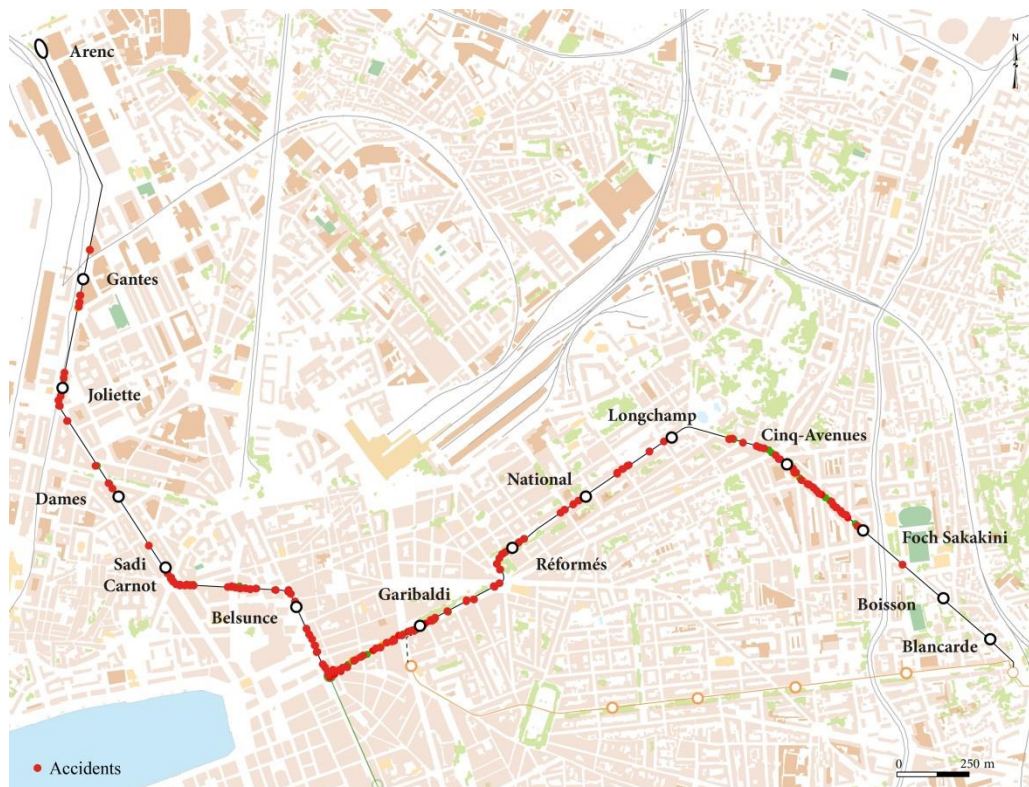
Fig. 2: Distribution of accidents occurred in the streets located along the tram line 2 of the city of Marseilles

The geolocation of accidents occurring in the streets covered by the tram line 2 appears on the map presented in fig.2. This map showing the distribution of accidents highlights the relative abundance of accidents on the whole line, although a more marked concentration can be observed within the more central areas.

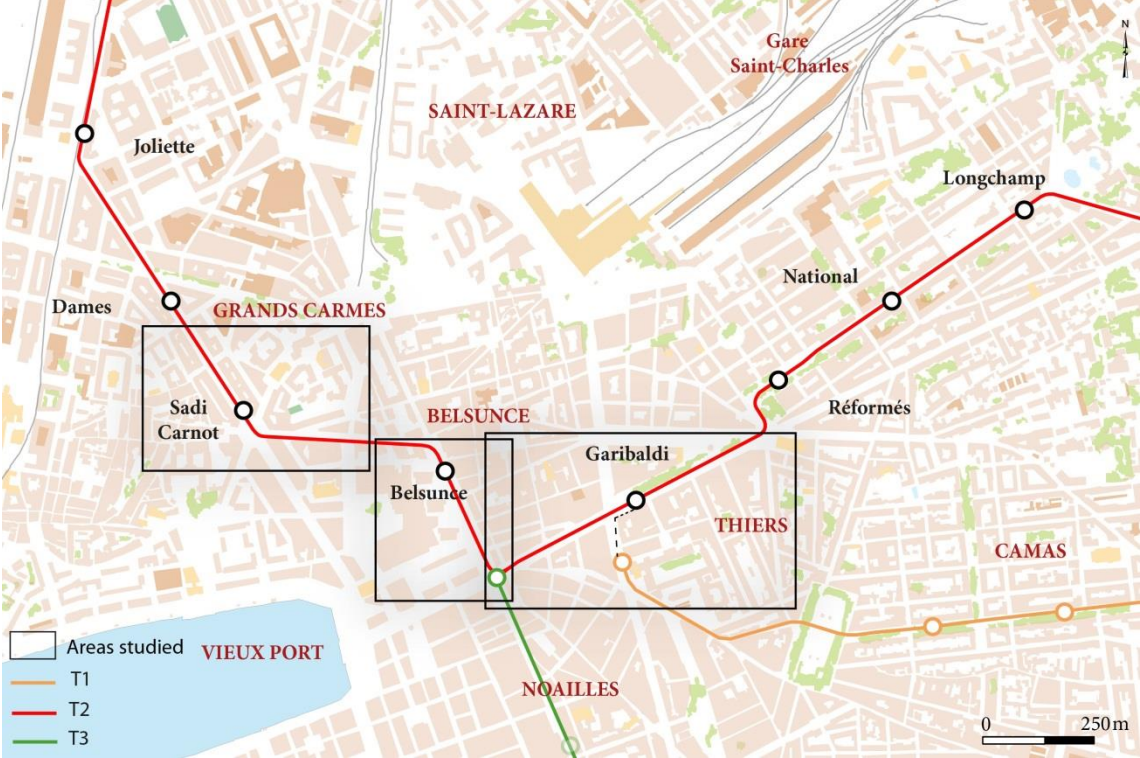
Fig. 3: Areas studied for the detailed analysis of safety problems and difficulties of use of public space

Based on our *in situ* observation and description of the different public spaces re-designed for tram, we distinguished three main sections on which our analyses of the safety problems and difficulties of use can be deepened: at first the section of *La Canebière*, historical street, symbolic of the city; secondly, the vast pedestrian area of *Cours Belsunce* perpendicular to *La Canebière*; thirdly, the *Place Sadi Carnot*. These three sections are located in the dense urban area of Marseilles as well as the whole of line 2 (Fig. 3). Nevertheless they correspond to different urban contexts, since *La Canebière* constitutes the symbolic main street of the city, *Cours Belsunce* is characterized by its pedestrian area, and *Place Sadi Carnot* constitutes the intersection between the Haussmannian breakthroughs of *Rue de la République* and *Rue*

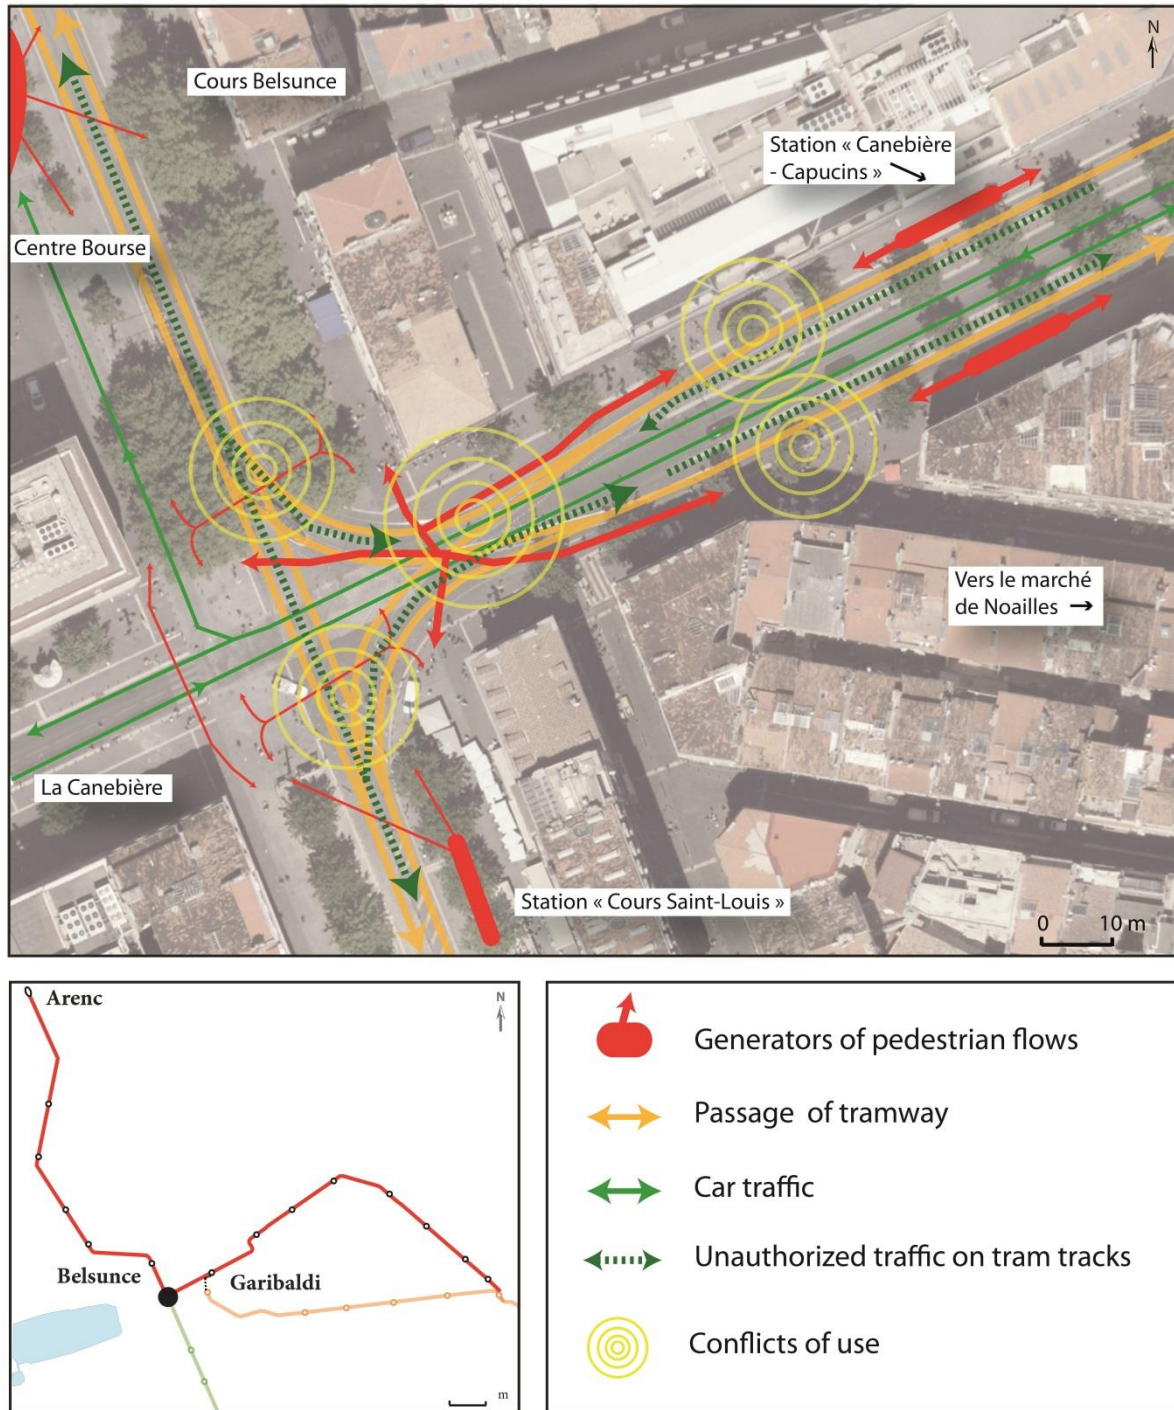
Fig. 4: Users' practices in the sections of *La Canebière* and *Cours Belsunce*

The sections of *La Canebière* and *Cours Belsunce* include many pedestrian flow generators and are located in an area of important shopping streets of the city (*La Canebière*, *Cours Belsunce*, *Rue de Rome*, *Cours Saint-Louis*) (Fig.4). The station "Canebière-Capucins" is very busy. The access to the Noailles market also generates a flow of pedestrians. Numerous pedestrians also walk towards *Cours Belsunce*. Its pedestrian shopping area and the shopping center "Center Bourse" constitute the main places generating travel. These sections are also

characterized by high motorized traffic. Based on our field observations and interviews conducted with the users, different points of conflict can be identified within these sections (Fig.4).

A first in La Canebière, our accidents analyses reveal various influences of the re-design public space for tram on the occurrence of accidents. Our in situ observations also highlight conflicting points causing difficulties of use. The first type of influence corresponds to complicated space layouts leading to a poor understanding of the site or complicating users' search for information. This first type of influence affects six accident cases. Two other cases of accident are related to the incomprehension of the organization of traffic directions by motorized users. These difficulties of use particularly affect the intersection between La Canebière and Cours Belsunce.

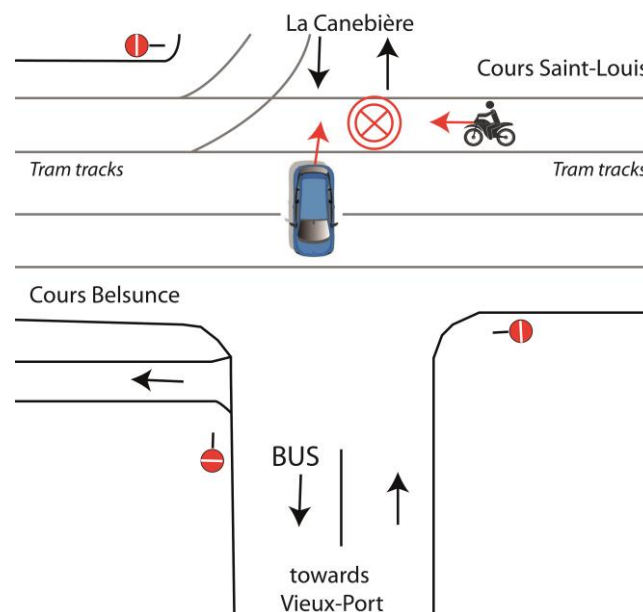
Fig. 5: Example of an accident (*La Canebière / Cours Belsunce*)

In the accident taken as an exemple in Fig.5, a motorist arriving at intersection from *La Canebière* in the direction of *Vieux-Port*, only belatedly understands that he cannot continue straight and makes a reversing maneuver. He then hit a motorized two-wheeler (coming from *Rue de Rome* in direction of *Cours Belsunce* (in prohibited direction).

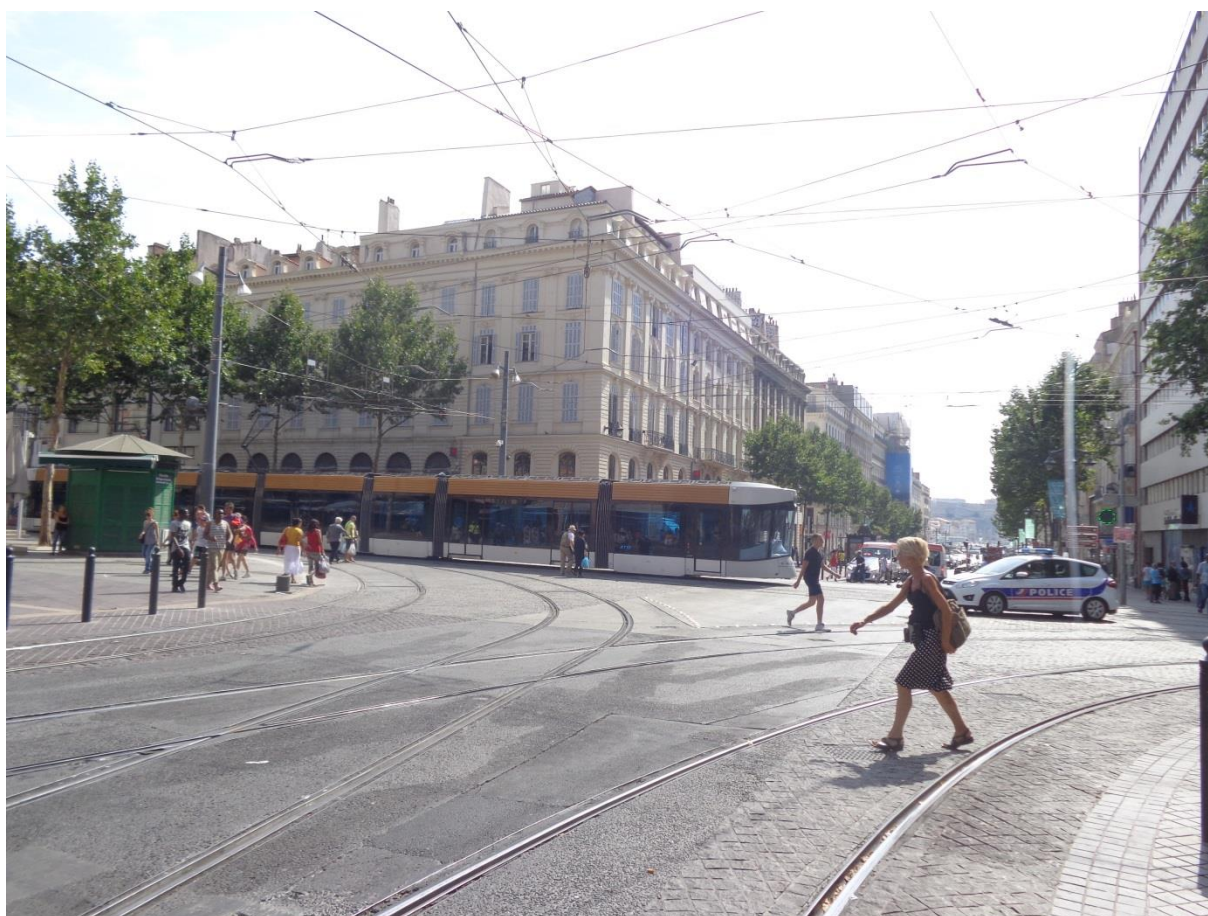
Fig. 6 : La Canebière / Cours Belsunce

Secondly, in *Cours Belsunce* problems of inappropriate incursion of traffic into the tram lanes also play a role in the occurrence of accidents. Furthermore, the weak salience of the tram

tracks leads to difficulties for users who cross these lanes, especially to distinguish the limits of the different spaces (Fig.6). According to users: "There is nothing that indicates that the tram arrives"; "From what I see it is pretty dangerous. There is no signposting, there is nothing at all "; It's a bit ... badly marked. The arrival of the tram is not necessarily ... well, very visible, it lacks visual warnings a little more marked ". According to the safety expert "we have problems with the colour of the tram lanes, which are similar to the rest, the border is also not very distinguishable, we have problems of visual contrasts".

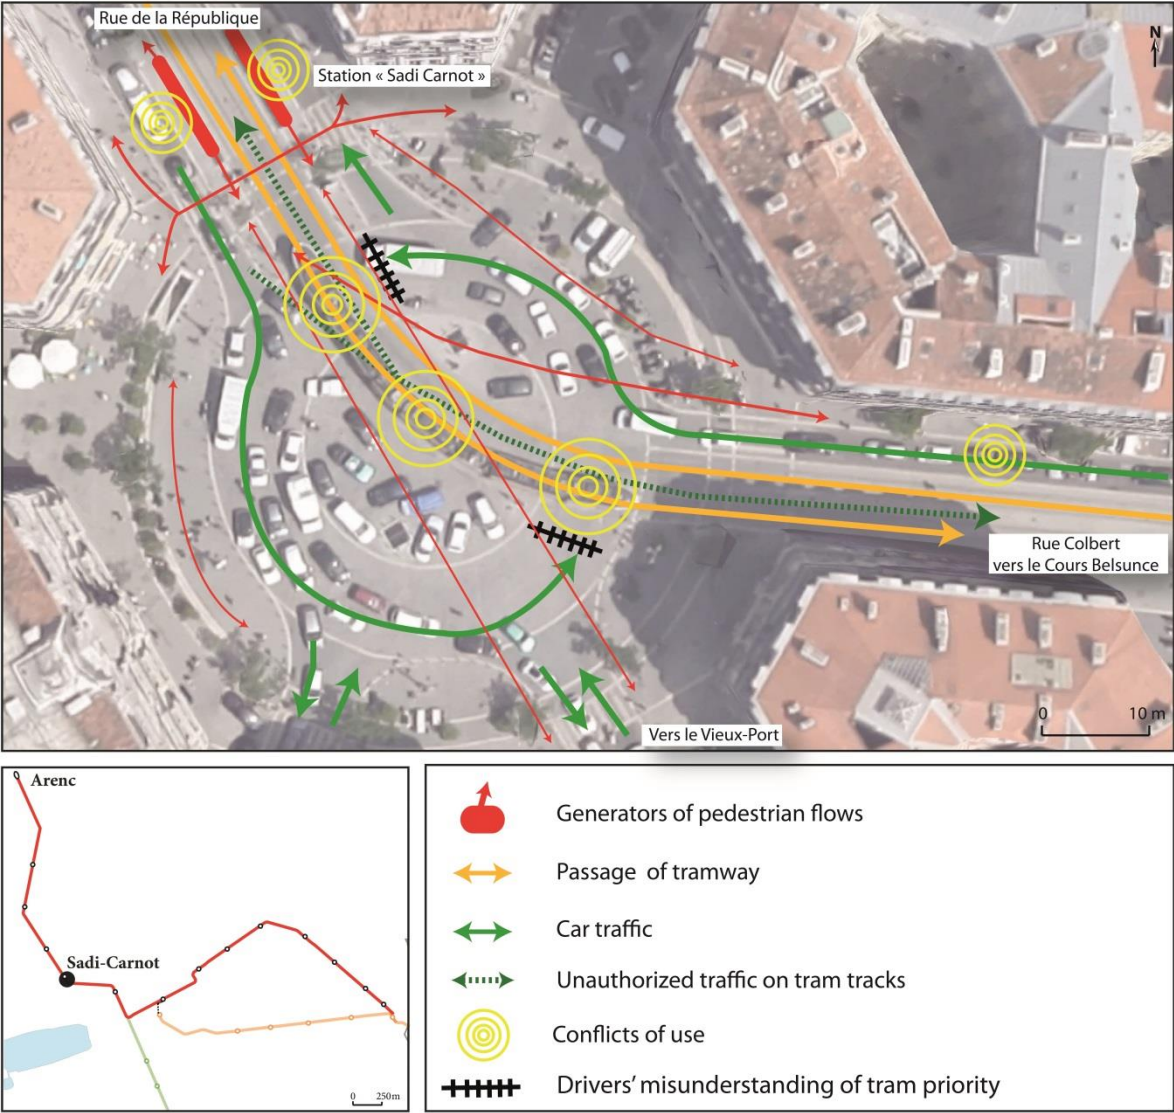
Fig. 7: Users’ practices in the section *Place Sadi Carnot*

After *Cours Belsunce*, the tram is located on *Rue Colbert* and then on *Place Sadi Carnot* located at the intersection of the Haussmaniann breakthroughs of *Rue Colbert* and *Rue de la République*. The *in situ* analysis of users’ practices highlights difficulties of use within this

sector, linked in particular to problems of readability of tram tracks. Pedestrians cross this area without clearly distinguishing traffic lanes from the rest of the space. Moreover, illegal parking of vehicles, which is very present in this area, constitutes obstructions to visibility for crossing pedestrians (Fig.7). In addition motorists do not always detect the oncoming trams and the corresponding signposting.

The interviews of the users provide elements on problems of weak salience of the limits between the different spaces and on the difficulties of use encountered: *"I was wondering whether I was on the road, it's a question ... but they would have to mark better"* ; *"This one [the roundabout of the square Sadi Carnot] it is not very clear for pedestrians, it lacks signposting and marking"* ; *"The first time, I suddenly found myself in front of a car, I thought it was reserved for the pedestrians"*. Moreover, according to the road safety expert: *"There were a lot of collisions in this square, people did not see the traffic light and hit the tram, and others were parked all over the place and when they left they, were no longer appropriately managed by the traffic lights and collided with the tram. There is no change in level or colour, so there are problems related to the weak salience of the tram layouts in public spaces. There are problems of readability of tramway tracks and particularly of the surface swept by the tram. This could be improved with a shift in colour or materials to see these limits more clearly. It is mainly for car drivers, but it is also used by the tram driver to determine whether the car is in his path or not to know whether he can continue »*.

On this section, three accidents occurred in relation with this problem of poor differentiation between spaces, leading to the inappropriate presence of traffic or parked cars on tram tracks.

Moreover the special status given to the tram on this type of intersection (trams always have right of way) leads to the introduction of specific signs (traffic lights on the roundabouts, for example) which contradict the general principles of operation of roundabouts (priority to the road users already on the roundabout) and may be misperceived or misunderstood by other road users.
