Water-repellent and biocide treatments: Assessment of the potential combinations

Keywords: Water-repellence; H224; Biocide; Limestone; Microdrop test.

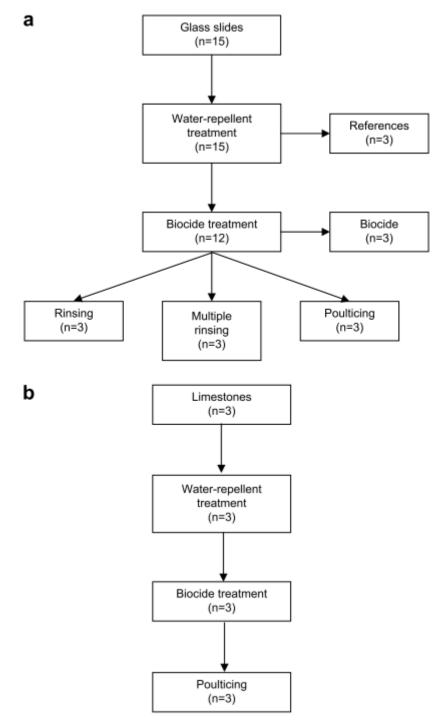
Fig. 1. Experimental set-up for glass slides (a) and for limestone (b).

To eliminate the remains of biocide on the water-repellent film, three different methods are tested, on three glass slides each time (Fig. 1a): - rinsing with distilled water, by spray; - rinsing with distilled

While the first two techniques are modified from the CEBTP experiment [8], the last one is adapted from the common use of poultices to remove salts from a stone. According to the results obtained on the glass slides, only the more efficient method is tested on the stone cubes (Fig. 1b).

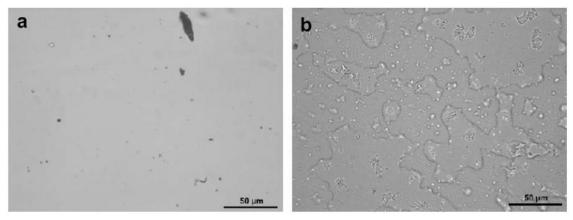
On Fig. 2, two images are depicted, Fig. 2a showing the glass slide coated with water-repellent, and Fig. 2b, the same glass slide after application of the biocide. In Fig. 2a, the water-repellent film appears to coat the glass slide uniformly, except for some small defects (bubbles, dust .). Fig. 2b reveals that the water-repellent film, which is uniform, is covered with areas of irregular shapes, delimited by a darker edge, which most probably correspond to remains of the biocide. The whiter spots look like a crystallisation of an undefined product.

Fig. 2. Microscope pictures of the glass slide. (a) Water-repellent film, and (b) water-repellent followed by biocide treatment.

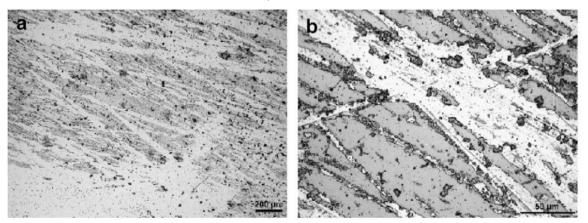
Fig. 3. Microscope pictures of the glass slides after the following treatments: waterrepellent/biocide/water rinsing. (a) General view, and (b) detail.

After spraying water, the surface of the glass slide appears very inhomogeneous, as shown in Fig. 3. In Fig. 3a, there is a juxtaposition of grey zones and white stripes, which have different orientations. The grey zones are assumed to be remains of the biocide product, while the white stripes correspond to the water-repellent film. At higher magnification, in Fig. 3b, the edges of the remains of biocide are put in evidence: they are neat and indented, clearly separated by the white stripes of the water-repellent film. This heterogeneous distribution of the biocide remains is probably due to the application technique with the brush, which creates more or less thick stripes of a biocide product.

By spraying water, the less thick areas of biocide are cleared preferentially. When repeated several times, the rinsing allows for a slightly better cleaning of the surface: less residues of biocide are visible on the water-repellent film, but the surface is still not evenly cleaned. To conclude, it is obvious that

the water spraying is not satisfactory. The cleaning is not homogeneous, as the biocide product is only partially removed from the surface of the water-repellent film.

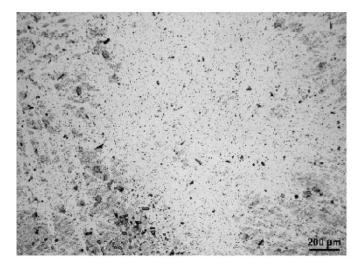
Fig. 4. Microscope picture of a glass slide. After cleaning with poultices.

Looking at Fig. 4, the application of poultices leads to a better elimination of the biocide product on the surface, than the technique of water spraying. Only some small darker zones (biocide product remains) are visible, while most of the surface corresponds to the water-repellent film in light grey. However, some residues of the poultice (black particles) are clearly noticeable on the surface.

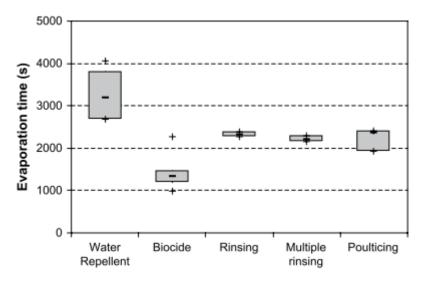
Fig. 5. Results of the microdrop test on the glass slides.

The results of the microdrop test on the glass slides are displayed in Fig. 5. The evaporation times for the reference samples, i.e. the evaporation time on samples treated with a water-repellent, are widespread, between 2 679 and 4 057 s. Within the frame of this study, the mean value, which is over 3 000 s, will stand as a reference of a good water-repellent treatment. After the application of the biocide, the evaporation time drops considerably. The mean value is only 43% of the reference evaporation time, but the values are still widespread. Single and multiple rinsing allow for a same

increase of the evaporation time, reaching 71% of the water-repellent reference value. The repeated rinsing on glass slides does not increase the evaporation time. Moreover, the range of evaporation times, after rinsing, is now very narrow. The values of evaporation time after poulticing are less homogeneous, but the mean value is almost the same, reaching 69% of the reference value.

The different techniques used to remove the biocide lead to an increase of the evaporation time. Nonetheless the value is still lower than the reference time (water-repellent treatment).

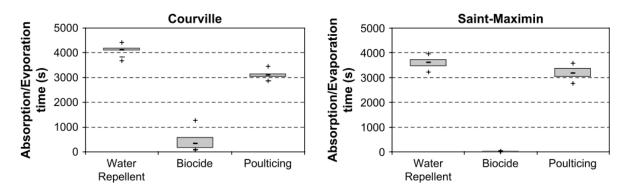
For the two types of limestones, the reference value, i.e. the evaporation time on samples treated with a water-repellent, is slightly different, but in the same range: over 3 000 s, as shown on Fig. 6. After the application of the biocide, a high decrease of the evaporation time is observed: there is a drop of 90% for the Courville stone, while the evaporation time for the Saint-Maximin stone falls down to 10 s. After poulticing, the level of the evaporation time is restored at 80% of the reference value for the Courville stone and even 99%, in case of the Saint-Maximin stone. The poultice is a very efficient way to bring back the level of evaporation time close to its reference value, after the drop down due to the application of a biocide treatment.

Fig. 6. Results of the microdrop test on Courville and Saint-Maximin stones.

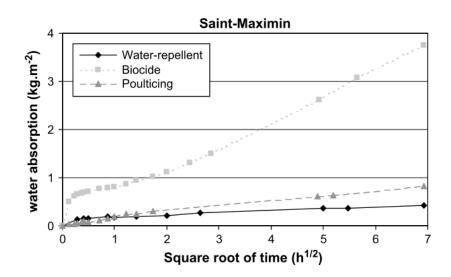
brought back to the reference level of $0.1 \text{ kg m} - 2 \text{ h} - \frac{1}{2}$. The study of the water absorption by capillarity test charts (Figs. 7 and 8) can give a clearer indication about the capillary behaviour of the stone samples. The curve of the sample treated with the water-repellent is almost linear with a low slope. The water-repellent film prevents water to penetrate the stones pore system. After the biocide treatment, there is a great increase of the water uptake of the Saint-Maximin stone at the very beginning (the first 10 min), proving that water penetrates the pore system of the stone.

Fig. 7. Water absorption capillarity charts for Saint-Maximin stone.

The "poulticing" curve is almost a straight line, following the reference curve. At the beginning, the slope is slightly lower than the reference one, while after 1 h, it is higher. The absorption behaviour of these two samples is very similar: it is very hard for the water to penetrate into the capillary system of the stones.

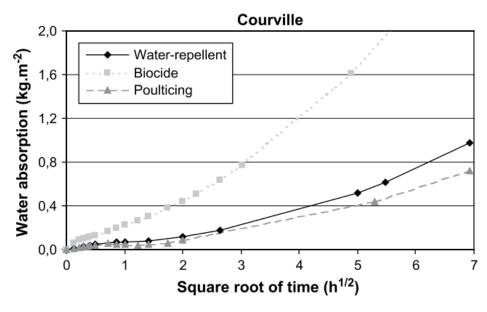
Fig. 8. Water absorption capillarity charts for Courville stone.

Then a decrease of the slope is observed: after penetrating few millimetres of the pore system, the water seems to be prevented from any further penetration. However, after 1 h, another slower increase starts: the water is reaching the rest of the pore system. Because of the lower water uptake coefficient of the untreated stone, the phenomena are less visible on Courville limestone (Fig. 8) but still occurs.
