## Implementation of a new method for robotic repair operations on composite structures

Elodie Paquet, Sébastien Garnier, Mathieu Ritou, Benoît Furet, Vincent Desfontaines

Elodie Paquet, Sébastien Garnier, Mathieu Ritou, Benoît Furet, Vincent Desfontaines. Implementation of a new method for robotic repair operations on composite structures. *Advances on Mechanics, Design Engineering and Manufacturing*, 2017, 10.1007/978-3-319-45781-9\_33. hal-01691351

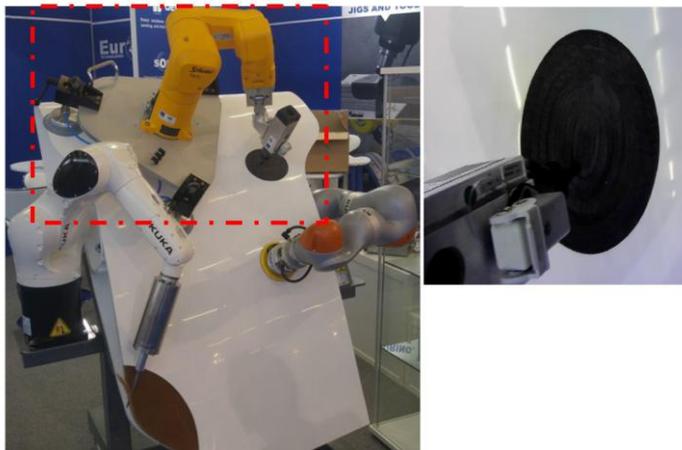
Fig. 2 Robotic solution developed for composite materials repair in the project COPERBOT

To perform and automated this repair operations on CFRP components, a light-weight, portable manipulator with a collaborative robot has been designed and developed during the project “COPERBOT”.

The aim of this project is the development of an integrated process chain for a fast, low price, automated and reproducible repair of high performance fiber composite structures with a collaborative robot.

This platform will be mountable on aircraft structures even in-field, which allows for repairs without disassembly of the part itself. Consequently, a faster, more reliable and fully automated composite repair method is possible for the aeronautical and nautical industry. The objective of this article is to propose a new method to automate repair process of composite parts, for example monolithic CFRP laminate plates representative of primary aircraft structures.

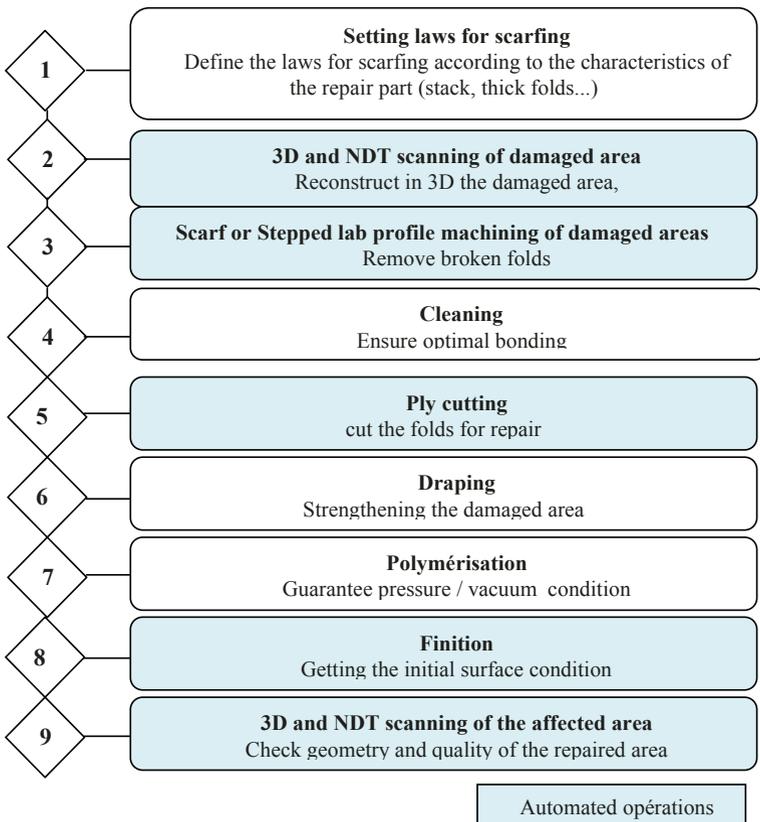
Fig. 3 Reparation range of an impact on a composite structure

Repair range of an impact on a composite structure consisted of the steps listed below:

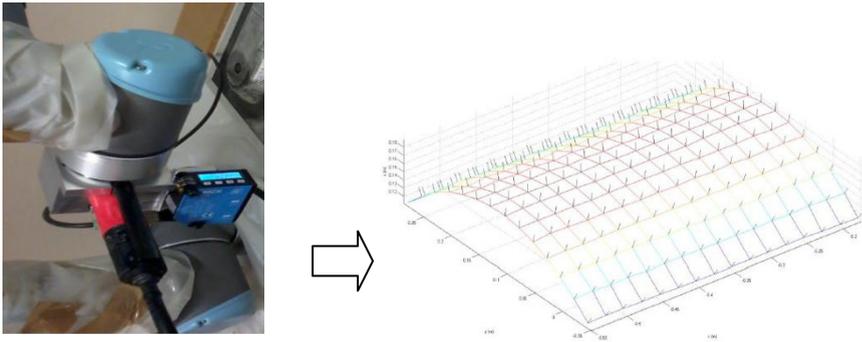
Fig. 5. Surface reconstructed by laser sensor fixed on a robot

The first step in our robotic repair method is to reconstruct the surface to prepare the stepped lap trajectory of the damaged area with an onboard laser sensor on the 6th axis of the robot. The method adopted to reconstruct the surface is scanning the surface with the robot following a regular mesh defined by three points by the operator. By combining the position of the robot and the information given by a distance sensor (a line laser), we can then reconstruct the damaged area surface. Three typical examples are shown in fig 5:

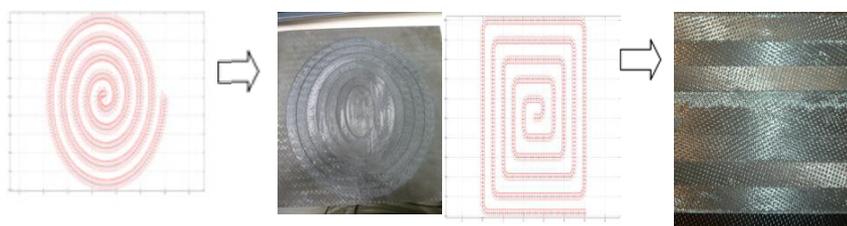
Fig. 6 Two trajectories for a stepped lap.

From the recovered data on the reconstructed surface, machine path trajectories are calculated to create the appropriate geometry scarf on the surface. This patch needs to be draped mathematically on the surface, otherwise it wouldn't fit later in the scarf especially for parts with a smaller radius. [2] [5] Based on this 3D scarf definition the final milling trajectory is calculated taking into account different cutter types (shank or radius) as well as the stability of the part during the milling process. Two typical trajectories are shown in fig 6:

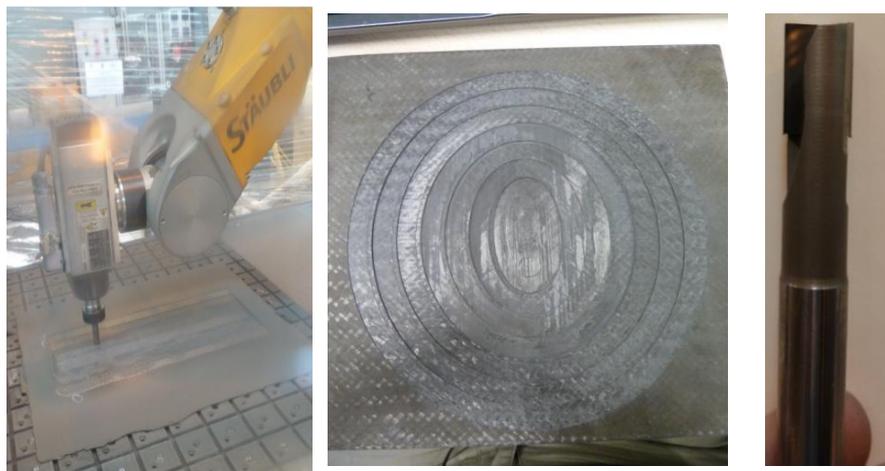
**Fig 8** Stepped lab composite part produced by the robot

Results of tests recommend to use a polycrystalline diamond tool (PCD) for machining of stepped lap. This type of cutter is designed to withstand the abrasive properties of composite material.

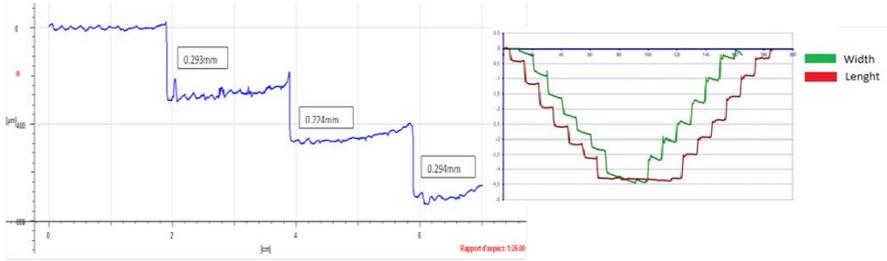
**Fig 9** Metrological controls realized of stepped lap in composite part produced by the robot

Optical 3D measurement has controlled the removed pleat depths and the surface roughness obtained by machining robots on our test plates.

Micrographic examination of the surface topography and the profile control review by a coordinate measuring machine on machined steps show an accuracy of a tenth of the depth machined on each floor for each of the two tests. Robotic scarfing made by the technical steps with PCD tool enables a low roughness (Ra of approximately 21) and without the presence of delamination floors contour levels.
