Implementation of a new method for robotic repair operations on composite structures

Keywords: Robotic machining, Composite repair, Repair of structural composite parts, machining process.

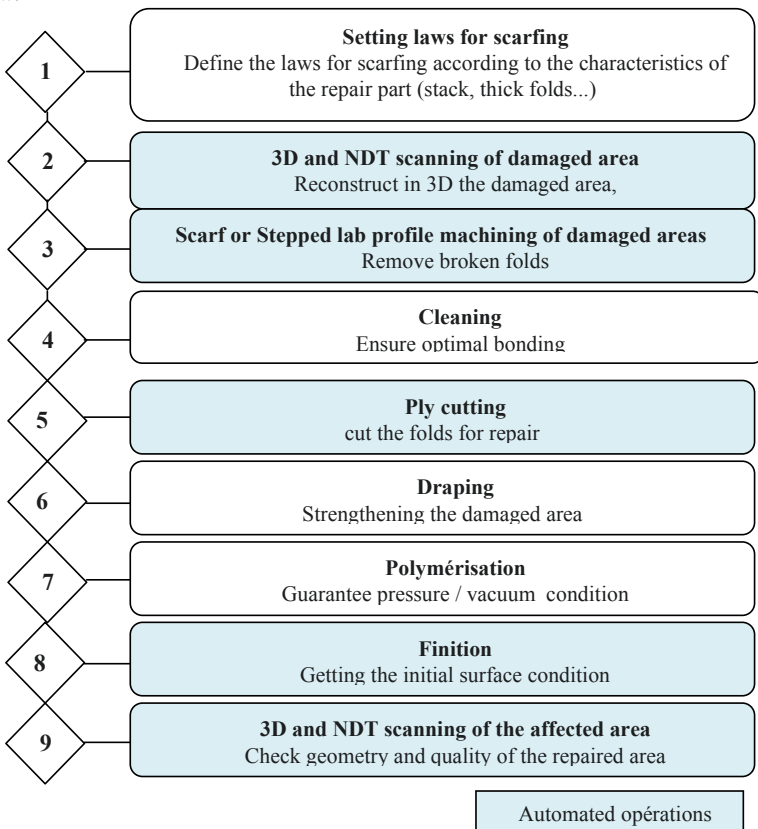
Fig. 3 Reparation range of an impact on a composite structure

Repair range of an impact on a composite structure consisted of the steps listed below:

The work carried out in the project COPERBOT are limited for the moment to repair tests on monolithic composite prepreg Hexply 8552 - AGP280-5H with a draping plan [0,45,0,45,0,0, 45,0,45,0]. This type of plate is representative of materials, thicknesses and stacking sequences found in primary aircraft structures such as the radome of aircraft.

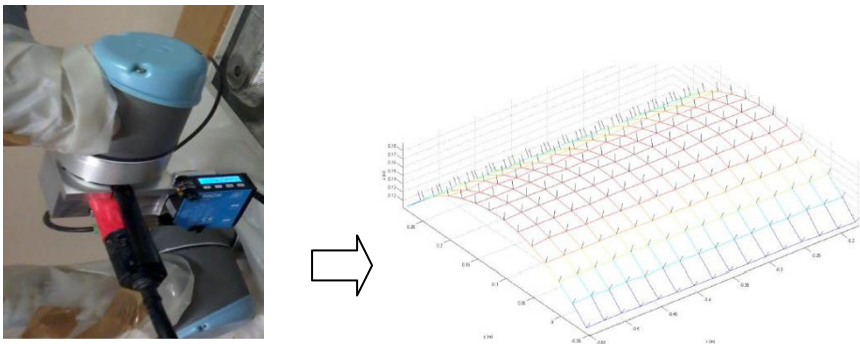
Fig. 5. Surface reconstructed by laser sensor fixed on a robot

The first step in our robotic repair method is to reconstruct the surface to prepare the stepped lap trajectory of the damaged area with an onboard laser sensor on the 6th axis of the robot. The method adopted to reconstruct the surface is scanning the surface with the robot following a regular mesh defined by three points by the operator. By combining the position of the robot and the information given by a distance sensor (a line laser), we can then reconstruct the damaged area surface. Three typical examples are shown in fig 5:

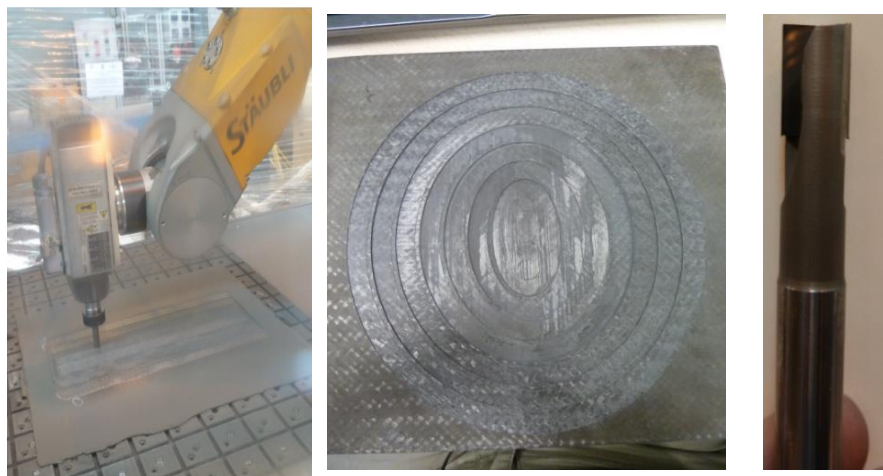
Fig 8 Stepped lab composite part produced by the robot

Results of tests recommend to use a polycrystalline diamond tool (PCD) for machining of stepped lap. This type of cutter is designed to withstand the abrasive properties of composite material.

To limit the defects created by the machining forces, two types of parameters were tested to determine the most suitable for our application: on one side, those associated with the tool, those related the cutting conditions (feed per revolution, cutting speed, direction of the fibers in relation to the feed rate ...) [2]. The machining paths that were chosen with a view to study subsequently the influence of fiber orientation on the cutting forces [5].

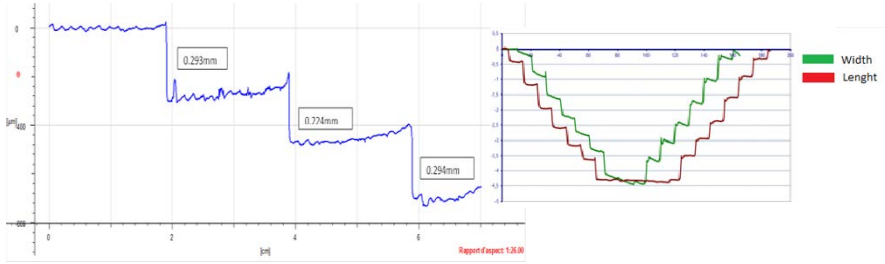
Fig 9 Metrological controls realized of stepped lap in composite part produced by the robot

Optical 3D measurement has controlled the removed pleat depths and the surface roughness obtained by machining robots on our test plates.

Micrographic examination of the surface topography and the profile control review by a coordinate measuring machine on machined steps show an accuracy of a tenth of the depth machined on each floor for each of the two tests. Robotic scarfing made by the technical steps with PCD tool enables a low roughness (Ra of approximately 21) and without the presence of delamination floors contour levels.
