# Improving a pavement-watering method on the basis of pavement surface temperature measurements

Martin Hendel, Morgane Colombert, Youssef Diab, Laurent Royon

Martin Hendel, Morgane Colombert, Youssef Diab, Laurent Royon. Improving a pavement-watering method on the basis of pavement surface temperature measurements. 2014. hal-01698358v2

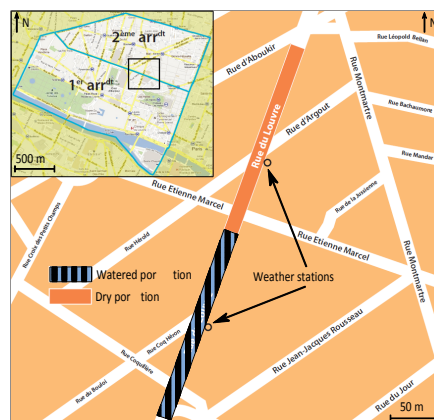
Figure 1: Map of the rue du Louvre site

Street surface temperatures were investigated on rue du Louvre, near Les Halles in the 1<sup>st</sup> and 2<sup>nd</sup> Arrondissements in Paris, France over the summer of 2013. Measurements were collected during the same experiment as that described by Hendel et al. [3]. Watered and control weather station positions are illustrated in Figure 1, however only data from the watered site will be studied. Both watered and dry portions of the street are approximately 180 m long and 20 m wide. Rue du Louvre has an aspect ratio approximately equal to one and has a N-NE-S-SW orientation. Data is presented in local daylight savings time (UTC +2).

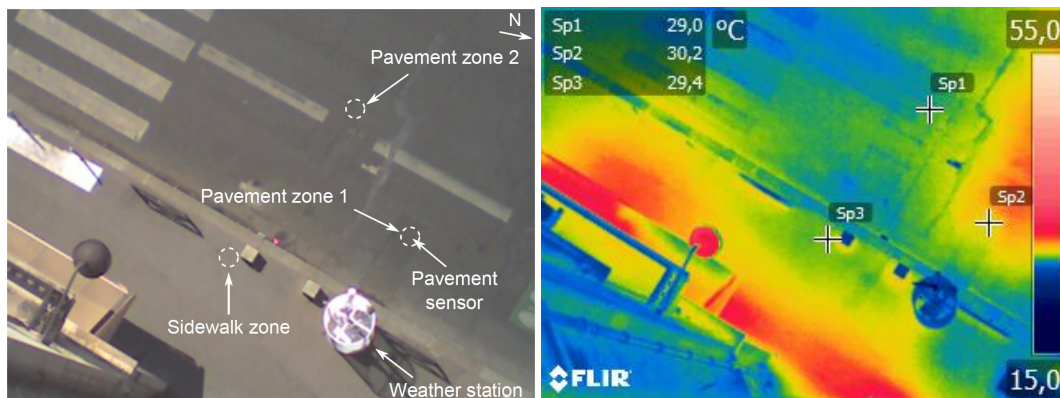
The surface temperatures of three street areas were surveyed as illustrated in Figure 2 (left): pavement zone 1, located above the pavement sensor used in the parent analysis [3], pavement zone 2, located further towards the street's center and a sidewalk zone. All three had an emissivity of 0.97 despite different surface composition and texture. No change in emissivity was applied for the wet pavement. It is assumed that the wet pavement has the emissivity of a water film, i.e. 0.98.

The studied zones were selected according to the presence of thermal disturbance sources, detected via a nighttime infrared photograph of the area provided in Figure 2 (right). The use of a nighttime rather than daytime infrared image prevents interpretation errors due to differences in insolation or shading. Thermally disturbed areas are either significantly warmer or colder than their surroundings, once differences in emissivity have been accounted for.

Figure 2: *Surface temperature measurement zones (left) and corresponding nighttime corrected infrared photograph on July 22<sup>nd</sup> at 03:20 (right). Temperature scale is in degrees Celsius. Sp2: pavement zone 1; Sp1: pavement zone 2; Sp3: sidewalk zone.*

The main disturbance is caused by a district heating main, which runs below the sidewalk along the edge of the building and crosses the street perpendicularly below the weather station. It is most easily recognized in its sidewalk portion in the form of a distinct red band running from left to right from the awning to the bottom edge of the false-color infrared image. It then runs perpendicularly, from bottom to top, underneath the weather station where it is not as visible and continues until the other side of the street, reappearing with rough contours just after pavement zone 1 (Sp2).

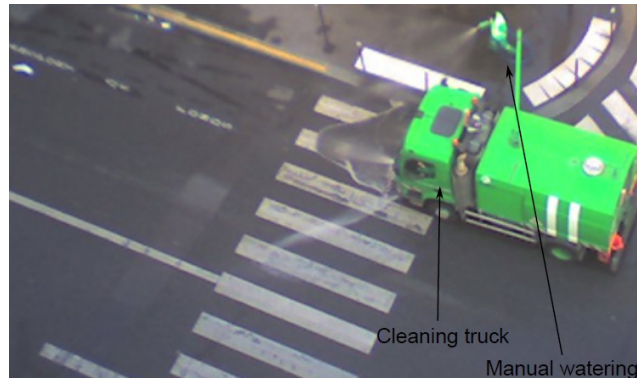
Figure 3: Pavement- and sidewalk-watering on July 8<sup>th</sup> by a cleaning truck and its operators. Watering is taking place across the street from the weather station visible in Figure 2.

Cleaning trucks assisted by manual operators sprinkled approximately 1 mm every hour from 06:30 to 11:30 and every 30 minutes from 14:00 until 18:30 on the sidewalk and pavement. This amount of water is considered to be the maximum water-holding capacity of the road surface in Paris by the Roads and Traffic Division. Exact watering times were reported by truck drivers, cross-checked against visible images taken by the rooftop camera when available. Resulting watering time precision is estimated to be no better than 5 minutes. A picture of pavement-watering underway across the street from the studied street surfaces (the same pedestrian crosswalk is visible) is presented in Figure 3. Each watering cycle required two passes by the cleaning truck to water both halves of the street.

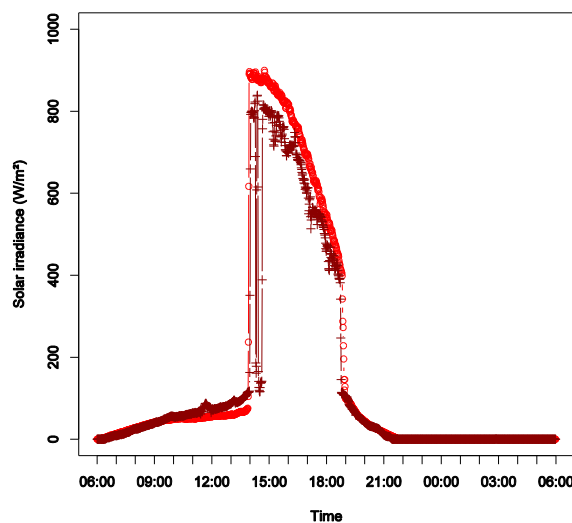
Figure 4: Solar irradiance measured on July 8<sup>th</sup> and 22<sup>nd</sup>.

approximately 25 minutes shorter than on July 8<sup>th</sup>, while solar zenith is reduced by less than 2°. The magnitude of these changes can be seen in Figure 4 which illustrates solar irradiance as measured by the weather station on July 8<sup>th</sup> and 22<sup>nd</sup> for comparison. Daily shading conditions were checked and were found to be unmodified for the studied surfaces between July 8<sup>th</sup> and July 21<sup>st</sup>. For the purpose of this discussion, we therefore consider the changes in sun trajectory to be negligible.

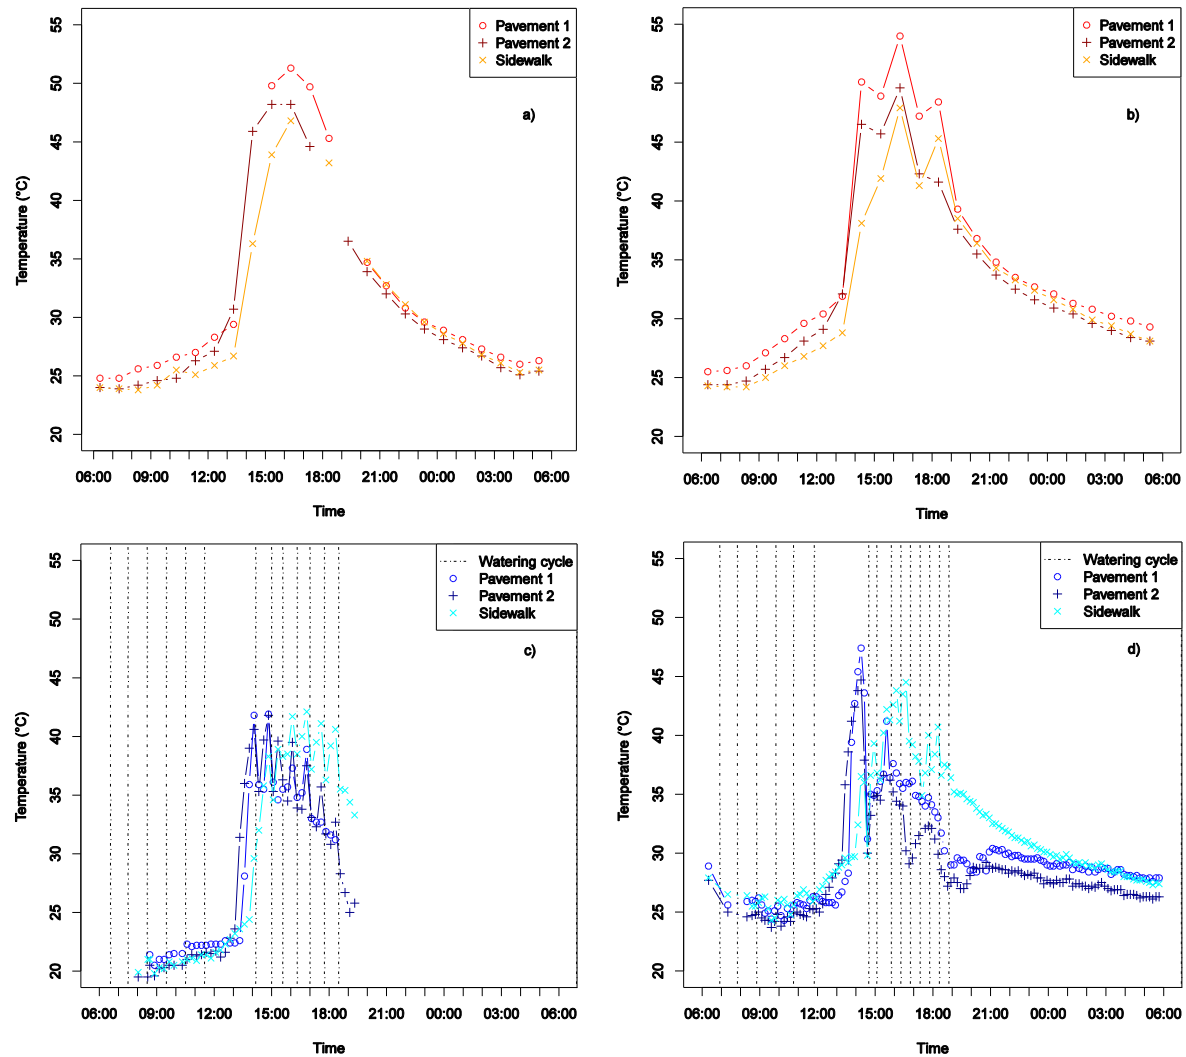
Figure 5: Pavement Directional Radiometric Temperature on control days: a) July 20<sup>th</sup> and b) July 21<sup>st</sup>; and on watered days: c) July 8<sup>th</sup> and d) July 22<sup>nd</sup>

Figure 5 presents directional radiometric temperature for the three defined areas of the street: the (o) series represents pavement zone 1; the (+) series represents pavement zone 2; the (x) series represents the sidewalk. Some data points are missing due to passing or parked vehicles over the measurement areas. Vertical dot-dashed lines indicate watering cycles for July 8<sup>th</sup> and 22<sup>nd</sup>. It should be noted that afternoon watering on July 8<sup>th</sup> occurred about every 45 minutes, while it was every 30 minutes on July 22<sup>nd</sup>.

On July 20<sup>th</sup> and 21<sup>st</sup>, surface temperatures reach a low of 24°C between 06:00 and 07:00 and a high of 50-54°C at 16:00. All three surfaces follow a very similar approximately bell-shaped curve. Morning temperatures increase slowly until they spike when the pavement becomes insolated around 13:30. Pavement shading causes an exponentially-shaped decrease in temperatures starting between 18:00 and 19:00. Pavement zone 1 is generally the warmest, followed by pavement zone 2 and the sidewalk, with nocturnal temperatures being the most similar with differences smaller than 2°C. Temperature differences are more pronounced during the day, particularly during insolation. It should be noted that the temperature fluctuations which occur on July 21<sup>st</sup> are due to the passing of isolated clouds.

On July 22<sup>nd</sup>, the daily low was about 25°C, but this temperature was maintained from 07:30 until 12:00. A maximum temperature of about 47°C was reached just before afternoon pavement-watering began. The bell-shape of the temperature curves is greatly affected by watering. Morning increases are slower, insolated surface temperatures are several degrees lower and nighttime temperatures follow a more linear decrease, except for the sidewalk zone. After watering begins, the temperature of all surfaces remains below 45°C. Furthermore, unlike on control days, the sidewalk becomes the warmest area after afternoon watering begins and remains so until late in the night. Similar temperatures and trends are observed in available data from July 8<sup>th</sup>.

A dip in the temperature of pavement zone 2 and that of the sidewalk should be noted on July 22<sup>nd</sup>. It occurs due to shade caused by the buildings across the street at approximately 17:00 and 18:00, respectively. This shade event did not occur before this date.

In addition to these changes, the presence of several temperature spikes during and just before afternoon watering is noted on both July 8<sup>th</sup> and 22<sup>nd</sup>. For pavement zones 1 and 2, these are mainly found on July 8<sup>th</sup>, with nearly all occurring during afternoon watering. On July 8<sup>th</sup>, the detected spikes are up to two 15-minute measurements wide. On July 22<sup>nd</sup>, when watering occurs more frequently, only two spikes are visible, excluding the temperature dip due to building shading: one before and one during afternoon watering. The latter spike follows a 50-minute interruption in pavement-watering and is only detected by one measurement. For the sidewalk, spikes are found on both watered days. The amplitude of these local maxima is in the order of 5°C on July 8<sup>th</sup> for all three zones. On July 22<sup>nd</sup>, the amplitude of the sidewalk maxima is reduced to about 2-3°C while temperatures are comparable. In the morning of July 22<sup>nd</sup>, small temperature spikes may occur for the sidewalk zone, but these are of low amplitude and are hard to distinguish.

Spikes just before afternoon watering begins occur for the pavement zones only. This is because the studied areas are not insolated simultaneously and pavement-watering began before the sidewalk was insolated, but not before the pavement zones were.
