Transmission electron microscopy study of precipitate morphology and precipitate overcoming processes in aluminum alloy 6056 T6

Marie Vivas, Philippe Lours, Christophe Levallant, Alain Couret, Marie-José Casanove, Armand Coujou

Marie Vivas, Philippe Lours, Christophe Levallant, Alain Couret, Marie-José Casanove, et al.. Transmission electron microscopy study of precipitate morphology and precipitate overcoming processes in aluminum alloy 6056 T6. *Materials Science and Engineering: A*, 1997, 234, pp.664-667. 10.1016/S0921-5093(97)00274-8 . hal-01701684

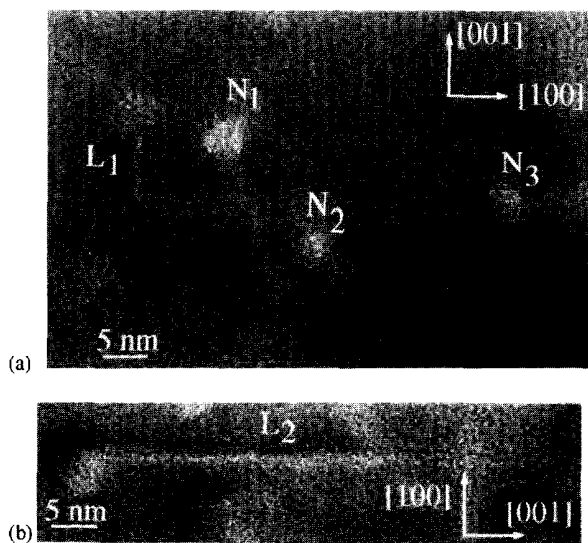
Fig. 1. HREM images of precipitates.

Fig. 1 shows two HREM pictures of different zones of the same specimen. Fig. 1(a) shows several precipitates: Some of them (noted N_1 , N_2 and N_3) have a roughly circular cross-section with a diameter of about 2–4 nm and another one (noted L_1) has a roughly rectangular cross-section lying along the [001] direction of the aluminum matrix. In Fig. 1(b), a longer precipitate L_2 (46 nm) is seen. It is elongated along the [001] direction of the aluminum matrix.

HREM pictures show precipitates with circular or rectangular cross-sections, with characteristic dimension in the range of 2–5 nm, and very elongated precipitates with the length in the range of 40–120 nm. Conventional transmission electron microscopy (TEM) pictures taken at an intermediate magnification show that the present observations reproduce well the precipitate population of the 6056 T6 aluminum alloy [5]. The number of elongated precipitates is smaller than that of circular and rectangular ones. These results are interpreted as follows (Fig. 4). Precipitates with circular (N_1) and rectangular (L_1) cross-sections are needles and laths seen edge on. Elongated precipitates (L_2) are laths with the length of the rectangular cross-section parallel to the electron beam. Laths (L_3) with the width of the rectangular cross-section parallel to the electron beam and needles (N_2) with length perpendicular to the electron beam can not be imaged because the quantity of matter crossed by the electron beam is not sufficient to provide a contrast on the HREM pictures especially as they are embedded in a rather thick matrix. These results are in agreement with those reporting the presence of needle-shaped β'' and lath-shaped L precipitates in a T6 peak aged aluminum alloy with a composition close to that of 6056 [6].

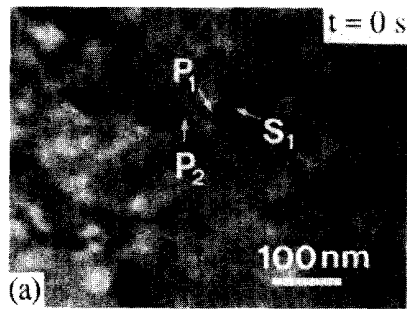
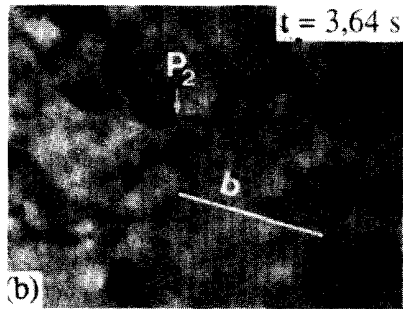
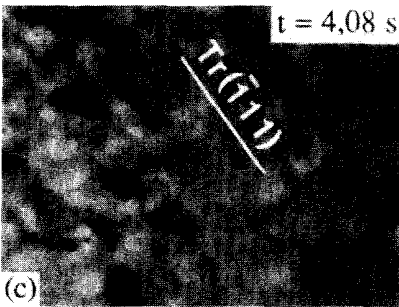
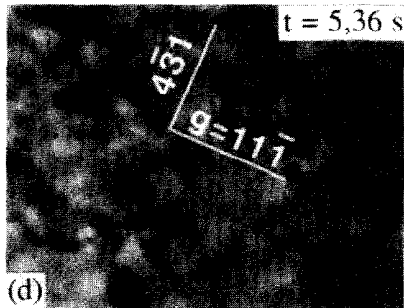
Fig. 2. Dynamic TEM in situ straining sequence showing the shearing of precipitates by a dislocation.

Fig. 2 shows a deformation sequence issued from a TEM in situ straining experiment performed at room temperature, which is representative of our observations. In Fig. 2(a), a dislocation is pinned at several precipitates. Under the effect of the applied stress, the dislocation is bowed out between precipitates. The con-

trast of the dislocation vanishes in the vicinity of the precipitates, owing to a compensation effect between the dislocation and the precipitate strain fields. This is particularly obvious in Fig. 3 taken under weak beam condition at larger magnification. Between Fig. 2(a) and (b), segment S_1 escapes from precipitate P_1 . Between Fig. 2(b) and (c), the dislocation escapes from all the precipitates on which it is pinned, glides quickly and stops at the position shown in Fig. 2(c). These two positions of the dislocation are seen on two successive frames of our video tape, indicating that all this movement occurs in less than 1/50 s. Between Fig. 2(c) and (d), only a part of the dislocation escapes from the precipitates on which it is pinned.

Fig. 2 shows thus that the dislocations overcome the precipitates by a shearing process. To calculate the critical force corresponding to this process it is necessary to measure the breaking angles corresponding to the critical position at which the obstacle breaks [5]. Fig. 3, showing a dislocation in critical position just before it shears a precipitate, displays an example of such a determination. T_1 and T_2 are tangent vectors to the dislocation line at points A and B, where the dislocation is in contact with the precipitate. β_1 and β_2 are the angles between the Burgers vector of the dislocations and T_1 and T_2 , respectively. Values are subsequently corrected taking into account both the specimen tilt angle and the inclination of the slip plane

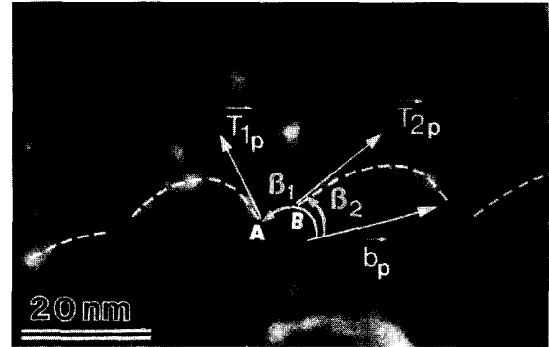
Fig. 3. Image of a dislocation in critical position just before it shears a precipitate. T_{1p} and T_{2p} are the projection in the glide plane of T_1 and T_2 .

For the case displayed on Fig. 3, for which $\beta_1 = 126^\circ$ and $\beta_2 = 46^\circ$, one has $T_1 = 0.36$ nN, $T_2 = 0.44$ nN and $F_m = 0.61$ nN. The average value of our measurement is 0.6 nN [5].
