Thermomechanical characterization of monolithic refractory castables

Keywords: refractory castable, mechanical behavior, microstructure, damage, creep, high temperature and experiments.

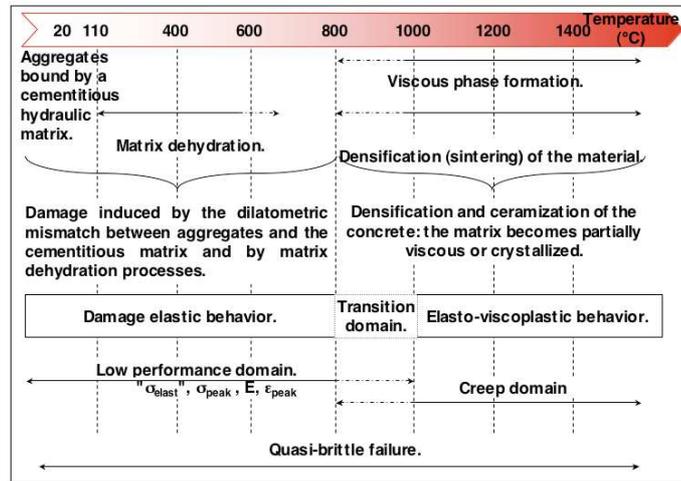
Fig. 1. Main evolutions of microstructures and thermomechanical behavior of monolithic castables at high temperature [1 to 7].

Optical and scanning electron microscopies allow linking microstructural mechanisms and thermomechanical behaviors in a wide temperature range. As indicated in figure 1, the behavior of monolithic castables remains a quasi-brittle one in a wide temperature range. Fiber reinforcement is one way to modify highly the monolithic castable behavior. That is why some results of studies conducted on short fiber reinforced refractory monolithic castables are considered too.

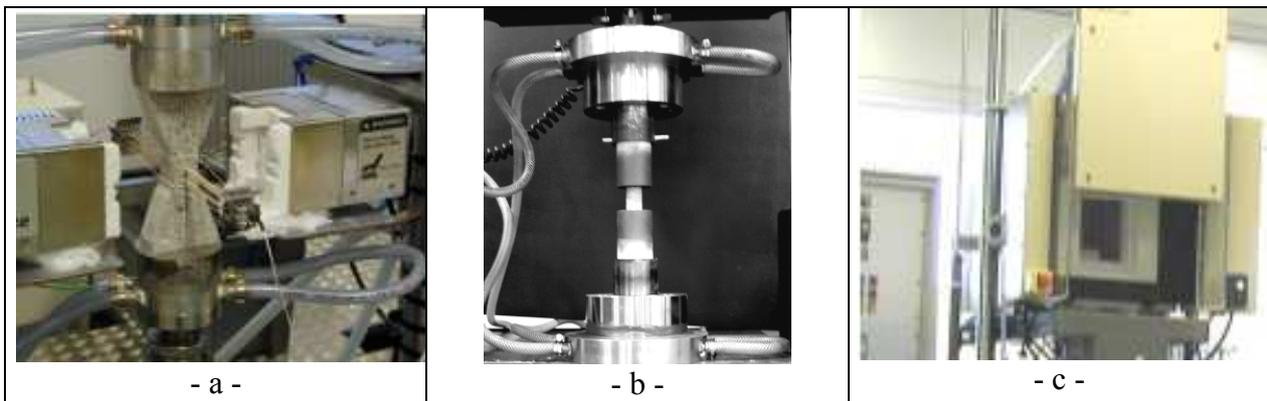
Fig. 2. Complementary test types for characterizing the thermomechanical behavior of monolithic castables: a) tension, b) compression, c) bending.

Figure 2 presents some complementary test types for characterizing the thermomechanical behavior of monolithic castables. Because of the asymmetric behavior in tension and in compression of such materials, performing both tension and compression tests is the most appropriate way. But such tests remain difficult to be carried on, particularly tension tests [1,8]. Performing three or four points bending tests is easier but one has to remember two main difficulties of bending tests: one deals with the difficulty to measure the bending deflection of the sample without introducing the behavior of loading contacts in the measurements [8], the other one deals with the difficulty to identify parameters of behaviors laws. This last point is due to the heterogeneous stress state of bending samples, to the asymmetric behavior of castables and to stress redistribution phenomena due to damage.

The different test types considered here (figures 2 and 3) have been described in details in previous papers [3,8,9,10,11].

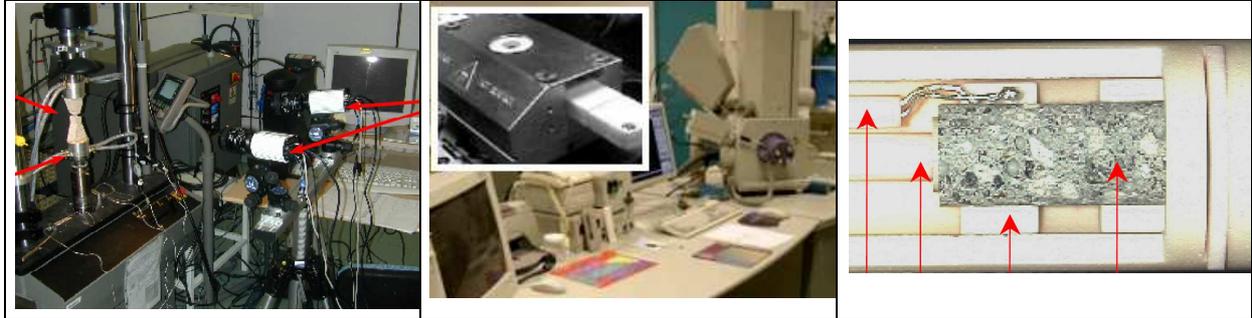
Fig. 3. Helpful test types to complete mechanical tests when studying monolithic castables: a) digital image correlation (DIC), b) in-situ high temperature environmental scanning microscopy (in-situ HT-ESEM), c) dilatometry.

Figure 3 gives some details on complementary test types that allow obtaining complementary results compared to mechanical test results. Considering a macroscopic scale, the DIC method is helpful to follow the development of damage processes at room temperature and during a tensile test. The diffuse damage step, the localization and the macrocracking initiation phenomena can be studied by considering strain or displacement fields. Links with the behavior curve can be done. At

a microscopic scale, scanning electron microscopy observations are really useful to understand and to establish relationships between microstructural and thermomechanical changes. This is particularly true when considering the results of in-situ high temperature environmental scanning microscopy observations. Furthermore, dilatometry remains a method that allows identifying the temperature levels and ranges where microstructural changes take place.

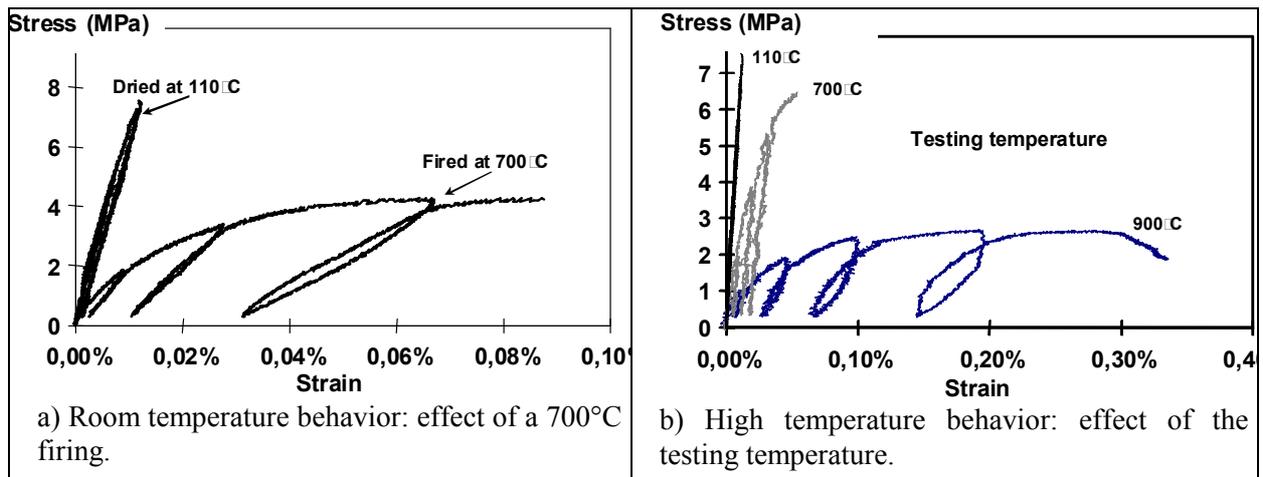
Fig. 4 : Mechanical behavior in tension of an andalusite based monolithic castable

For an andalusite based refractory concrete, examples of room temperature tensile test results are given in figure 4a. One have been performed on a 110°C dried sample whereas the other one was performed on a 700°C fired sample. As previously described [3,10], damage develops during the first thermal cycle at such a temperature, particularly during the cooling stage. An example of such a thermal damage is given in figure 5a. For the 110°C dried material, the tension behavior is elastic linear up to the maximum stress level. In the case of the 700°C fired material, the behavior curve is characterized by a very restricted linear domain at the test beginning. It moves then to a wide non-linear domain, due to diffuse damage processes. This example allows observing the deformation capacity of such a material when the mechanical damage develops as a superposition to the thermal damage, due to firing. More than the non-linearity of the envelope curve, loading/unloading loops confirm the development of a diffuse damage. Such phenomena have already been observed in other refractory castables [1,2,3]. Furthermore, an increase of the permanent strain levels is observed too. It can be related to the unclosing of damage that has been created by the tensile loading as observed in figure 5b. In that case, damage deals with numerous aggregate/concrete debondings that are connected by matrix microcracks. They appear as being more opened when their orientation is perpendicular to the tensile loading direction.

The high temperature tension behavior can now be considered (figure 4b). Up to 700°C, similarities are observed between room and high temperature behaviors. This must be related to the fact that similar damage mechanisms act in both cases. Considering now the 900°C, the behavior curve underlines the transition that occurs at this temperature level. Compared to the 700°C behavior curve, the maximum stress level strongly decreases whereas the material strain capacity is considerably increased. Viscoplasticity is now present in the mechanical behavior of the monolithic castable and is due to the formation of local liquid phases; particularly in silica fume rich areas.

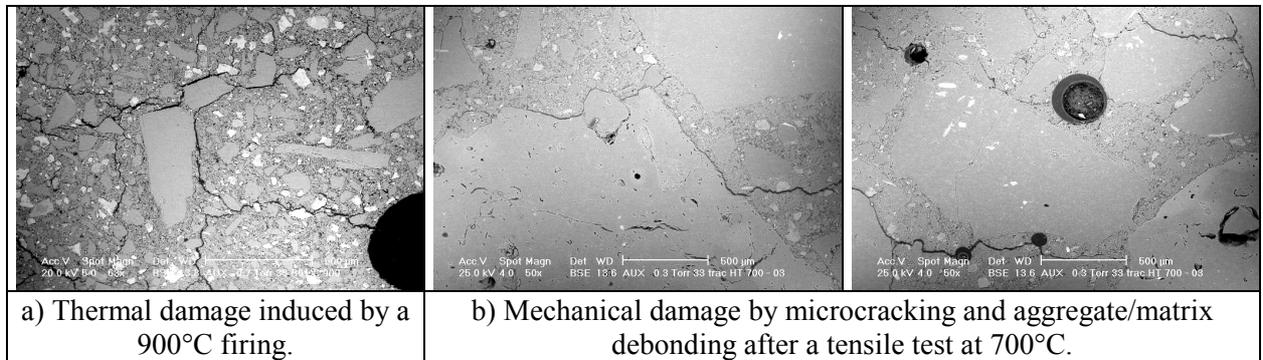
Fig. 5: Damage in an andalusite based monolithic castable.

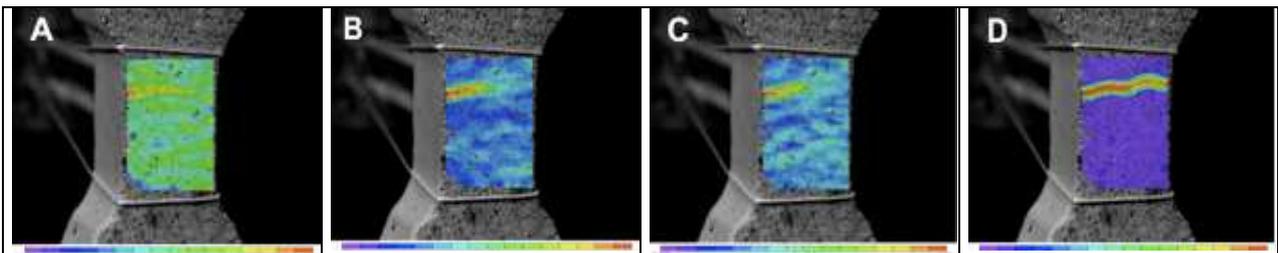
Fig. 6: Strain fields determined by DIC at different steps of a tensile test (andalusite based material)

Strain fields, obtained from performing the DIC method during a room temperature test on the 700°C fired andalusite based monolithic castable, allow observing the development of the strain localization phenomenon and of the progressive initiation of a macrocrack that will lead to the sample failure (figure 6) [3]. Such a method makes possible to detect strain localization sites earlier to classical strain measurements, for example with contact extensometers.

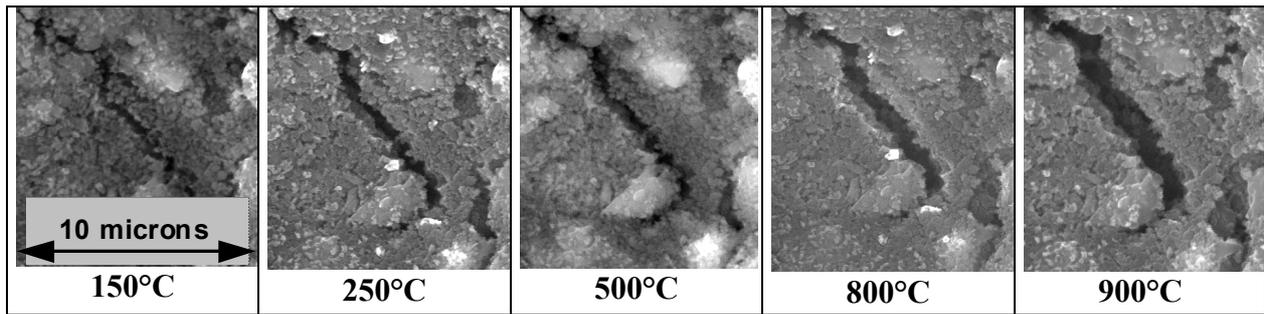
Fig.7: Evolutions of a microcrack during the first heating in an andalusite based monolithic castable (high temperature in-situ ESEM micrographs).

Results of in-situ ESEM observations are shown in figure 7. This micrograph sequence focuses on the evolutions of a microcrack that has appeared at 150°C and that can be related to dehydration processes. A progressive microcrack opening occurs when increasing the temperature with an increase of the opening amplitude in the 900-1000°C temperature range [3,10]. Such observations really contribute to obtain a better understanding of damage mechanisms that occur in monolithics during heat treatments and due to their heterogeneity.

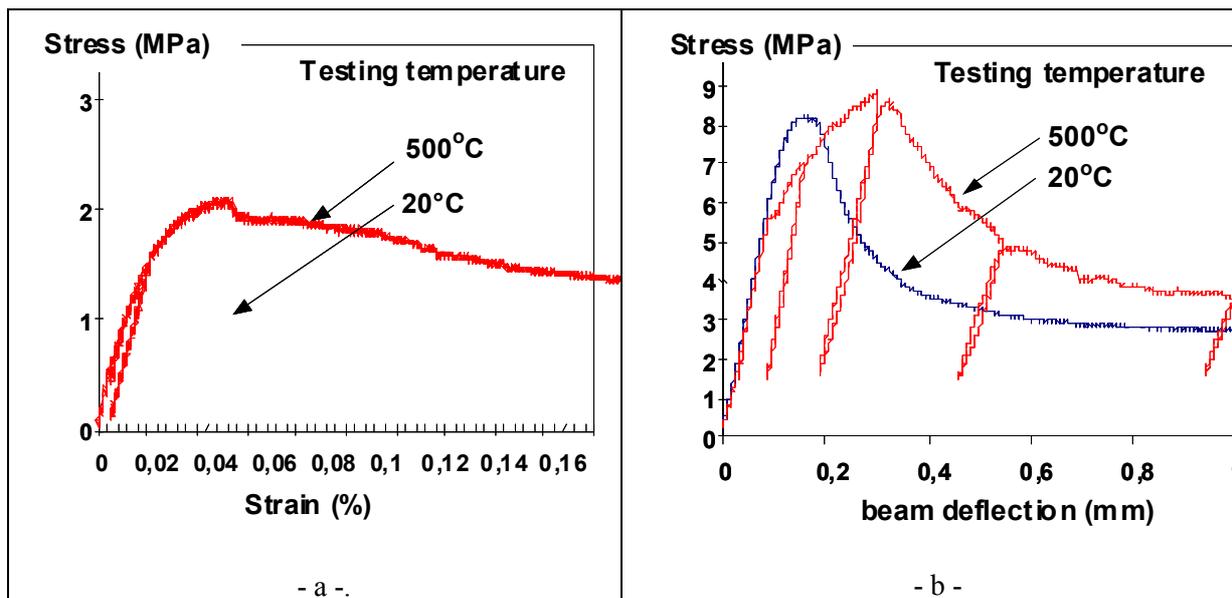
Fig. 8: Macroscopic behavior of a geopolymer based FRRC after a 500°C firing and as a function of the testing temperature (comparison between the room temperature and the 500°C behaviors): a) in the case of a direct tensile test, b) in the case of four points bending tests.

Figure 8a and figure 8b show behavior curves in tension and in four points bending of 500°C fired samples of a geopolymer based FRRC [12]. Both test types were performed at 20°C and at 500°C.

Before the peak stress, the non-linear part is due to the development of diffuse damage by microcracking processes. While the peak stress is exceeded, the behavior moves to a softening branch and finally to a constant load deformation domain. Such a mechanical behavior is characteristic of fiber reinforced concretes. In the case of direct tensile tests, the peak stress value decreases when considering the high temperature test results. Nevertheless, in the case of the 500°C testing temperature, the FRRC develops a high softening behavior and the decrease of the stress values in the post-peak domain is really low. Contrary to the tensile test where the maximum stress level decreases according to the testing temperature, in the case of the four points bending test, the peak stress remains stable for the different testing temperatures. As previously shown [10], this must be related to the characteristics of the tension softening curve. Indeed, the softening slopes are stronger at high temperature during tensile tests. The tension behavior can be highly modified by

increasing the strain capacity of the material. This can be done by extending the non-linear pre-peak domain where diffuse damage occurs. Another way consists in enhancing the load capacity of the material in the post peak domain.

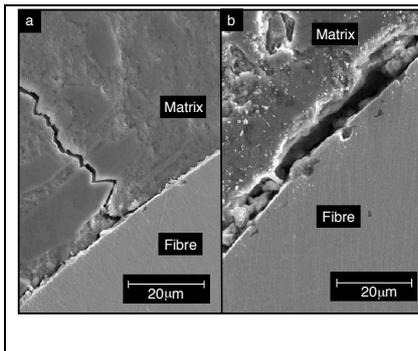
Fig. 9: Evolutions of fiber/refractory concrete interfaces of a geopolymer based refractory concrete reinforced with short metallic fibers, after a 500°C firing.

Adding metallic fibers creates another heterogeneity degree in these materials. A metallic component, characterized by a high expansion coefficient compared to ceramic ones, is included in the microstructure. When subjecting a FRRC to thermal cycles, specific internal stress fields are induced. They result in specific damage mechanisms at fiber/concrete interfaces [13]. As shown in figure 9, they deal with radial matrix microcracking and with fiber/concrete debonding. The presented micrographs have been obtained after subjecting the FRRC to a first thermal cycle. Heating again the FRRC will lead to a closing mechanism of fiber/concrete debondings and to the development of a fretting pressure at fiber/concrete interfaces

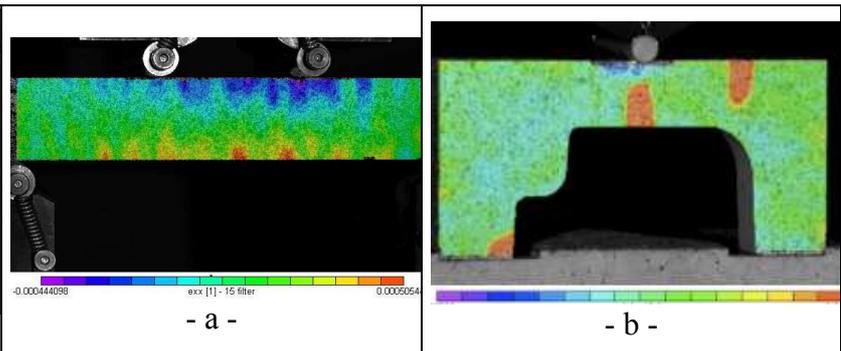
Fig. 10: Room temperature strain fields determined by DIC on a geopolymer based refractory concrete reinforced with short metallic fibers. Illustration of stress redistribution phenomena: a) on a four points bending sample, b) on a technological sample.

Figure 10 presents some results of DIC measurements performed on FRRC samples: a four points bending one (Fig.10a) and a technological one (Fig.10b) [11,12]. In both cases, strain fields illustrate the capacity of the reinforced material to develop stress redistribution phenomena. Even if one macrocrack is initiated, because of fiber bridging effects, the macrocrack propagation is stable and multicracking phenomena are able to develop.

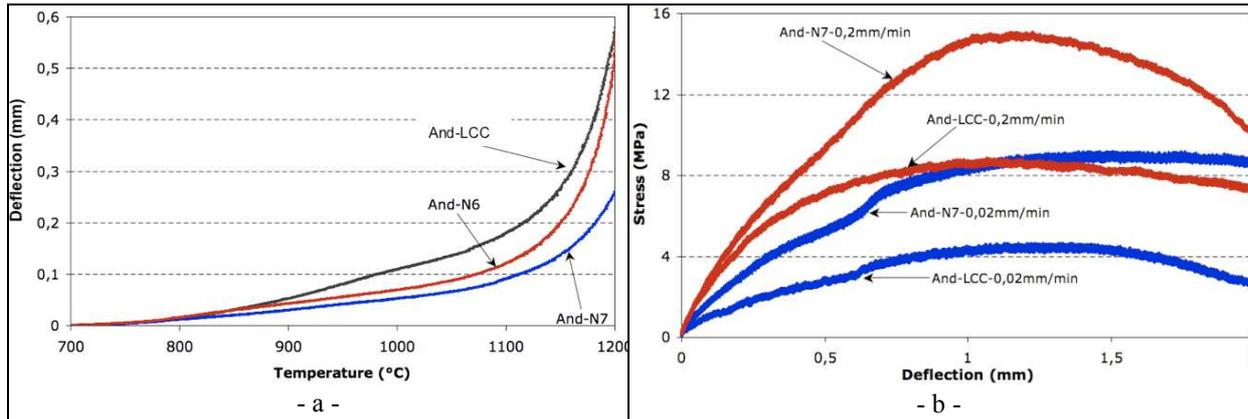
Fig. 11: Four points bending behaviors at high temperature:
 a) Non-isothermal creep test results for a non-reinforced And-LCC castable and for Nextel 720[®] (And-N7) and Nextel 610[®] (And-N6) reinforced grades, under a 2MPa stress level.
 b) Strain velocity effect at 900°C both for a non-reinforced And-LCC grade and for a Nextel 720[®] reinforced grade.

Results of non-isothermal creep tests in four points bending are given on Figure 11a. Tests have been performed under a 2MPa stress level in the 20°C to 1200°C temperature range for a non-reinforced andalusite based castable (And-LCC). Under such conditions, creep starts to occur between 750°C and 800°C. This indicates that local liquid phases starts to have effects at such temperature levels. Complementary four points bending tests have been performed to quantify the effects of modifying the strain rate on the high temperature behavior. Figure 11b gives some results obtained at 900°C for 0,2mm/min and 0,02mm/min crosshead speeds [14]. For the And-LCC a high strain rate sensitivity is observed. This confirms that a high viscoplasticity component characterizes its high temperature behavior.

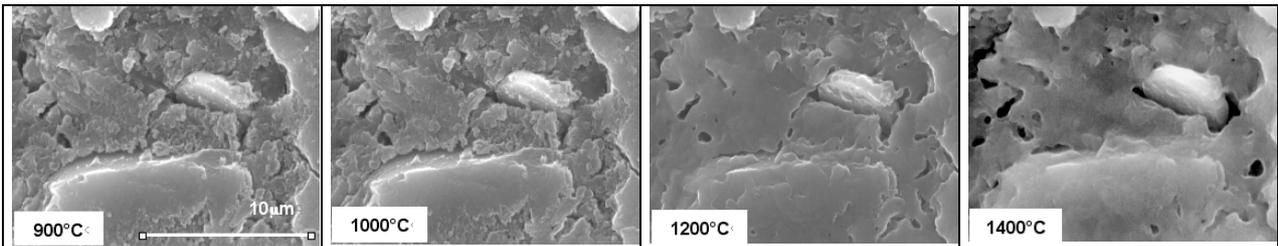
Fig. 12: High temperature microstructural evolutions during the first heating of an andalusite based monolithic castable (high temperature in-situ ESEM micrographs).

In-situ ESEM micrographs of figure 12 give some illustrations of drastic microstructural changes that take place in the 1000-1300°C temperature range for the considered And-LCC monolithic castable [3]. From 1100°C, a small amount of liquid phase appears and is accompanied by a progressive vanishing of the binder phase particles. The amount of liquid phase clearly increases at 1200°C where liquid phase bridges are observed. At 1400°C crack bridging is clearly observed. Such transformations have a large influence on the high temperature material behavior.

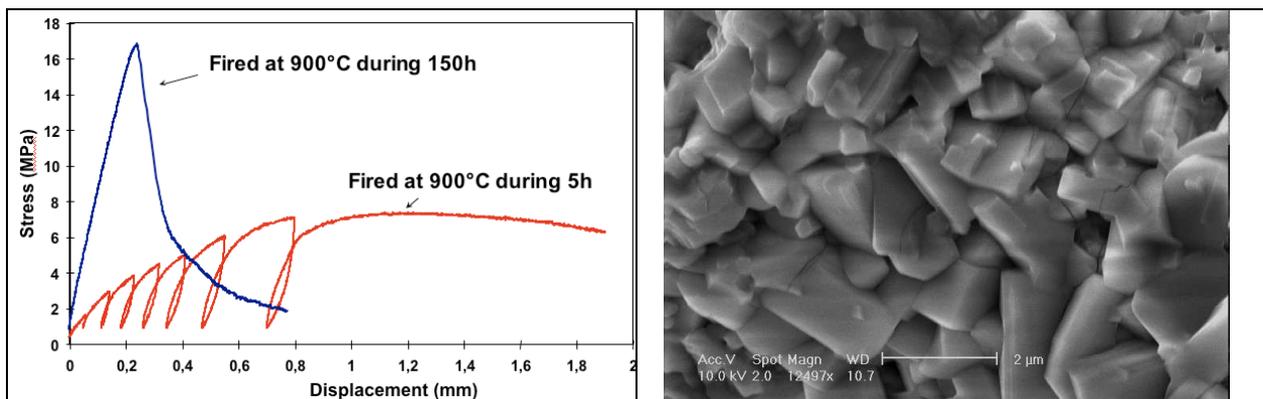
Fig. 13: Effect of the firing time on the four points bending behavior at high temperature:
 a) Four points behavior of a non-reinforced And-LCC castable at 900°C,
 b) Illustration of crystallization phenomena that occur for long firing times (here 150h) at 900°C.

At a given temperature, the thermomechanical behavior can highly depend on the monolithic thermal history. Figure 13 gives an example of such a dependence by comparing the 900°C four points bending behavior for two 900°C firing durations: 5 hours and 150 hours. After a long time firing (150h), the viscoplastic part of the behavior disappeared, due to crystallization phenomena

that have taken place in the castable binder phase. At this temperature level, located in the transition domain, the behavior has moved from a highly non-linear one to a quite linear one.

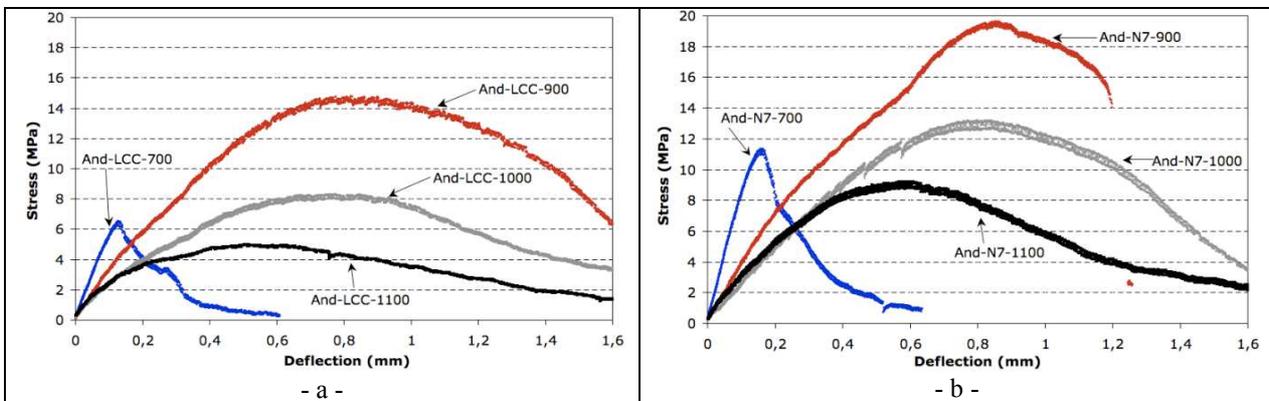
Fig. 14: Four points bending curves at various temperatures (700°C, 900°C, 1000°C and 1100°C): a) for a non-reinforced grade (And-LCC), b) for a Nextel 720[®] reinforced grade (And-N7).

Figures 14a and 14b show bending curves for a non-reinforced And-LCC monolithic castable and for a Nextel720[®] reinforced one (And-N7 grade) [15]. Tests have been performed at 700°C, 900°C, 1000°C and 1100°C. Reinforcing the And-LCC castable with Nextel720[®] fibers leads essentially to large modifications of the pre-peak behavior. They mainly deal with an increase of the width of the pre-peak linear domain and with an increase of the stress peak and deflection peak levels. Nextel720[®] fibers can also be considered as delaying diffuse damage phenomena and to limit the viscoplastic behavior of the concrete. Because of the high alumina content of Nextel720[®] fibers, the temperature range in which such phenomena can be obtained is largely increased. No benefit effect is observed in the post-peak domain. Due to the Nextel720[®] fiber reinforcement of the And-LCC refractory concrete, the increase of the peak stress levels for the 700°C, 900°C, 1000°C and 1100°C testing temperatures are respectively of 86,1%, 79%, 94,7% and 52,7%.

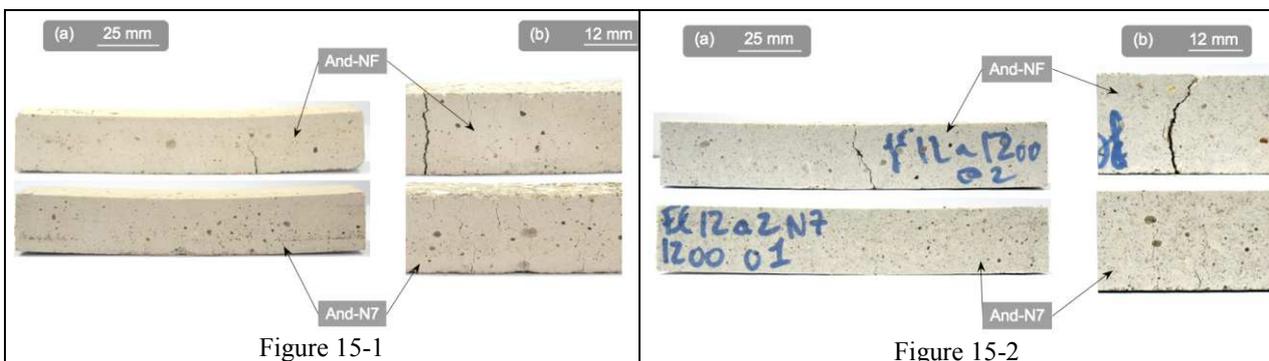
Fig. 15: Macroscopic views of four points bending samples (a: lateral faces, b: zoom on lower faces, in tension) for a non-reinforced grade (And-LCC) and for a Nextel 720[®] reinforced grade (And-N7):
 - after 900°C tests at a crosshead speed of 0,02mm/min,
 - after non-isothermal creep tests up to 1200°C.

On figure 15 are some macroscopic views of a non-reinforced and of a Nextel720[®] reinforced andalusite grades [15]. After testing at 900°C, results show that fibers allow delaying the initiation of a macrocrack and permit multicracking phenomena. Similar results are obtained at 1200°C concerning the effects of a fiber reinforcement. But even if macroscopic behaviors appear as being similar, deformation mechanisms and microscopic fiber effects are note the same.

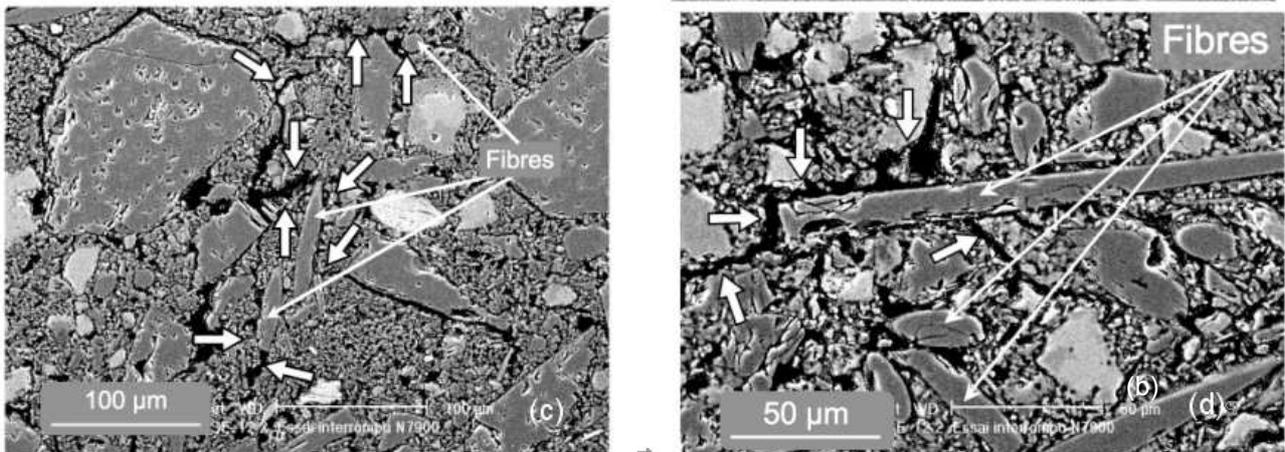
Fig. 16: Views of diffuse damage developed during a 900°C four points bending test (interrupted before the peak stress) in an andalusite based castable reinforced with 2_{vol.} % of Nextel720[®] fibers. White arrows indicate microcrack deviation phenomena, close to N7 fibers.

In the case of an interrupted 900°C bending test (figure 16), observing cross sections of the reinforced grade (And-N7) allows identifying damage which is made of a microcrack network highly influenced by the presence of fibers. Numerous microcrack deviations and bridging

configurations can be seen. Debonding phenomena have extensively taken place both at matrix/aggregate interfaces and at matrix/fiber interfaces too.

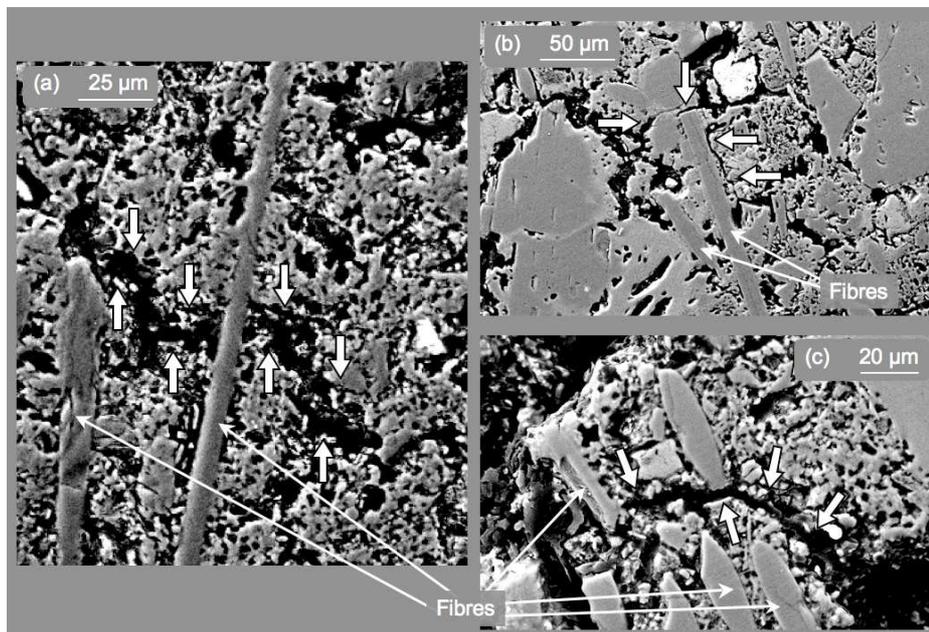
Fig. 17: Views of damage developed during a 1200°C four points bending test (interrupted at the peak stress) in an andalusite based castable reinforced with 2_{vol.} % of Nextel720[®] fibers. White arrows indicate microcrack deviation phenomena and cavitation limitation phenomena, close to N7 fibers.

In the case of an interrupted 1200°C bending test (figure 17), observing cross sections of the reinforced grade (And-N7) allows identifying damage which is made of a microcrack network and of a high density of cavities in the castable matrix [15]. Viscous deformation phenomena have played a major role in the deformation mechanisms of the castable and are highly influenced by the presence of fibers. Microcrack deviations, microcrack bridging configurations can be seen again. Such results allow obtaining a better understanding of fiber effects on the high temperature strain mechanisms of monolithic castables.
