Advances in the field of new smart thermal barrier coatings

Keywords: thermal barrier coatings, sol-gel, filling-up, topography.

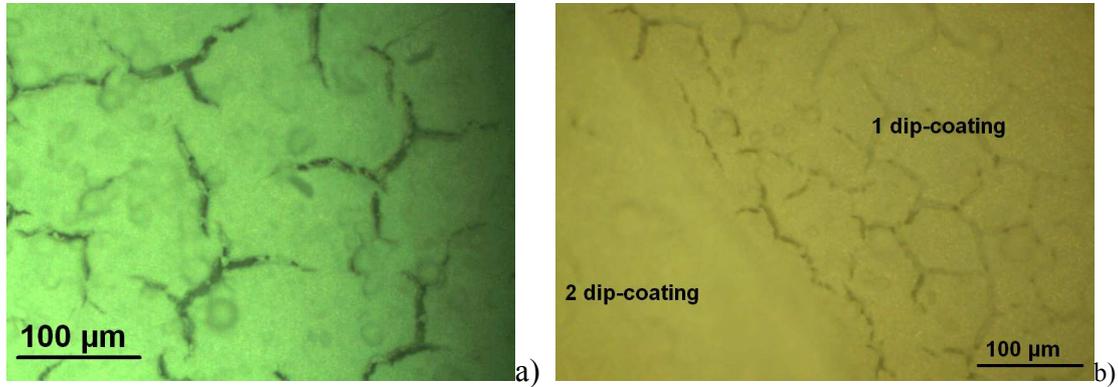
Figure 1. Microscopy of sample a) before filling-up b) after filling-up

Study of feasibility of damaged thermal barrier repair. Feasibility study is first performed on Hastelloy X substrates. Thermal barrier coating damage is generated by sample exposure during 1 hour at 1150°C, as seen on Figurea. After the filling-up with load sol at 40%wt with commercial

powder, sample is heated at 950°C during 2 hours. Figure 1b allows to compare different possibilities of repair between 1 and 2 coatings. Indeed one coating with load sol allows to fill in the cracks network. A second coating allows to recover more homogeneously the cracks network and to get smoother surface, close to a non-damaged coating surface.

From this simple metallographic analysis, it can be concluded that thermal barrier coating repair is possible using multiple successive dip coating. In the next section, a more specific investigation on surface topography, barrier microstructure and cyclic oxidation behaviour of repaired barrier is presented.

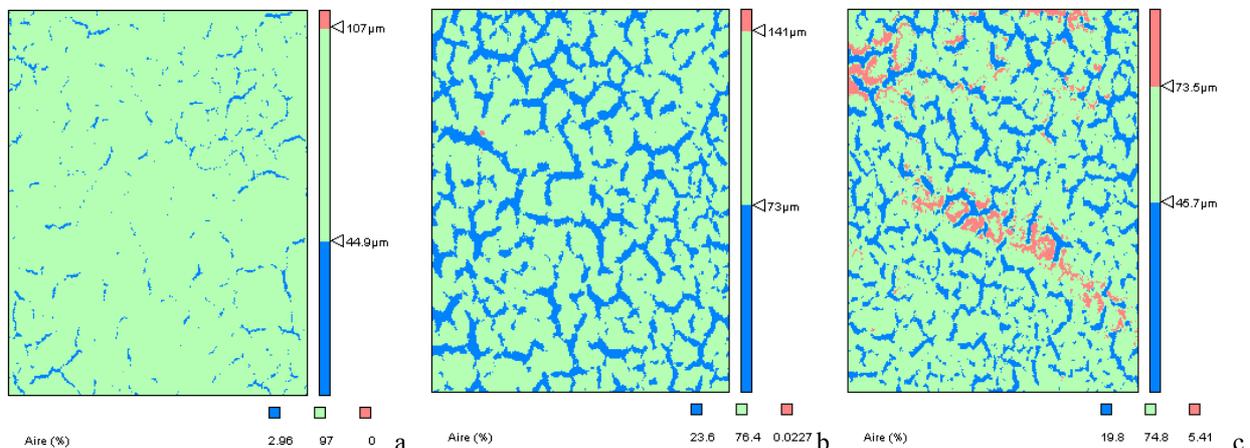
Figure 2. Surface topographies of sample a) before damage, b) after damage at 1150°C, c) after filling-up with 1 dip-coating with sol loaded at 40%wt

First, in figure 2a, is presented the surface topography of samples before the annealing damage and in figure 2b, the sample after the annealing damage, i.e. after a heat treatment at 1150°C. In these two cases, Δz values are similar (about 60-70µm), but micro-cracks network is larger and cracks are bigger for the damaged sample, because at high temperature micro-cracks network continues to progress. The Figure 2c shows the surface topography of sample D, i.e. sample after filling-up with 1 dip-coating with sol loaded at 40%wt of powder. We can remark that Δz is smaller, but there is an additional matter on surface. Then studies of surface topographies correlated to filling-up samples with 2 dip-coating have been performed.

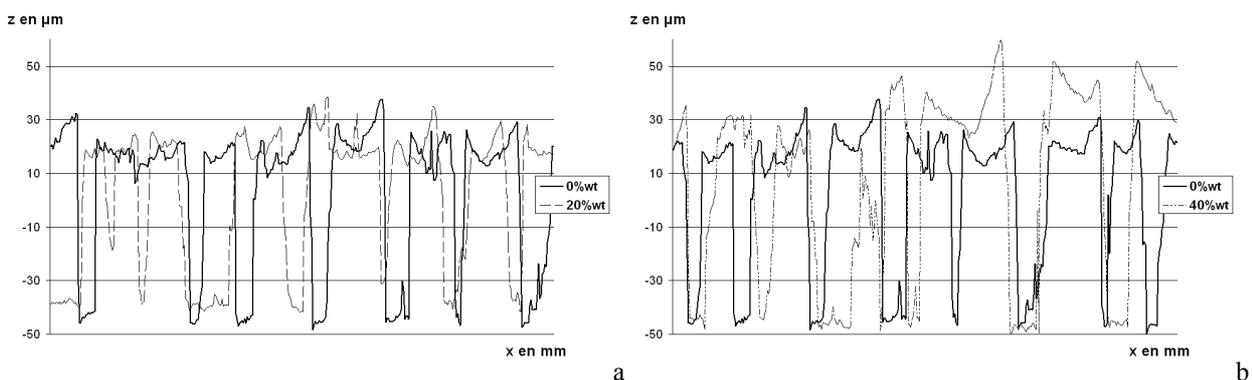
Figure 3. Comparison of Δz between a) A and B, b) A and C

The surface topography of sample covered by not loaded sol is similar to surface topography of sample before filling-up, i.e. directly after heat treated at 1150°C. On graph (see figure 3) corresponding to topographic measurements, Δz has been evaluated for different powder load conditions in the sol, then both samples (B et C) are compared with a filling-up sample with not loaded sol (A). We can see in figure 3a, the differences between sample A and sample B. We observe that the value of z parameter, representing surface top is quite the same in both cases, while the value of z representing the bottom of the cracks is larger for sample B. This shows that there is a best filling-up with the sol loaded at 20%wt, because it allows to reduce cracks depth. This powder content is the best compromise to optimize the filling-up conditions. Then, we can see in figure 3b the different surface topographies between sample A and sample C. First, the value of z, representing the bottom of the cracks is the same in the two cases, while the value of z corresponding to the upper surface is larger for sample C. This shows that a powder content of loaded sol of 40% of powder is too high. The sol cannot penetrate properly into the micro-cracks. Consequently, the matter only recovers the top of the surface. To confirm this point, figure 4 shows 3D surface topographies of samples filling-up with different powder contents in the sols. It allows to illustrate previous observations.

Main disadvantage of filling-up with sol loaded at 40%wt of powder is the additional matter brought from first dip-coating. Finally, for filling-up, powder loading at 20wt% allows to reach the best compromise corresponding to a satisfactory filling-up without recovering the surface. So, if necessary, the number of dip-coating can be increased to get a sample with a minimum Δz value.

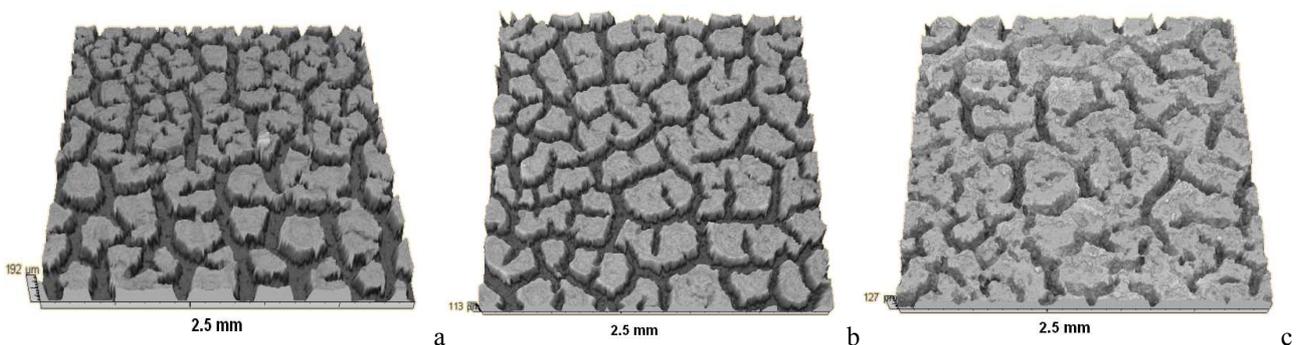
Figure 4. 3D surface topographies of sample after filling-up
a) sample A b) sample B c) sample C

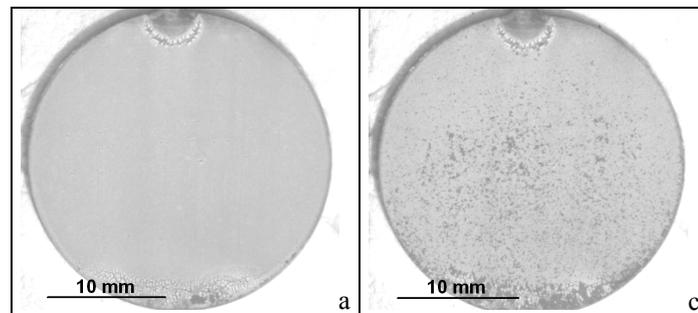
Figure 5. Cyclic oxidation test at 1150°C for sample without filling-up a) after 1 cycle, b) after 10 cycles

Our first objective has been to discriminate the suitable powder load content for the filling-up. First, cyclic oxidation tests have been performed on a sample with no filling-up, which is used as a reference for oxidation behavior. Figure 5 shows a damaged sol-gel thermal barrier. In opposition to damaged EB-PVD thermal barrier in which cyclic oxidation induces a non-progressive delamination of the major part of the coat, damaged sol-gel thermal barrier progressively proceeds through spallation. We can notice that the samples are more damaged on edges due to edge effects. For the filling-up of sample C containing a loaded sol at 40% of powder, damage mechanism is not the same. Indeed in figure 6, the topographies exhibit local buckling which can be due to two main reasons : first, the deposit is probably too loaded and we can see an important recovering of the upper surface of the sample. So, this impregnation is not suitable because the active matter is mainly located on the surface. The second reason is, of course, that 1150°C is probably a too high temperature to prevent from delamination, however, note that this choice has been done to accelerate the cracks network formation. According to Evans [8], observation of buckling suggests a poor adhesion between coating and substrate : cracks propagate at the interface and lead to delamination as a consequence of high stresses in the coating. Stresses resulting from the mismatch between thermal expansion coefficients of multilayers and alumina oxide. In our case, additional stresses may be due to the additional matter on the surface top during the filling-up.

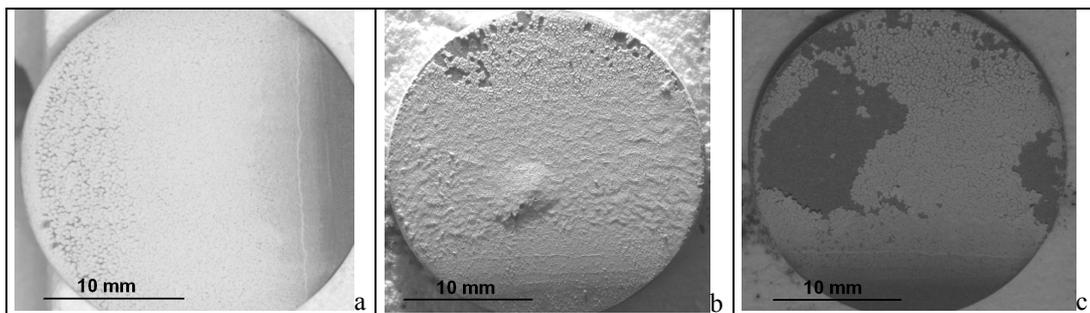
Figure 6. Cyclic oxidation test at 1100°C for filling-up sample with loaded sol of 40% of powder a) after 1 cycle, b) after 4 cycles, c) after 13 cycles
