Black anodic coatings for space applications: study of the process parameters, characteristics and mechanical properties

Abstract

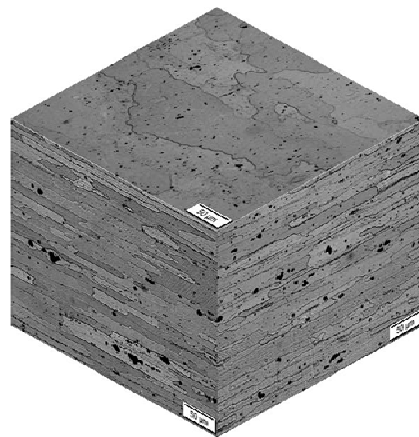
Fig. 1 shows the initial surface of the AA 7175T7351 just after degreasing and metallographic attack. The grains are long and aligned because of the thermo-mechanical (hot-rolling) processes.

Fig. 1 - Optical microscopic 3D views of the AA 7175T7351 substrate after degreasing and metallographic attack.

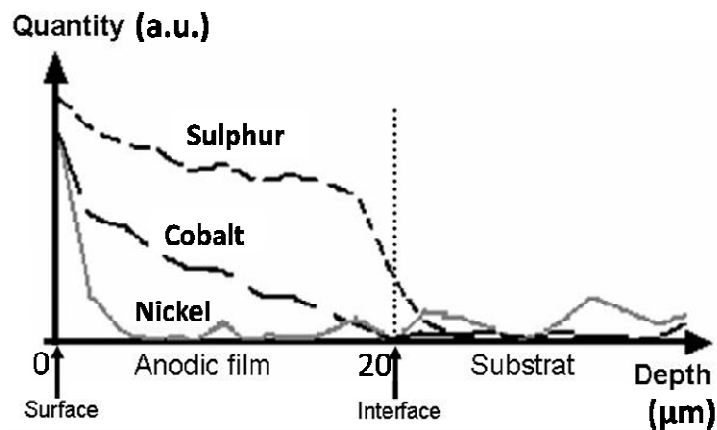
EDX analysis (Fig. 4) shows the distribution of cobalt, nickel and sulphur in the cross-section of the anodic film of a coloured and sealed sample.

Fig. 4 – EDX analysis of coloured and sealed anodic film on the AA 7175T7351.

Sulphur is present throughout the thickness of the anodic layer, but increases near the film surface and collapses at the interface with the aluminium alloy. The presence of the element sulphur has two possible origins: the first is the introduction of sulphates from the electrolyte ($[\text{H}_2\text{SO}_4] = 150\text{g/L}$) during anodizing; Thompson (Thompson, 1997) previously indicated that the anodic films obtained in sulphuric based electrolyte have a sulphur content around 12-17 weight%. The second possible origin is the introduction of sulphur during the colouring (second)

This second origin was confirmed by the presence of cobalt concentrated near the surface (Fig. 4), black CoS being formed in the upper part of the pores due to the immersion colouring process. Nickel was only detected at less than five microns under the surface. This element comes from the sealing bath but its penetration is limited by the presence of CoS particles in the upper part of the pores.

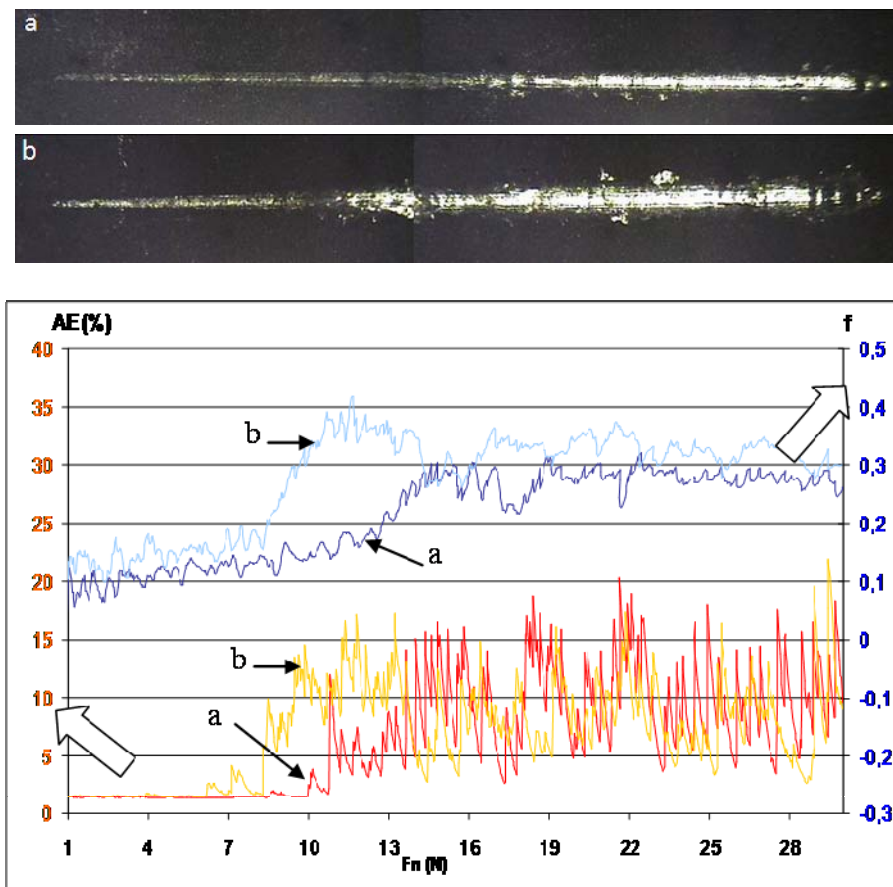
The scratch test is particularly suited for hard coatings on soft substrates (Darque-Ceretti and Felder, 2003; Bull and Berasetegui, 2006) and is used for instance to study the adhesion of various coatings including TiN (Holmberg et al., 2003) or CN (Liu et al., 2004). Increasing the normal load of the stylus, a critical load can be measured when failure of the coating occurs. Numerous failure modes for thin films are known (Bull, 1997) and models have been developed to calculate adhesion energy thanks to the critical load (Laugier, 1984; Rickerby, 1988). For the present black anodized 7175 T7351 aluminium alloy, scratch tests showed that the critical load was always lower after thermal cycling than before as shown for instance in Fig. 9 (11 and 8 N, before and after thermal cycling, respectively). This therefore provides quantitative confirmation that thermal cycling induces a decrease in the adhesion of the anodic film to the alloy.

Fig. 9 - Scratch test of a black anodic film followed by SEM (pictures at the top); Acoustic Emission (Left axis) and friction coefficient between stylus and sample (Right Axis) (a) before thermal cycling (b) after 10 thermal cycles (-140°C/+140°C)

Overall, the decrease of adhesion after thermal cycling can be explained by successive tensile and compressive loadings of the coating, mainly due to the difference in thermal expansion between the coating and the substrate. During warming, tensile stresses cause crack propagation across the film and during cooling, compressive stresses result in cracks along the interface, favouring flaking and even self-flaking as observed during four-point bending tests. This mechanism of flaking associated with cooling has already been observed on thermally grown oxides (Chandra et al., 2007; Baleix et al., 2002; Lours et al., 2008).
