Fatigue crack growth in thin notched woven glass composites under tensile loading. Part I: experimental

Matthieu Bizeul, Christophe Bouvet, Jean-Jacques Barrau, Rémy Cuenca

^a Université de Toulouse, INSA, UPS, Mines Albi, ISAE, Institut Clément Ader, 10 av. E. Belin F-31077 Toulouse, France

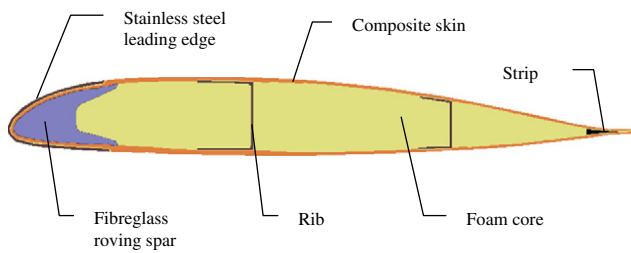
Fig. 1. Typical helicopter blade section.

For example, the skin of helicopter blades is often made of a few woven plies (Fig. 1). In these thin structure parts, a through-the-thickness crack might appear in service; such a crack could initiate and propagate from existing defects caused by manufacturing processes, stress concentration or low-energy impact [1]. In order to anticipate such a scenario which could slightly modify the rotor dynamic behaviour, it seems useful to study the crack propagation in these skins in fatigue. Blade loads are mainly defined by centrifugal forces and flap and drag bending moments due to cyclic aerodynamic loads. These structures are therefore subjected to fatigue stresses where the primary load is tension due to centrifugal effects.

In analyzing a typical blade section (Fig. 1), it can be stated that the skin has to follow the longitudinal strain of the spar mainly loaded by centrifugal effect. This remark leads to the development of a technological fatigue test specimen (Fig. 2) having a width 50 mm. A severe notch is performed on one edge with a 0.2 mm diameter diamond thread to limit the through-the-thickness crack initiation duration. On the other edge, a strip of T300/914 unidirectional carbon fibres having a stacking sequence of $[0]_2$ is placed to get closer to the real loading conditions and plays the role of spar. It also reduces the likelihood of global inelastic strains occurring

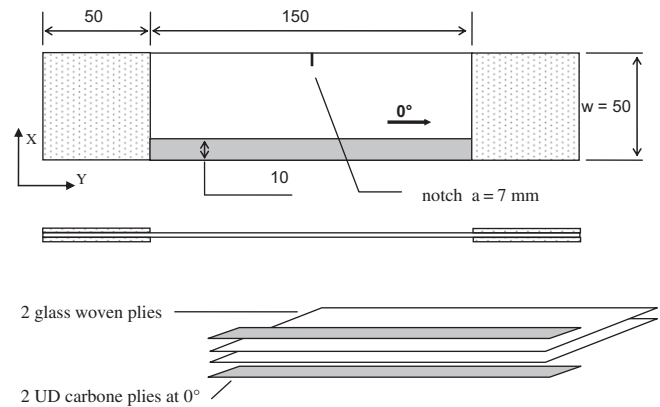
Fig. 2. Fatigue specimen test characteristics.

under fatigue loading. The fatigue tests are conducted under strain control at room temperature (about 20°C) on a 100 kN closed-loop servo-hydraulic Instron tension machine, with an extensometer placed on the carbon strip, at a frequency of 20 Hz. The imposed strain levels are $\epsilon_{\min} = 10^{-3}$ and $\epsilon_{\max} = 3 \times 10^{-3}$. This maximum fatigue strain level corresponds to the infinite life asymptote in $S-N$ curve [7–11] and is widely used as design fatigue strain for structures made of glass plies. The specimen is cooled down to room temperature by a fan and its temperature is saved (the thermocouple sensor is located 10 mm under the notch). Furthermore, no increase in temperature was recorded.

In order to study the crack growth in a larger domain and to reduce the mean initiation duration, the geometric characteristics of the specimen have been modified (Fig. 2): The ratio a/w has been increased in order to limit the initiation duration and the specimen width is larger.

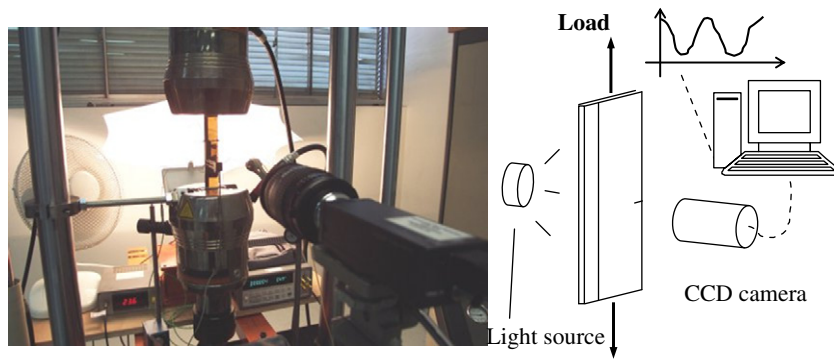
Fig. 3. General and schematic views of the experiment setup.

The crack growth is monitored with the help of a CCD camera (Fig. 3). The different devices are driven with the help of a Labview program. Due to the relative transparency of the glass fibres reinforced plastics, the propagation of a white damage zone by back-illumination is observed. This kind of phenomenon was also described by [5,9]. In a previous work [12], this damage zone was identified as a through-the-thickness crack all along by microscopic investigations. Since the beginning of the crack growth, this damage zone has presented tows breakage even in the tip. This damage zone also contains transverse yarn cracking and meta-delaminations [13].

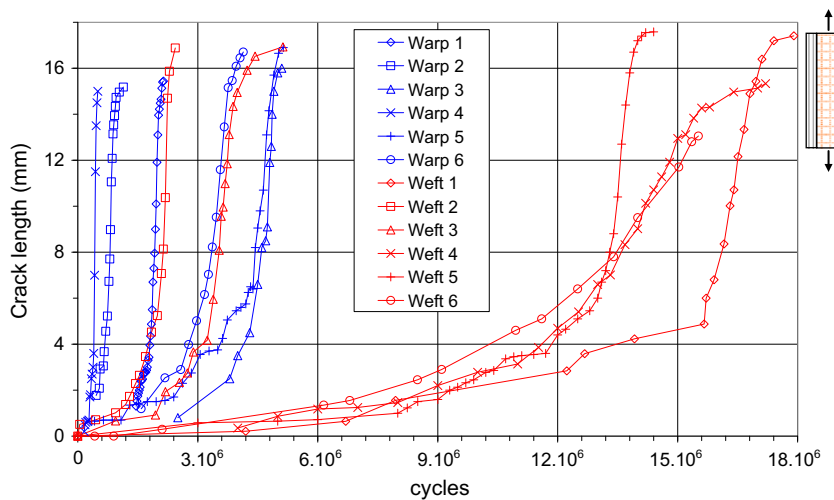
Fig. 4. Fatigue crack growth in warp $[0]_2$ (a) and weft $[90]_2$ (b) laminates in samples of 30 mm width.

Earlier experiments [12] showed a different behaviour between warp and weft directions of the studied balanced woven ply under static loading as well as in fatigue, especially in crack propagation tests in samples of 30 mm width (Fig. 4). The main fact underlined by these results is the large dispersion between samples in both cases, either for the laminates with warp tows coinciding with load direction, or for the weft ones. It can be noted on this figure, the six warp and weft samples are exactly the same, only the initial crack tip position relative to the yarns should be different (this manufacturing parameter is difficult to control). These differences have been connected to the crack initiation time [12] which depends on the solicitation direction and on the initial crack tip position relative to the yarns position. In fact, more the initiation time is long, more the crack growth decreases because of the extended of the damage zone. This fact may be due to the small number of plies [14] and perhaps because the experiments are led in strain controlled. Moreover, the crack growth initiation duration in warp laminates was lower than in weft laminates. As the weft direction undulation is more severe, the matrix damage in this direction appears sooner. So, the initiation phase lasts more and the crack growth rate decreases because of the extended damage zone.

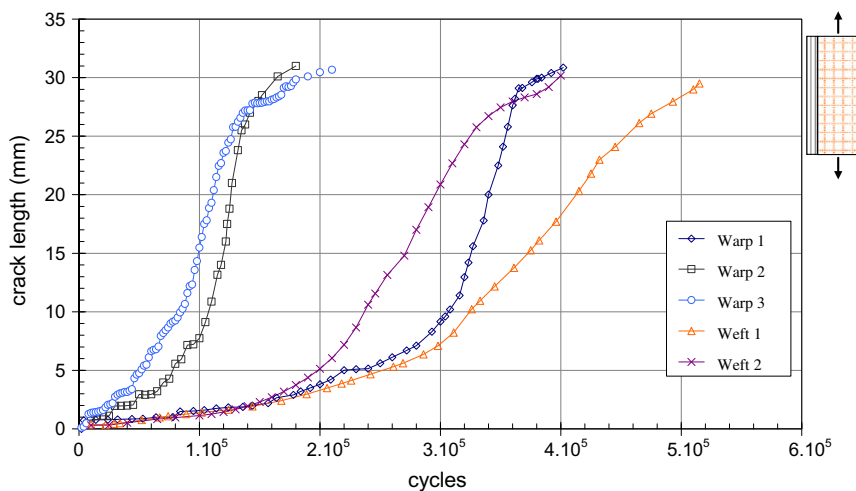
Fig. 5. Fatigue crack growth in warp $[0]_2$ and weft $[90]_2$ laminates in samples of 50 mm width.

The crack growth in 50 mm width samples exhibits qualitative similarity (Fig. 5). It can be noted, on this figure, the three warp and the two weft samples are exactly the same, only the initial crack

position relative to the yarns should be different. Three stages are easily noticed: the first two are commonly observed [3,4]: the “initiation” phase where crack length does not exceed 3 mm and the “stable propagation” phase. The last one corresponds to the crack arrest due to the carbon strip influence.

Actually, two main observations are noteworthy. First, the different behaviour between warp and weft directions in crack propagation does not subsist, as the crack growths are similar and even

overlap for two warp and weft samples. The second point is about the crack propagation test duration. This period of time is divided by around 10 compared to the previous geometry where the specimens' width was equal to 30 mm. Moreover, as the crack initiation duration does not vary as much as the one corresponding to 30 mm width specimens, the crack growth rates are of the same order (Table 1). Table 1 recalls the extreme results of crack growth in 30 mm width samples of the previous experimental campaign and specifies key results of crack growth in the 50 mm width samples. The initiation duration is determined owing to the typical decrease of crack growth rate at the beginning of the propagation (Fig. 6). This phenomenon is associated with the microstructure influence on crack growth [3,4]. Bizeul et al. [12] stated that crack growth evolves regularly when three to five tows are broken. In other words, as the yarn width is equal to 0.5 mm, microstructure influence seems to exist when the crack length is less than 3 mm.

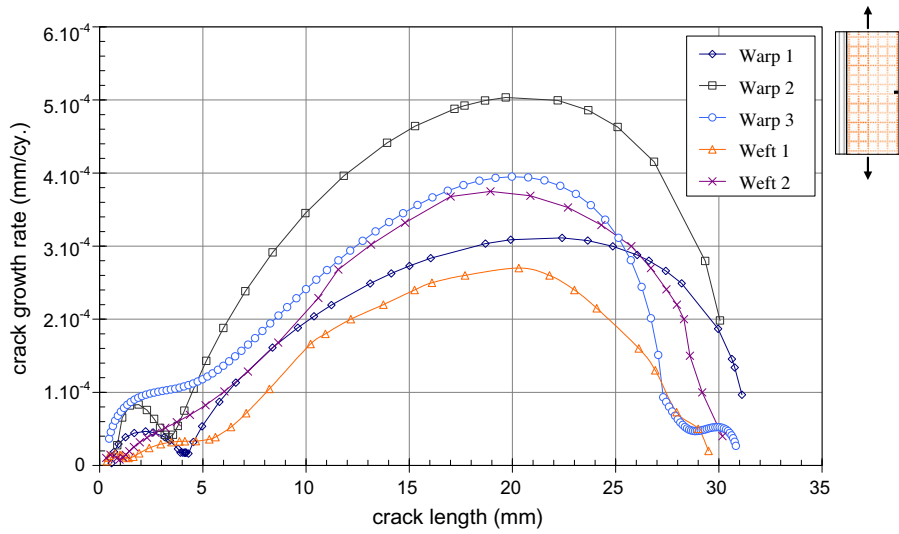
Fig. 6. Crack growth rates versus crack length in warp $[0]_2$ and weft $[90]_2$ laminates in samples of 50 mm width.

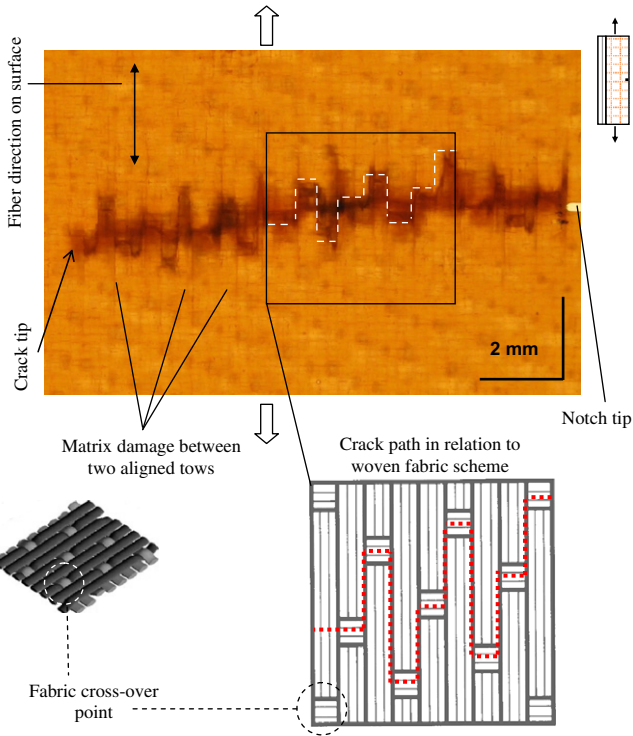
Fig. 7. Crack path in relation to woven fabric scheme in $[0]_2$ notched laminate loaded in fatigue.

The microstructure of the studied woven ply acts not only on the initiation duration but also on the crack path. It is interesting to examine the local crack path in relation to the woven scheme (Fig. 7). The warp side of the woven ply is observed on the photograph; the warp tows are then visible on the surface and lined up with the fatigue tensile load. The theoretical basic 8-harness satin weave pattern is shown next to the photograph. The crack path is overall straight but in focusing on the local crack path, it can be seen that the cross-over points of the woven plies are ideal places for fibre tow failure. The photograph also highlights that thin longitudinal matrix cracks are localized in the interstice between two consecutive tows and their lengths are limited by cross-over points.

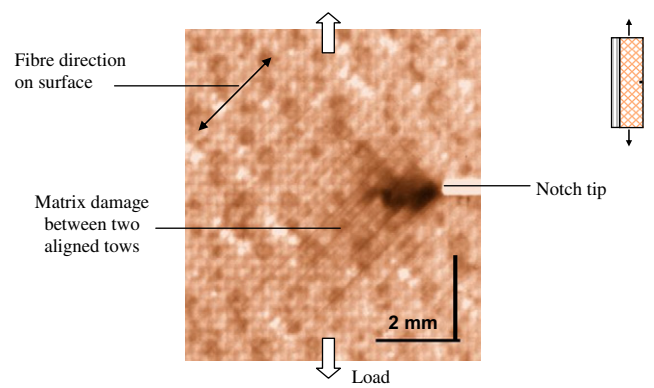
Fig. 8. Crack length after 5×10^6 cycles in $[45]_2$ notched laminate loaded in fatigue.

Usually, helicopter blade skins are mostly made of $\pm 45^\circ$ woven plies in order to ensure the torsional stiffness of the profile (Fig. 1). Thus, fatigue tests at controlled strain ratio are carried out on specific specimens (Fig. 2) with carbon strip on one edge in order to represent the blade spar and $\pm 45^\circ$ woven laminate elsewhere. The propagation of a white damage zone is monitored in particular test configurations detailed below. With the initial specimen (Fig. 2), the crack growth is very slow and even stops even in the case when the notch length is increased. A damage zone appears in the tip of the notch in a V-form (Fig. 8) and stays stationary. Owing to back-illumination, this zone appears in dark on the

photograph taken at the maximum fatigue strain level (5×10^6 cycles), which results in a through-the-thickness crack of less than 2 mm. It should be pointed out that matrix damage extends over the crack tip in the form of thin and straight matrix cracks between aligned tows.

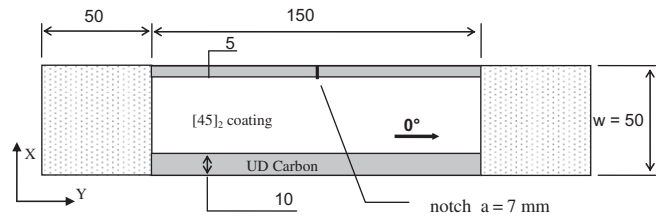
Fig. 9. Fatigue specimen test characteristics modified for $[45]_2$ laminates.

The accumulation of matrix damage specific to $[\pm 45]_n$ laminates [18], tends to limit the stress concentration in the vicinity of the crack tip and basically the crack growth. Hence, changes are made on the specific specimen to improve the initiation and the propagation of a through-the-thickness crack in $[45]_2$ laminates while maintaining the fatigue strain levels previously fixed. In order to get closer to the complex service loading conditions of blade skins, the trailing edge strip influence has been taken into account (Fig. 1). This rear strip has many functions such as closing the torsion box of the profile, dragging a part of centrifugal load and adding trailing flexural stiffness to the blade. The fibres of this structural part are then aligned with the blade longitudinal axis like leading edge spar fibres. Yet, the initial specific specimen lacks longitudinal stiffness on the notch side and the main part of the tensile load goes on the other side in the carbon strip. A small part of the load is thus drained in the notch tip, slowing even the crack initiation. In order to observe a fatigue crack growth in these bias woven laminates, the technological specimen has been modified accordingly (Fig. 9). A similar UD carbon strip has been placed on the other edge of the sample, acting as a trailing edge spar. After polymerization and cutting a notch with a diamond thread, whose length is narrowly greater than the strip width.

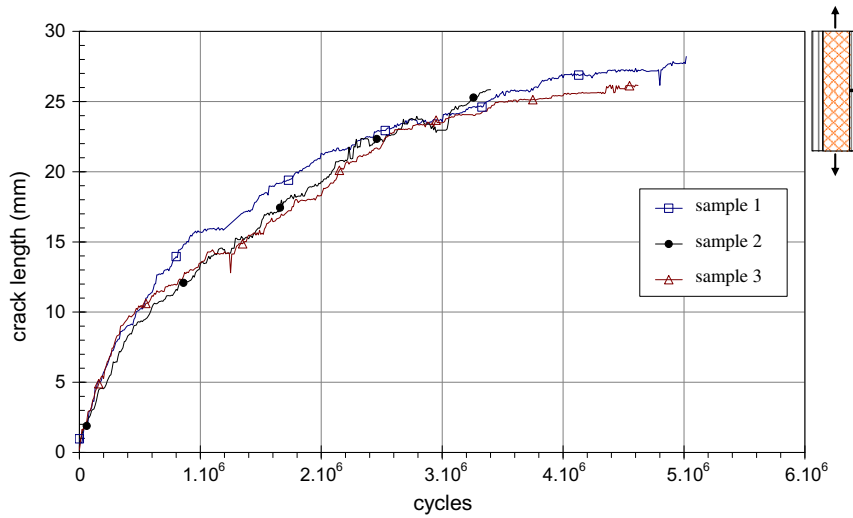
Fig. 10. Fatigue crack growth in $[45]_2$ laminates with two carbon strips.

The crack initiation is instantaneous with such a test configuration (Fig. 10), however the crack growth tends to slow down gradually. The fatigue tests show very similar results and have a duration of about 5×10^6 cycles. This may be attributed to the fact that in the beginning of the test, crack growth rate is high, the crack initiation duration remains thus low and relatively close to a specimen to another. Unlike oriented laminates, the initiation duration has negligible influence on crack growth.

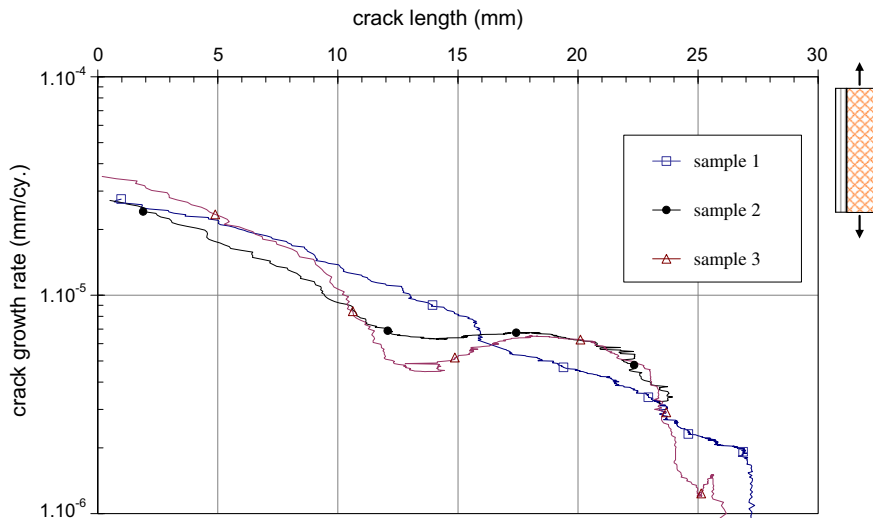
Fig. 11. Fatigue crack growth rate in $[45]_2$ laminates with two carbon strips.

After measuring the crack growth in fatigue, the crack growth rate is deduced and plotted versus crack growth for each sample (Fig. 11). In the beginning of the crack growth, its rate decreases and then reaches a steady state when crack length is between 10 and 20 mm. Finally, the crack growth tends to "stop" when the crack length measures 25 mm, corresponding to a distance of 8 mm from the carbon strip acting as a leading edge spar. Thus, inelastic strains are likely to occur in fatigue in $[45]_2$ laminates as reported by [8,19], especially in the vicinity of the crack tip. This phenomenon is due to the damage of the resin under shear solicitations and to the fibres rotations. As the fatigue tests are led in a strain control environment, the stress concentration in front of the crack is reduced with the appearance and development of inelastic strains. It seems that there is a threshold below which propagation cannot occur, as underlined by the fatigue tests on specimens without UD reinforcement corresponding to blade rear strip.

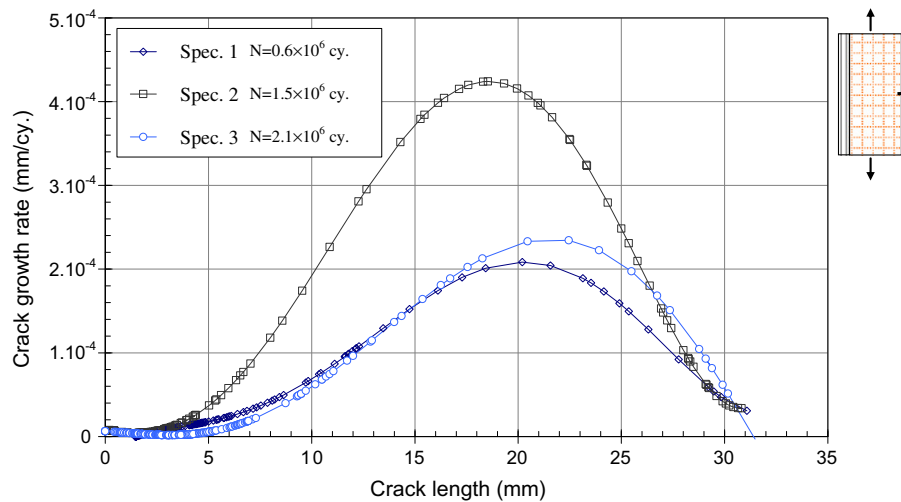
Fig. 13. Fatigue crack growth rate in [45; 0; 45] laminates.

The crack growth in “quasi-isotropic” laminates follows the same three stages of the warp laminates i.e., the crack growth is very slow when the crack length remains less than 3 mm, then the crack growth rate increases until it reaches a maximum corresponding to a crack length of 20 mm and eventually decreases quickly (Fig. 13). The maximum crack growth rate levels are very close to those recorded in warp laminates. Nevertheless, it should be noted that the first stage of crack growth, usually called ‘initiation phase’, lasts a long time in comparison with the warp laminates one. The test duration is between 0.6×10^6 and 2.1×10^6 cycles and the ‘initiation phase’ corresponds to 70% of this period, while the test duration for warp laminates is four times lower and the first related stage is equal to 40% of this time.

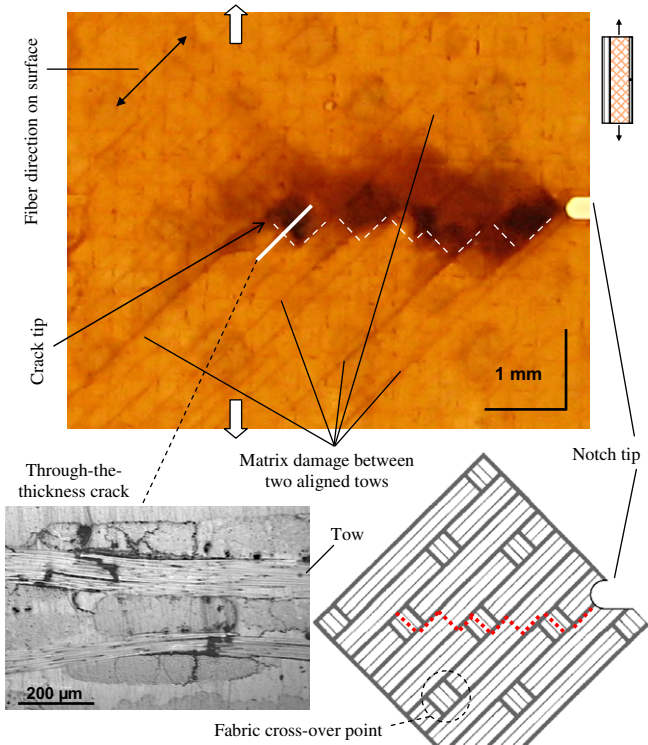
Fig. 12. Crack path in relation to woven fabric scheme in [45]₂ notched laminate loaded in fatigue.

The visible white damage zone which propagates corresponds to a through-the-thickness crack (Fig. 12). Tow breakage are easy to recognize in microscopic investigations if observations are carried out perpendicular to the fibres. Tow fracture mainly appear in the fibre undulation areas. Typical damages in woven ply also exist i.e., meta-delaminations, transverse microcracks, etc.

Again, optical analysis reveals that the local crack path in $[45]_2$ laminates is influenced by the weave pattern and the tow width (Fig. 12). As observed by Woo et al. [16], the through-the-thickness crack propagates perpendicular to yarn fibres and thus shifts alternately between $\pm 45^\circ$ directions. The entire crack path remains overall straight and perpendicular to the load direction. In addition,

it is noticeable that the crack extends according to the fibre tow width and the tows always seem to break completely.

Once more the crack path has to go through the nearest cross-over points of the woven plies; yarn failures mainly occur in these crimp areas. Finally, it is interesting to note that matrix damage surround the crack path. These consist especially of thin and long matrix cracks parallel to the fibres. It seems appropriate to associate these observations with the matrix degradation in the gap that exists between two consecutive yarns. Only the thin cracks parallel to the fibres closest to the surface are visible. They form a halo around the crack which extends over a length around 2–3 mm in the direction of fibres on both sides. Damage in V-form is visible in the crack tip.
