Issam Tawk, Julien Aubry, Pablo Navarro, Jean-François Ferrero, Steven Marguet, et al.. Study of impact on helicopter blade. *Engineering Failure Analysis*, 2012, 24, pp.38-45. 10.1016/j.engfailanal.2012.03.005 . hal-01853068

Study of impact on helicopter blade

ABSTRACT

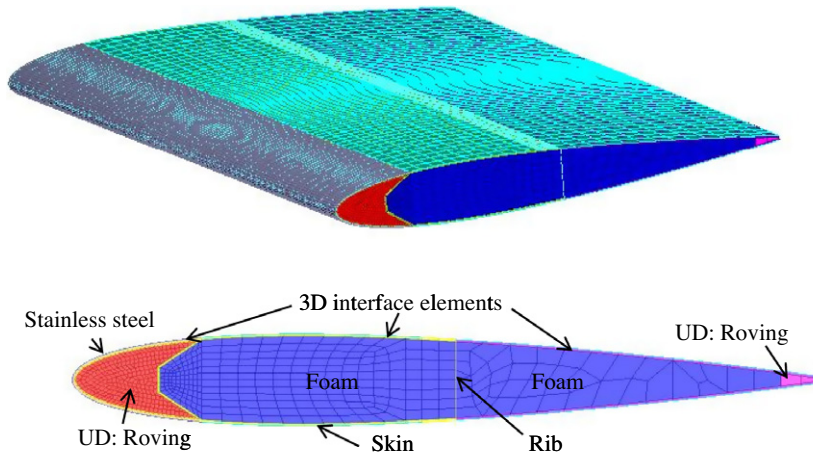
Fig. 8. Specimen mesh.

The numerical model (see Fig. 8) was made up of 104,810 nodes, consisting of 53,408 solid elements, 8819 shell elements and 20,509 bar elements. The length of the blade section with a grid was 280 mm. The definition of different interfaces allows the automatic definition of contacts.

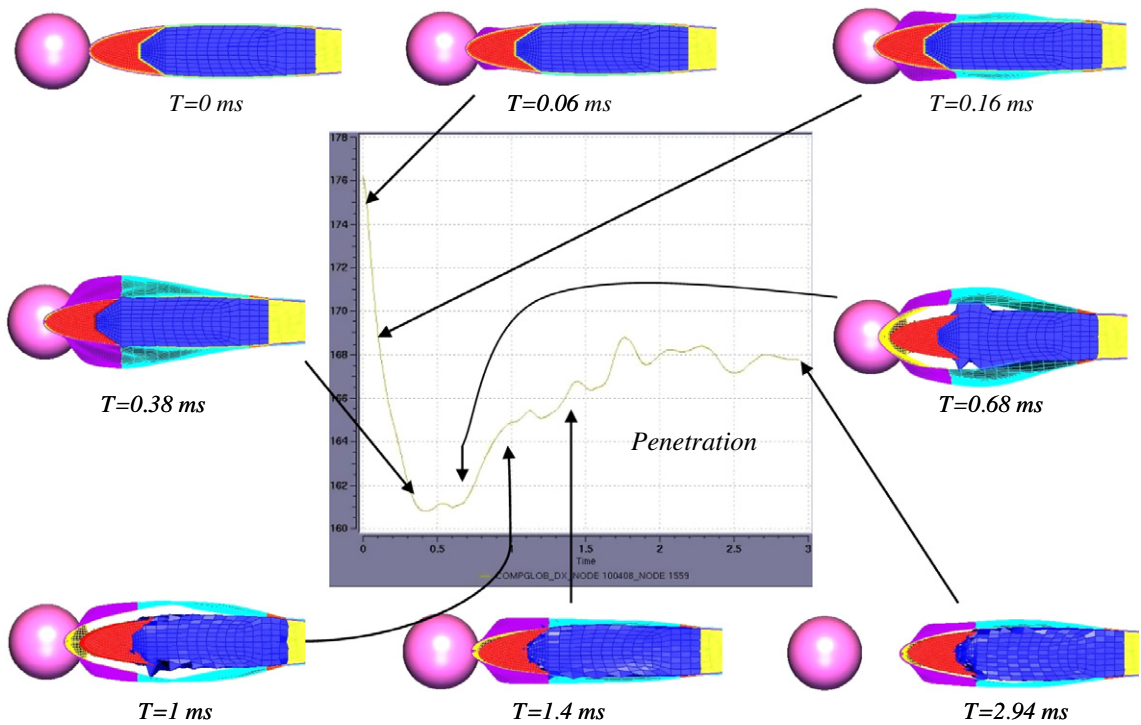
Fig. 9. Behaviour of the blade during the impact.

The analysis of results obtained from the model allows us to understand the kinematics of the impact. Fig. 9 shows the behaviour of the blade section during the impact for an impact energy of 550 J. The penetration of the front edge at the impact point is on the curve as a function of time.

The image at $t = 0.06$ ms shows the generation of the wave on the front edge caused by the contact with the ball. The amplitude of this wave increased and the wave propagated in the direction of the impact and towards the two ends of

the blade. This behaviour involved a swelling of the structure and led to delamination at the skin-roving and skin-foam interfaces.

On the graph, which gives the penetration of the front edge as a function of time, four zones can be observed:

- A first zone of load increasing during 0.35 ms, which corresponded to the local phase of damage. The penetration of the ball involved the rupture of the resin, the plastic deformation of the stainless steel protection, and then delamination between the skin and the roving which generated a swelling of the section. The maximum swelling was reached at approximately 0.38 ms.
- A second zone where the penetration of the front edge stabilised for a duration of 0.25 ms. During this time, delamination propagated throughout the entire area between the front edge and the rib.
- A third zone during the next 1 ms which represented the elastic return of the structure.
- A fourth zone where the blade took its final form.

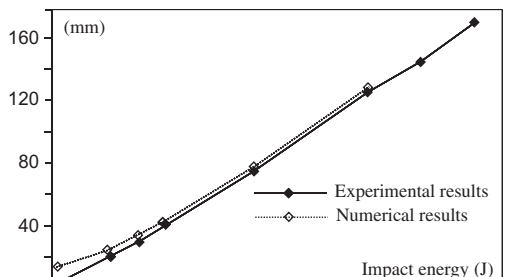
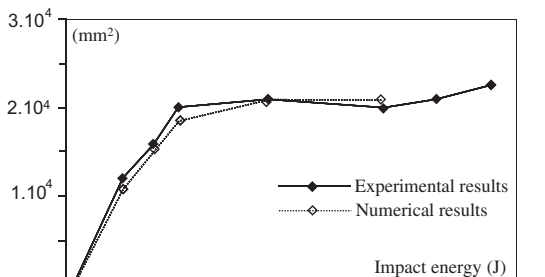
(a) Specimen speed after impact

(b) Residual penetration

(c) Residual deformation

(d) Skin foam debonding

Fig. 10. Numerical/experimental results.

To validate the model, the results obtained numerically were compared with experimental measurements. Fig. 10 shows the speed of the blade after impact (a), the depth of penetration (b), the length of the residual deformation in the front edge (c), as well as the surface of the skin foam debonding as a function of impact energy (d). The results obtained are rather close. The maximum relative error for the blade speed after impact is 8.48%, for an impact energy of 854 J ($V = 119$ m/s). It is 5.68% for the penetration in the front edge, 4% for the length of residual deformation of the front edge and finally, 7.5% for the delamination area. These results show that the strategy used for the model is valid and that the model provides a good representation of the experimental ruptures for energy levels less than 1000 J. To test the robustness of the model, an impact of 520 J on a specimen with two plies of skin was modelled. The skin was made up of one ply of glass with $0^\circ/90^\circ$ orientation and one ply of carbon fabric with $\pm 45^\circ$ orientation. For the experimental test, this specimen was instrumented with strain gauges bonded to the structure in the axis of the impact, on the level of the spar, at the level of the rib and behind the rib.
