Local building cultures for sustainable & resilient habitats - Examples of local good practices and technical solutions

Olivier Moles, Eugénie Crété (Dir.). Local building cultures for sustainable & resilient habitats - Examples of local good practices and technical solutions. 2017, 979-10-96446-13-1. hal-01877172

EXAMPLES OF LOCAL GOOD PRACTICES AND TECHNICAL SOLUTIONS

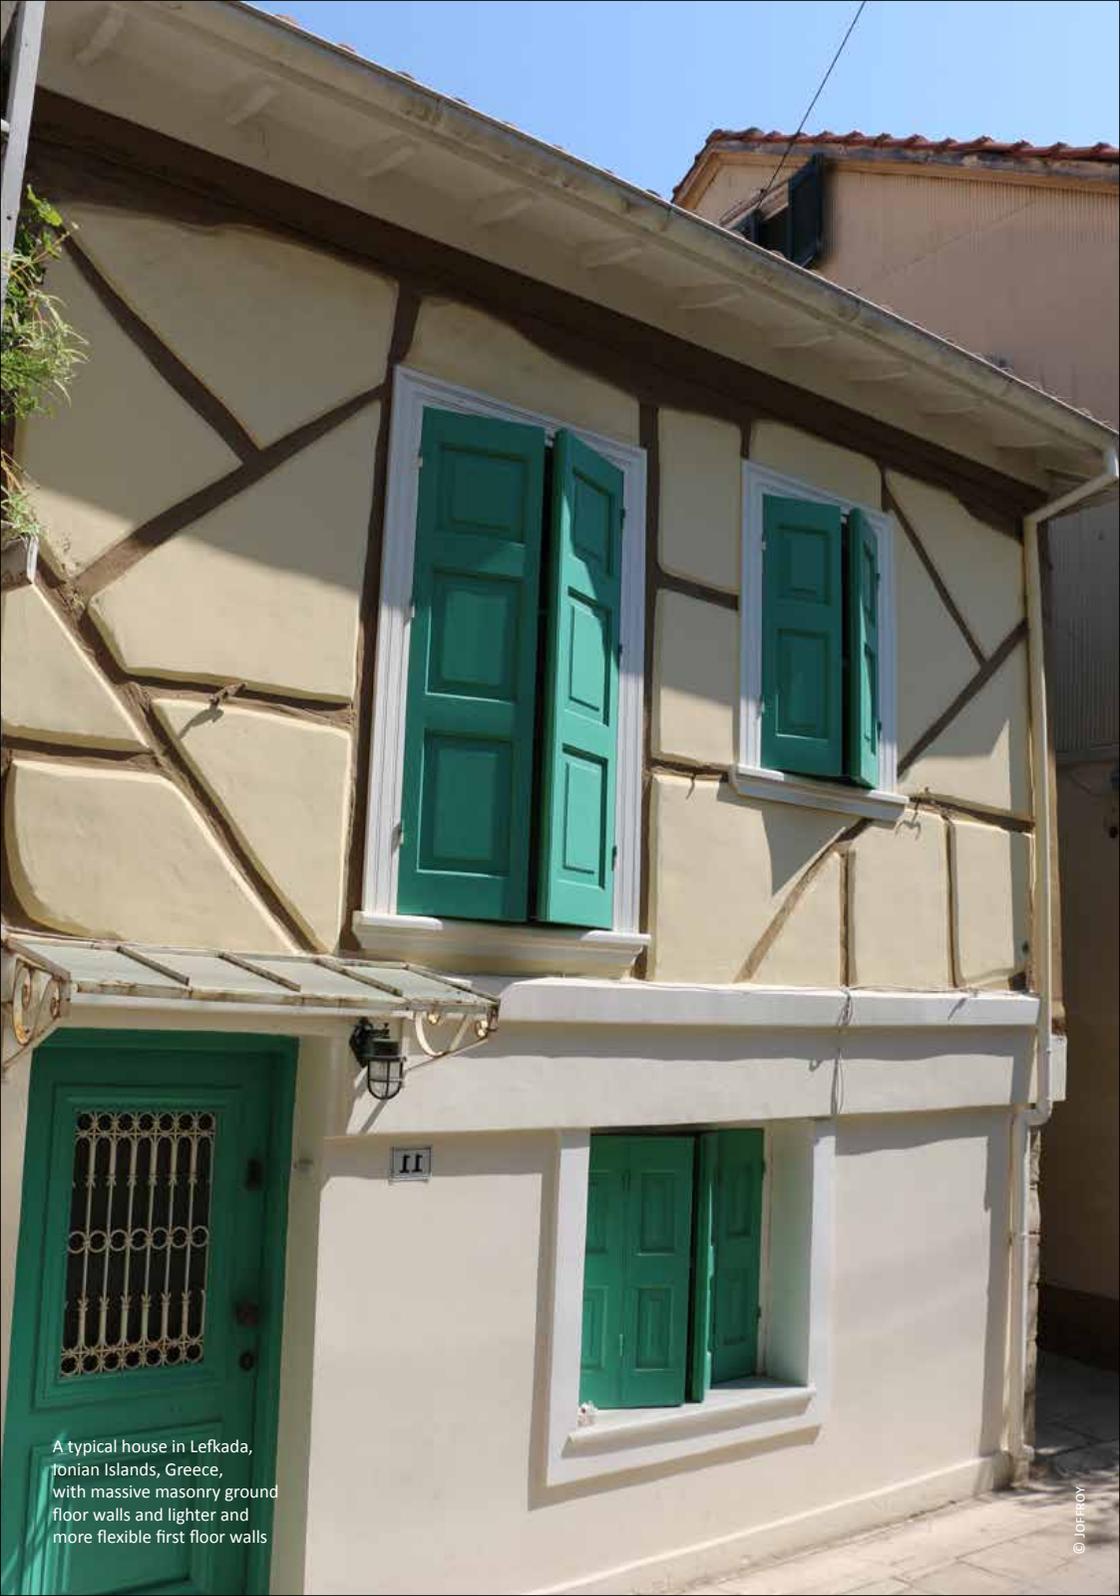
A typical house in Lefkada, Ionian Islands, Greece, with massive masonry ground floor walls and lighter and more flexible first floor walls

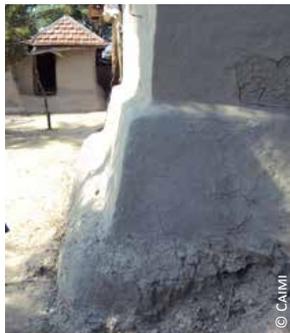
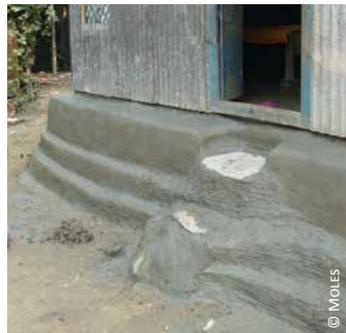
Bangladesh: 1) double step plinth; 2) double step plinth in very high flood prone area; 3) triple step plinth

During seasonal floods, even if the outer parts of the plinth are damaged by the water, the stability of the main structure is not compromised as the inner parts of the plinth are not affected. In addition, repairing is easily done at minor cost as the extent of damage is limited to the lower steps of the plinth.

The higher step keeps the inside living space above the water level of very high floods, protecting people, family assets and food stocks.

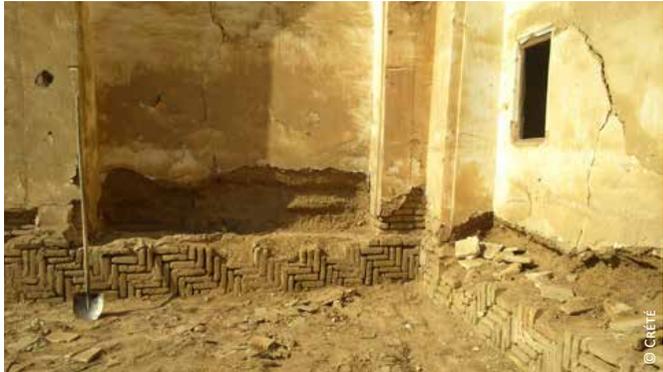
Iran: 1) brick cladding on outside wall

Fired bricks have a better resistance to water than sun dried bricks. Protection of the more exposed parts (foundation and/or lower portion of the wall) improves the capacity of the overall building to withstand during floods. It prevents loss of structural stability due to a weakening of the earthen wall caused by standing water and water erosion. In mixed masonry base, interlocking of the two sides every 5 layers ensures a connection between the two wall faces, preventing delamination.

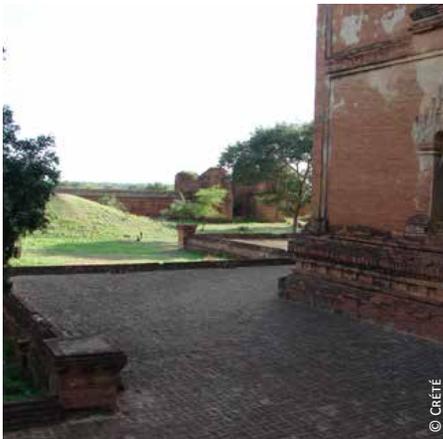
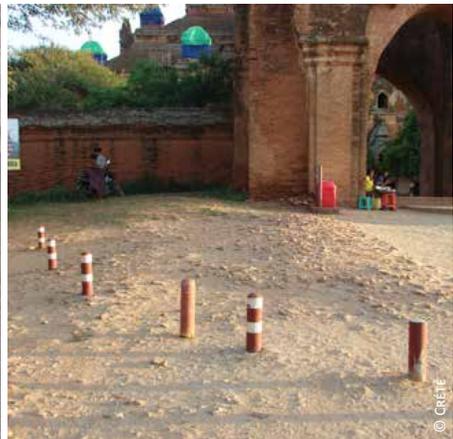
Myanmar, Bagan: 1) a partly over ground platform at Dhammayangyi temple, 2) the eroded core of an ancient platform is nowadays exposed at Dhammayangyi temple

Major buildings are built on a specific platform that is made out of sand mixed with lime, small stones and broken bricks. The over ground parts of the platform are enclosed by massive stones or brickwork.

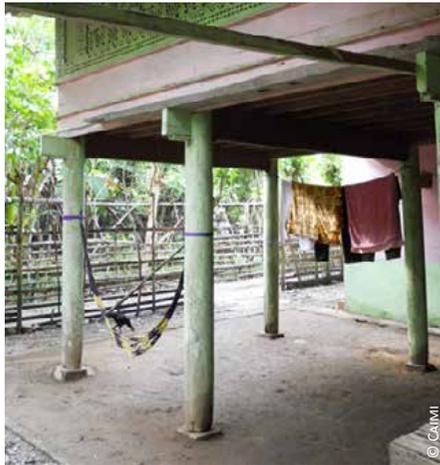
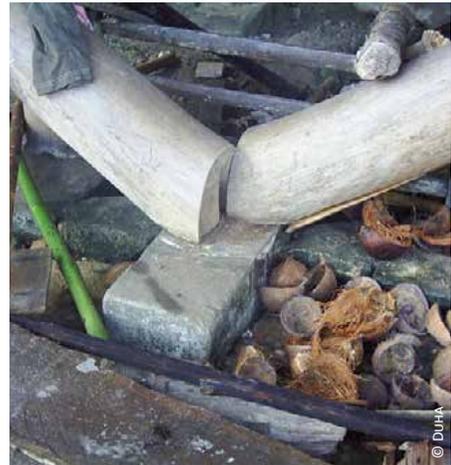
Indonesia: 1) structural frame on stone bases; 2) sliding of diagonal bracing on stone foundation during 2005 M 8.6 earthquake

The superstructure is decoupled from the foundations thanks to their structural disconnection. Movement and minor sliding of the posts on the foundation stones occur frequently, reducing the seismic loads and internal stresses in the structure.

A piece of jute or a layer of reeds is sometimes placed between the posts and the stones. It thus increases the friction between the foundation and the superstructure, and facilitates seismic energy dissipation.

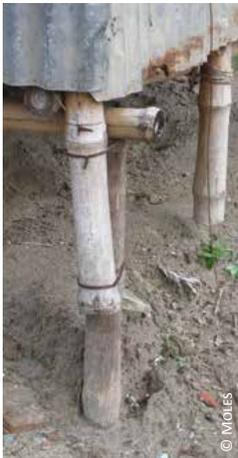
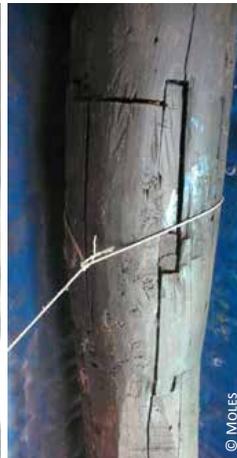
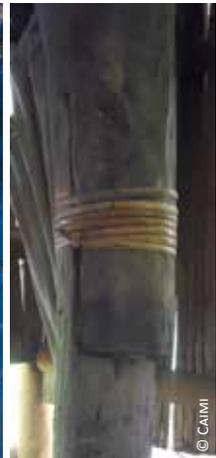
Bangladesh, different materials and connections between the main structure and the fuse posts:
1) bamboo and iron wire; 2 & 3) special carving to connect timber posts in the same plane
Philippines: 4) rattan tying to improve the connection between the main structure and the fuse post

The short posts anchor the building to the ground while keeping the main structure elevated and so protected from soil moisture. When damaged, the short posts driven into the ground (fuse) can be easily replaced without affecting the superstructure.

- Replacement of the damaged lower posts can be done at minor cost as only a short piece of wood is needed.
- A hard and long-lasting timber is often used for the lower posts to increase their durability.
- Shorter posts are needed for the superstructure.

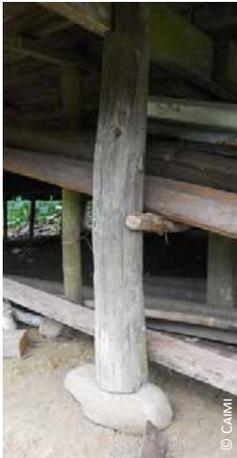
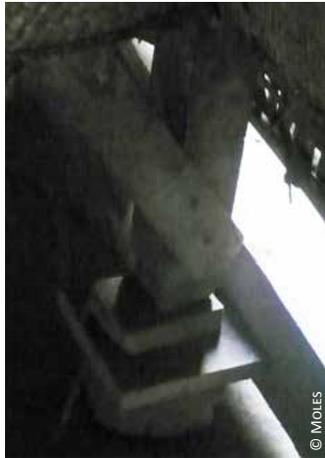
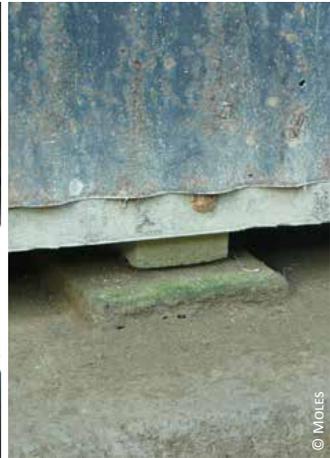
Philippines: 1) stone base under a post of a stilt house

The posts are raised up from the ground so that they are not in contact with soil moisture. This technique increases the structure durability by preventing posts rotting.

- This system is used for both stilt and on-the-ground houses.
- Low-cost locally available materials (such as stones, burnt bricks or small concrete elements) are generally used for waterproofing.
- In cyclone prone areas, the isolation is used mainly for the intermediary posts while the corner posts are driven directly into the ground or provided with foundation to ensure sufficient stability and anchorage of the building.

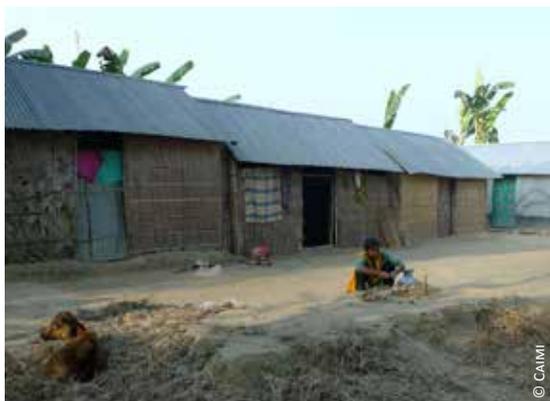
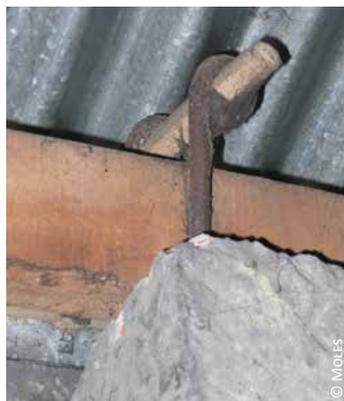
Bangladesh: 1) houses in normal time; 2) connection of the roof structure to the posts, the stick can be quickly removed and replaced so that the joint can be opened and closed several times using the same components

A fast recovery is then possible as the materials of the house are preserved and can be easily reused.

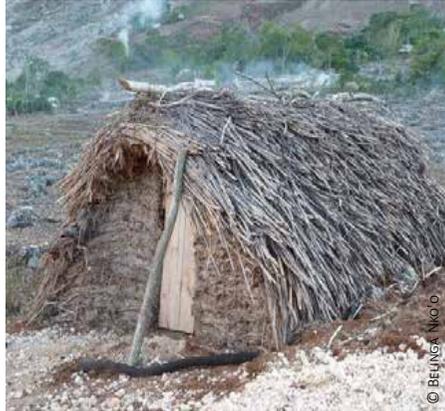
Haiti: 2) straw shelter

The very low height (in some cases, it is hardly possible to stand inside) and the roof extended to the ground provide improved aerodynamism to the building reducing the impact of strong winds.

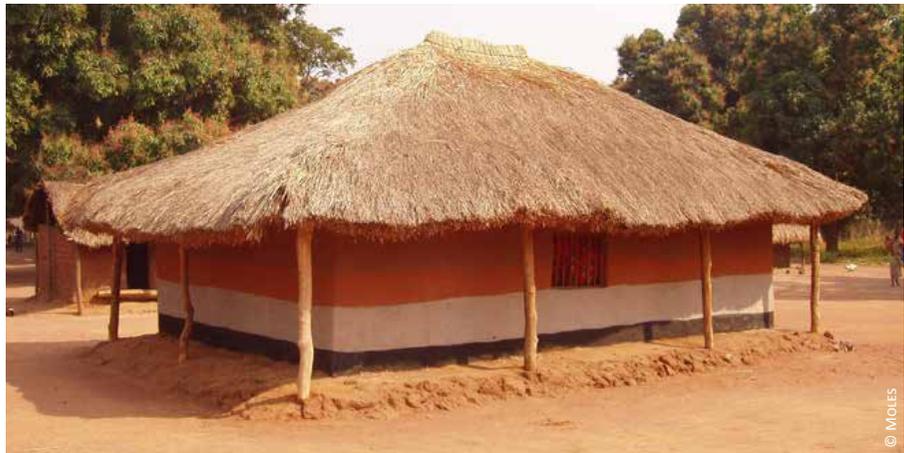
1) Democratic Republic of Congo: outdoor post structure bearing a 4-slope roof

In case of damage to the walls during floods or earthquakes, the risk of a complete collapse of the building is reduced thanks to the structural separation between the roof bearing structure and non-load bearing walls. The frame can withstand autonomously, hence preserving the roof which is often the most expensive part of the construction.

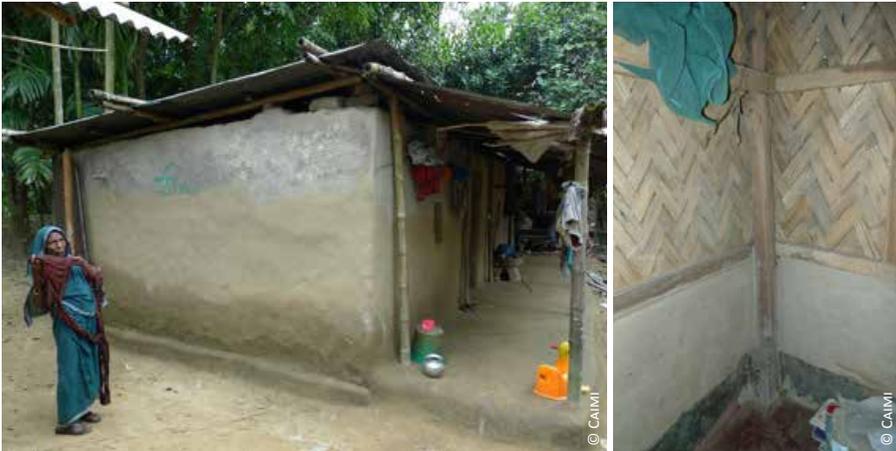
Bangladesh: 2) after flooding, people keep on living inside the house even if the back walls have been damaged;
3) half earthen wall with indoor independent structure for the roof

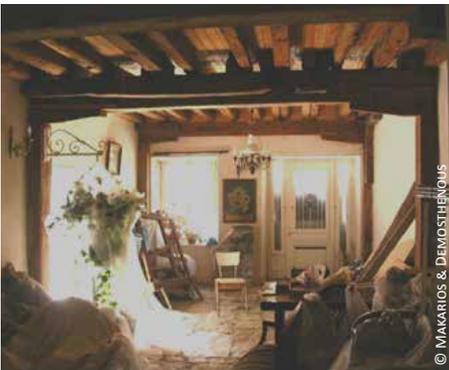
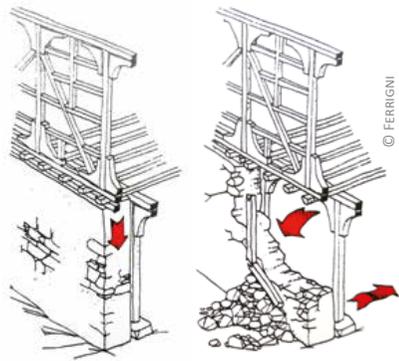
Greece, Lefkada Island: 1) inside timber frame; 2) behaviour of the double load-bearing system a) in ordinary situation and b) in case of an earthquake

In ordinary situation, the main structural loads are carried by masonry walls. In case of partial or total failure of the masonry walls during an earthquake, the timber frame takes over carrying the load of the upper stories and the roof. The risk of a collapse of the whole building is thus limited. As the floors stand even in case of wall collapse, occupants have more time to escape from the building.

- A gap is generally left between the two load-bearing systems to ensure their independent behaviour and to limit damage caused by pounding during earthquakes.
- In some cases, the upper stories are built with a timber frame structure behaving as a light and flexible box during earthquakes.
- In case of wall failures, the frame placed on the inside prevents the inwards collapse of the masonry reducing risk of injuries for the inhabitants.
- After an earthquake, the masonry walls can be rebuilt or repaired reusing the stones from the previous walls and without affecting the stability of the building.
- The building can continue to be used during reconstruction/repair providing on-site shelter.

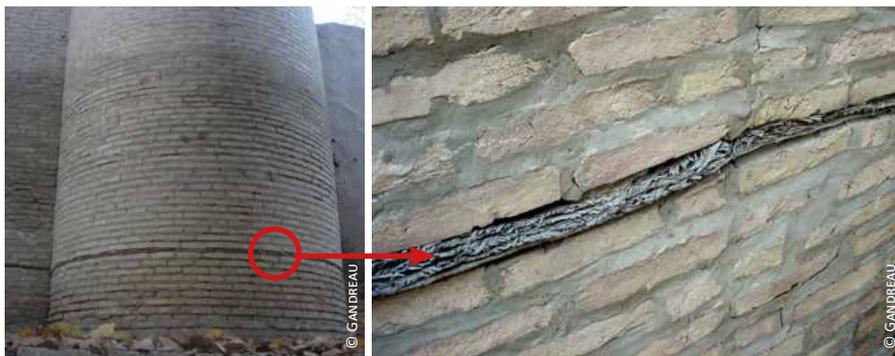
Uzbekistan: 1) walled town Itchan Kala; 2) straw woven mats integrated into the masonry wall

Layers of reeds are placed between the foundations and the masonry superstructure. In some cases, mats of woven straw are used instead of reeds.

The layers of reeds create a disconnection between the building and the ground. The superstructure is free to move as a whole independently from the ground and the foundations while the layers of reeds work as absorber of lateral loads. During earthquakes, slipping may occur between the foundations and the superstructure with small movements reducing stresses inside the masonry walls and dissipating a significant amount of seismic energy. The intensity of lateral forces on the superstructure is then reduced and the effects of the earthquake on the building are limited.

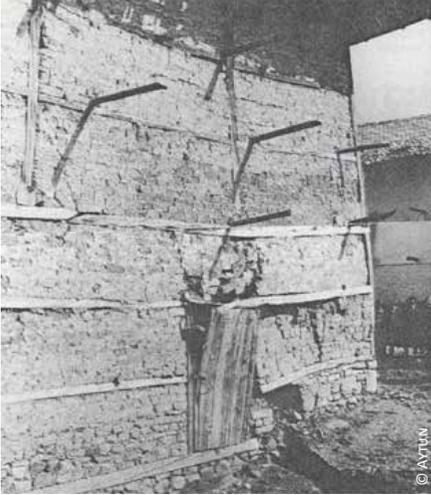
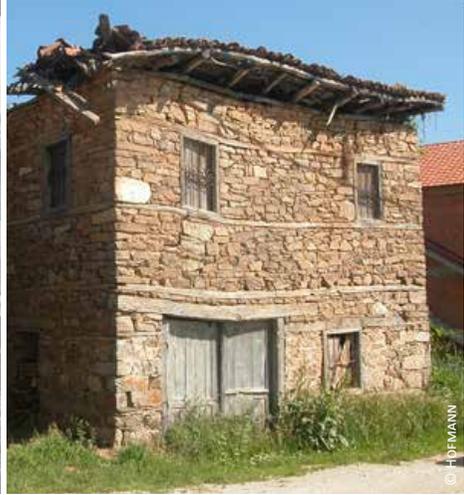
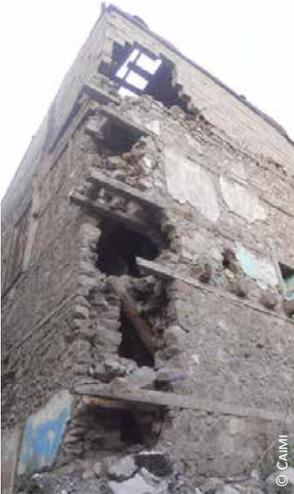
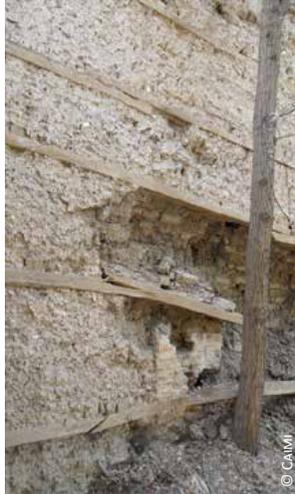
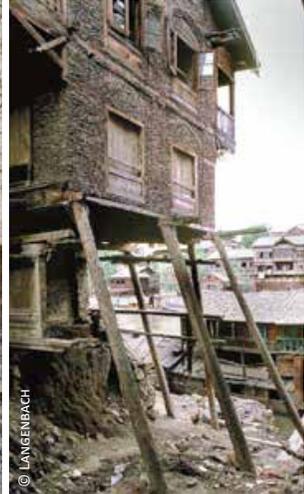
- 1) Turkey, old town of Erzurum
- 2) Pakistan, Besham fort dating from 1750 in a picture taken after the 2005 earthquake: the part of the beam protruding from the perpendicular beam ensures a resistance to tension
- 3) Macedonia: tension resistant corner joint connecting horizontal beams from two perpendicular walls
- India, Himachal Pradesh: 4) ladder shape of horizontal timber bands with cross pieces connected with tension resistant joints on the same level as the main beam; 5) hybrid system with overlapped horizontal timber bands and dry stone masonry

The seismic bands contribute effectively in stopping the extension of localised failures. They prevent diagonal cracks from spreading to large wall sections.

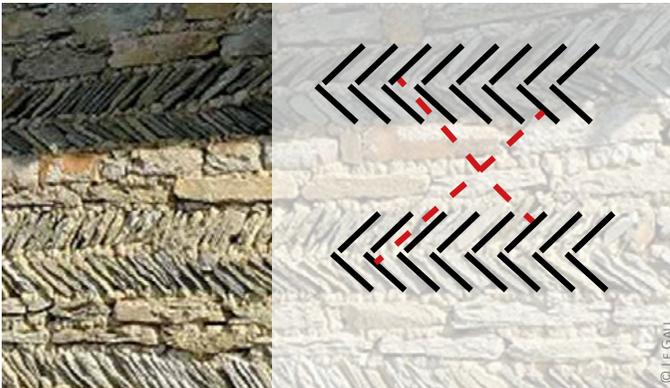
3) Interruption of diagonal cracking by 45° stones (hypothesis)

- Carved stones are used for the corners of the building in order to improve its stability and ensure a proper bonding between perpendicular walls.
- Stones in the lower layer and the upper one of the following diagonal course usually have opposite directions.

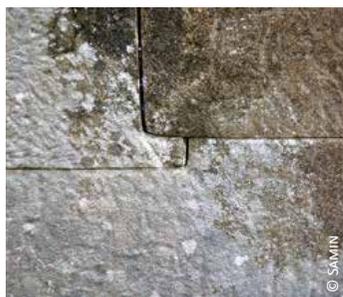
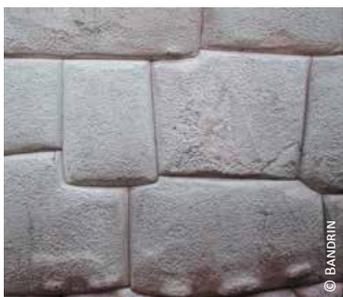
1) Cambodia, Beng Mealea temple; 2) Peru, wall in Cusco; 3) Egypt: grooves to install the pieces to connect blocks of the same row

- This type of connection between masonry units requires high skills and very precise work. It is generally found in very ancient buildings and it is not applied anymore.
- In some cases, interlocking is obtained using a connection piece, generally from a flexible material (like wood or lead) inserted into grooves carved in the masonry blocks and working as clips linking them together.

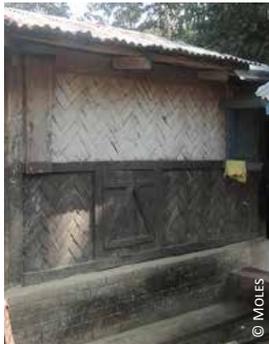
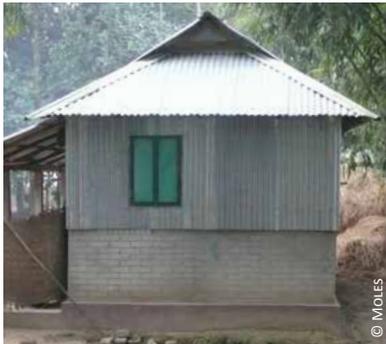
Bangladesh: 1) earthen wall with reed fences; 2) burnt bricks wall with bamboo fences; 3) cement blocks wall with iron sheet fences

CONCERNED PARTS	PROBLEMS
Walls	Water erosion, soil moisture
LOCATION	PRESENT & FUTURE APPLICATION
Bangladesh: Chittagong, Mymensingh, Sylhet	● Commonly known and applied
BRIEF DESCRIPTION	
A half wall built with long lasting materials is used for the lower part of the structure.	
VULNERABILITY REDUCTION	
The lower portion of the wall is more resistant to water erosion. Total cost is reduced as the upper portions can be built with cheaper materials.

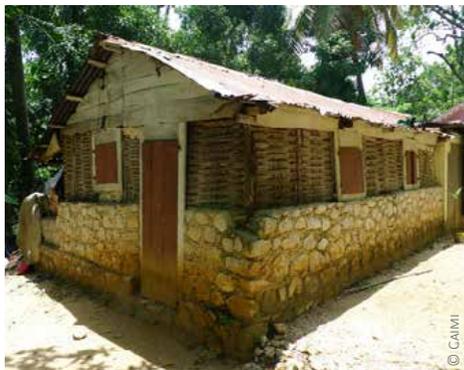
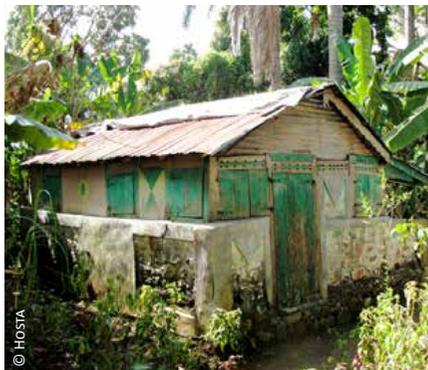
Haiti: 1) change in the materials: lower part with masonry walls and upper part with woven coconut sticks; 2) decreasing the thickness of masonry walls

In case of partial collapse of the wall, the risk of serious injuries to the occupants is considerably limited thanks to the reduced weight of the materials used.

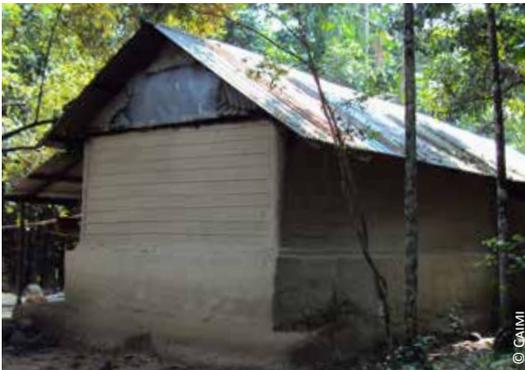
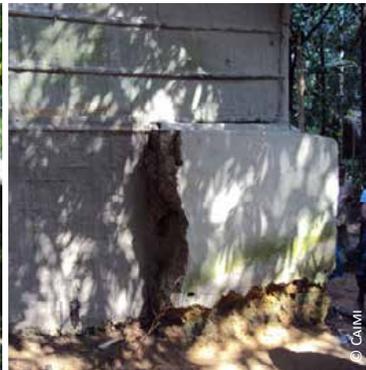
Bangladesh: 3) half earthen wall and upper part with jute stick panels; 4) wall damaged during floods and temporarily repaired with lighter materials

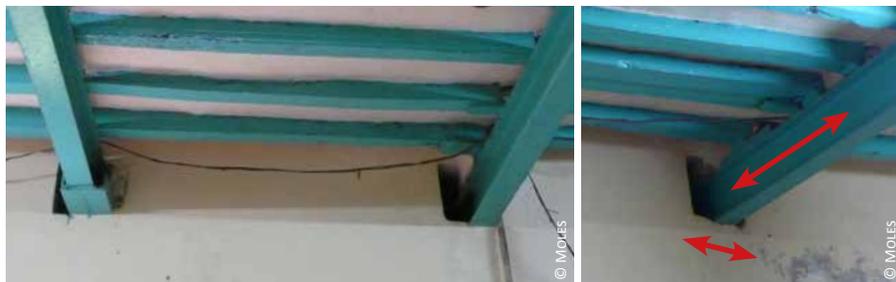
Bangladesh: 1) upper floor beams free to move; 2) behaviour under lateral forces

The holes are a little bit bigger than the size of the beams. During earthquakes, the beams are free to move horizontally and independently from the walls without affecting the main masonry structure. It thus prevents cracks and failures due to punching.

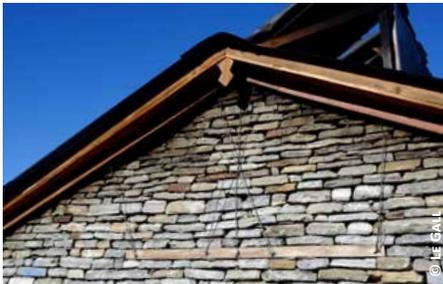
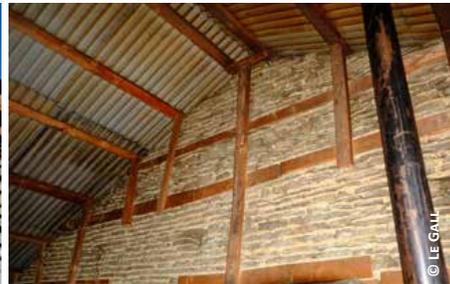
Nepal, light roof with confined gable walls using 1) steel cables and 2) timber studs

In case of an earthquake, the cables and the studs prevent the gable wall from tilting. It thereby limits damage and reduces the risk of injuries for the inhabitants.

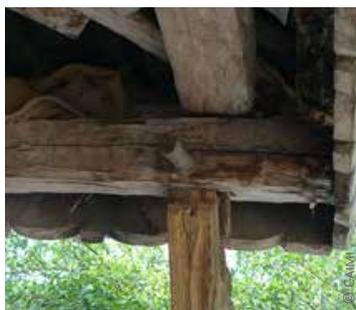
Haiti: 1) beam-post connection with long peg; 2) double pegged joint connecting the post to the beam and the roof structure to the beam; 3) pegged joint for connecting two parts of the top beam

The whole frame can swing and deform without the risk of a sudden collapse due to the break of structural elements caused by stiff points at the connections. In case very important deformations occur, inhabitants have time to leave the building and move in a safer place.

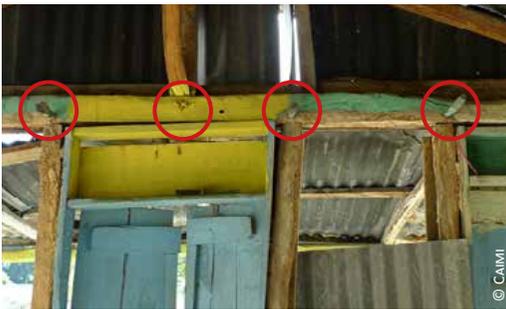
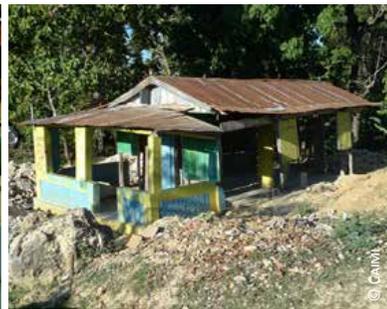
Haiti: 4) pegged tenon and mortise joints are used for each connection between structural elements, including for the roof structure; 5) during 2010 earthquake the building was damaged but the main structure was able to withstand

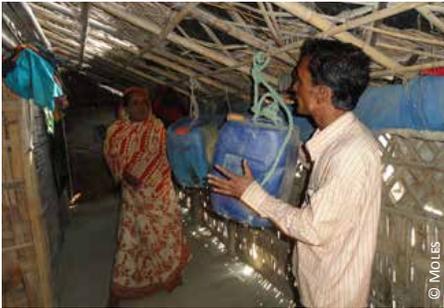
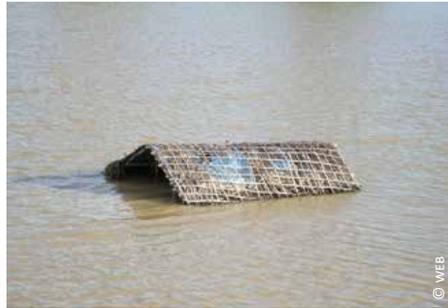
Bangladesh: 1) empty jerrycans suspended to the roof structure; 2) a floating roof during a flood

During high floods, the jerrycans work as floats avoiding a complete sinking of the roof. Damage to the roof is significantly reduced as the whole roof will be kept above the water level.

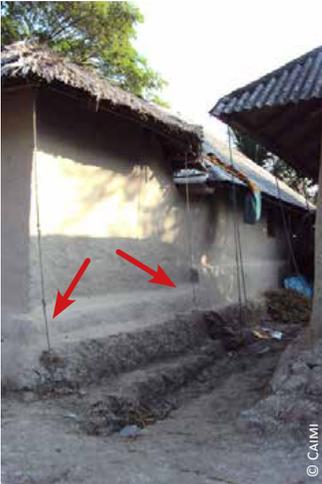
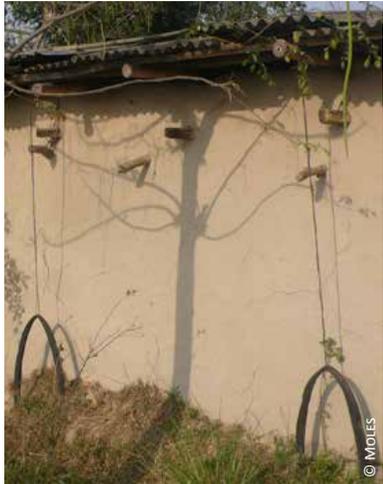
Bangladesh: anchoring using 1) ropes and wood stakes, 2) existing roots and 3) used tyres

Fastening the roof structure provides an additional connexion thus preventing the roof from being entirely blown off under wind pressure. The roof structure can slightly move but it is kept in place avoiding wrenching and severe damage.

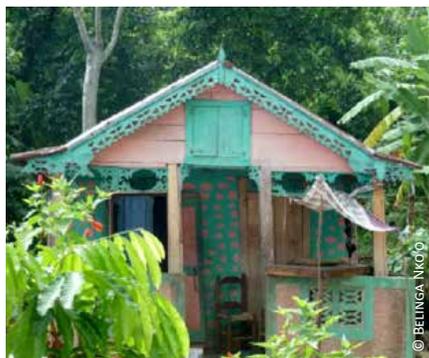
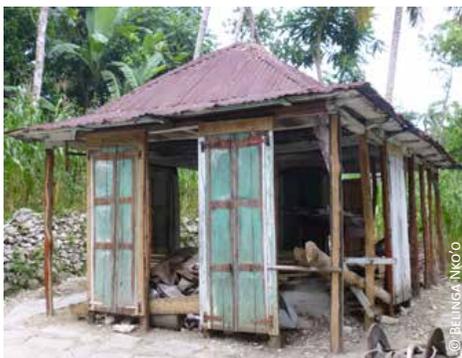
Haiti: double slope on 1) gable roof and 2) 4-slope roof

This device improves the protection of the wall while limiting the extension of the overhangs, vulnerable to strong winds.

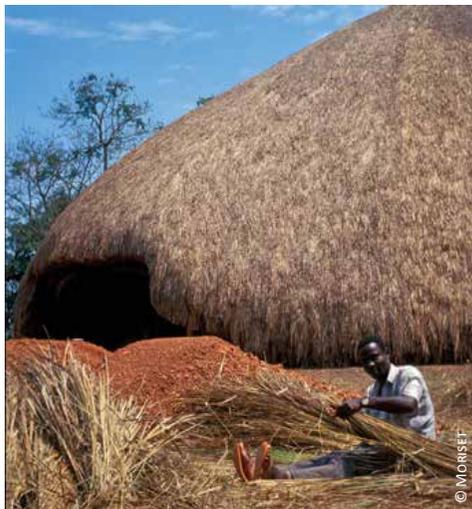
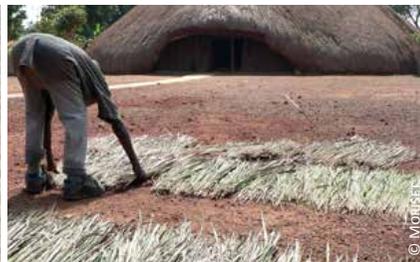
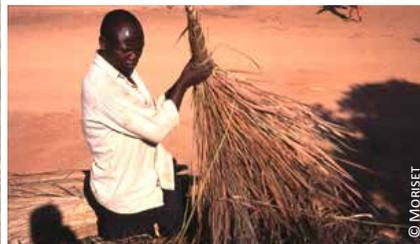
Uganda: 1, 2 & 3) preparation of conical bundles

When one bundle is rotten, it can be easily pulled out and replaced by driving another bundle at its place. This practice facilitates maintenance allowing for a fast and a very localized replacement of damaged parts.

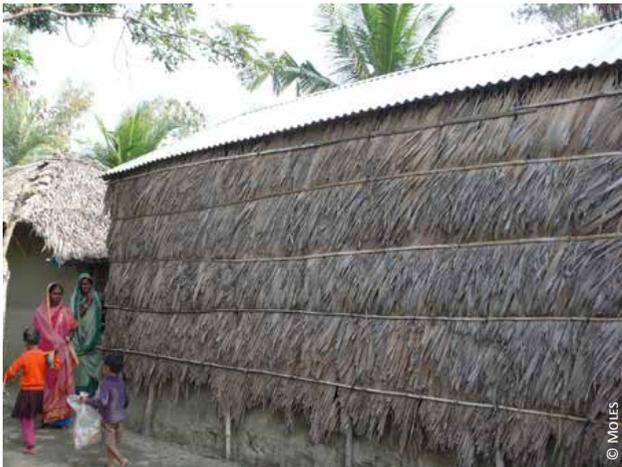
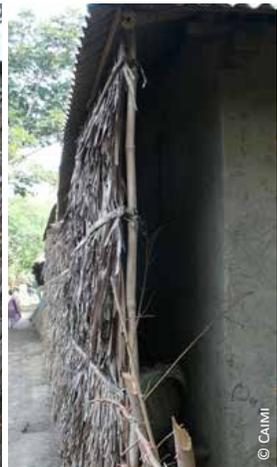
Bangladesh, vegetable double-skin: 1) covering the whole façade; 2) gap ensuring the ventilation of the wall

The panels protect the earthen walls from erosion and degradation due to direct exposure to rain and strong winds. Maintenance cost and work are thus reduced as the lifespan of the wall is increased and the panels can be easily replaced using freely available materials.
