Local building cultures for sustainable & resilient habitats - Examples of local good practices and technical solutions

Olivier Moles, Eugénie Crété (Dir.). Local building cultures for sustainable & resilient habitats - Examples of local good practices and technical solutions. 2017, 979-10-96446-13-1. hal-01877172

EXAMPLES OF LOCAL GOOD PRACTICES AND TECHNICAL SOLUTIONS

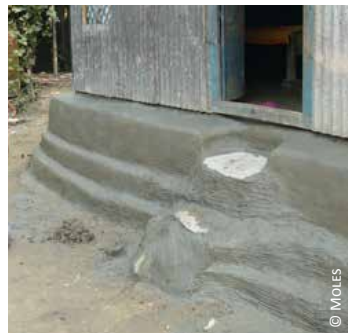
During seasonal floods, even if the outer parts of the plinth are damaged by the water, the stability of the main structure is not compromised as the inner parts of the plinth are not affected. In addition, repairing is easily done at minor cost as the extent of damage is limited to the lower steps of the plinth.

The higher step keeps the inside living space above the water level of very high floods, protecting people, family assets and food stocks.

Bangladesh: 1) double step plinth; 2) double step plinth in very high flood prone area; 3) triple step plinth

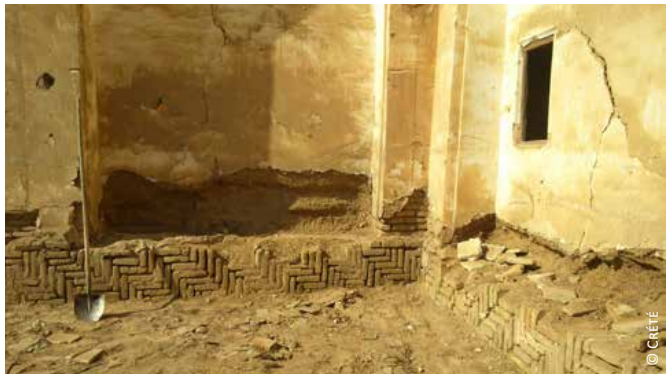
Fired bricks have a better resistance to water than sun dried bricks. Protection of the more exposed parts (foundation and/or lower portion of the wall) improves the capacity of the overall building to withstand during floods. It prevents loss of structural stability due to a weakening of the earthen wall caused by standing water and water erosion. In mixed masonry base, interlocking of the two sides every 5 layers ensures a connection between the two wall faces, preventing delamination.

Iran: 1) brick cladding on outside wall

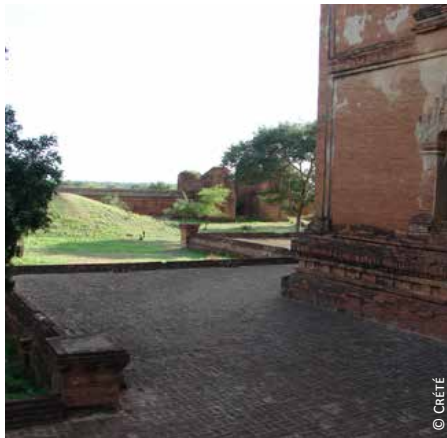
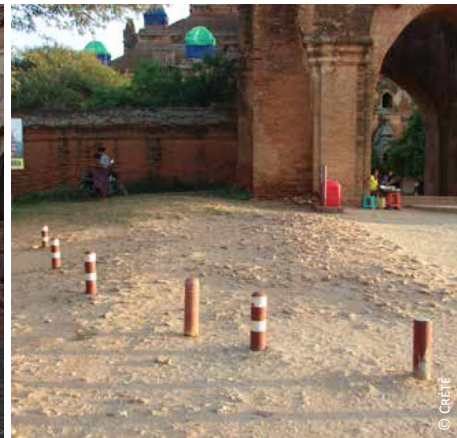
Major buildings are built on a specific platform that is made out of sand mixed with lime, small stones and broken bricks. The over ground parts of the platform are enclosed by massive stones or brickwork.

Myanmar, Bagan: 1) a partly over ground platform at Dhammayangyi temple, 2) the eroded core of an ancient platform is nowadays exposed at Dhammayangyi temple

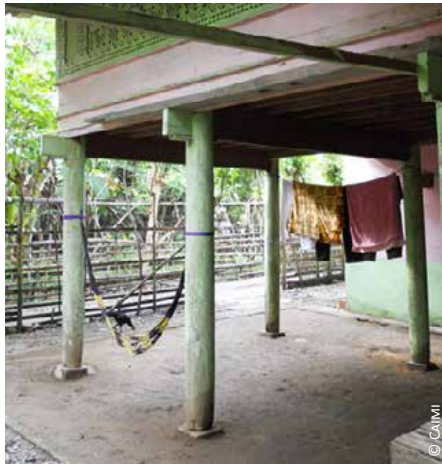
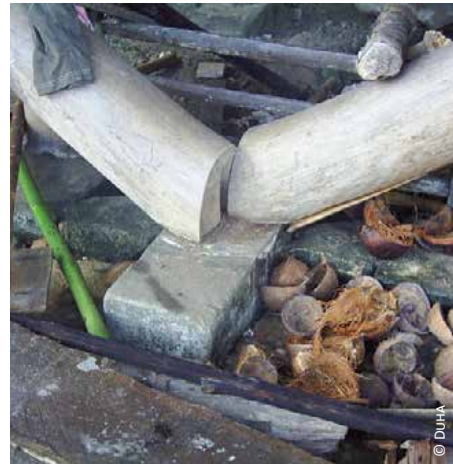
The superstructure is decoupled from the foundations thanks to their structural disconnection. Movement and minor sliding of the posts on the foundation stones occur frequently, reducing the seismic loads and internal stresses in the structure.

Indonesia: 1) structural frame on stone bases; 2) sliding of diagonal bracing on stone foundation during 2005 M 8.6 earthquake

A piece of jute or a layer of reeds is sometimes placed between the posts and the stones. It thus increases the friction between the foundation and the superstructure, and facilitates seismic energy dissipation.

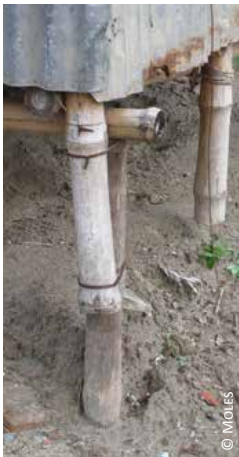
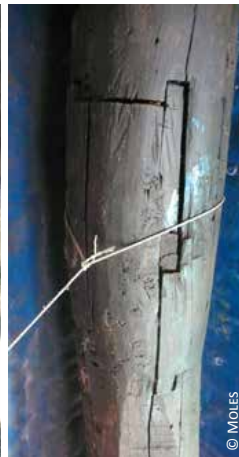
The short posts anchor the building to the ground while keeping the main structure elevated and so protected from soil moisture. When damaged, the short posts driven into the ground (fuse) can be easily replaced without affecting the superstructure.

Bangladesh, different materials and connections between the main structure and the fuse posts:
1) bamboo and iron wire; 2 & 3) special carving to connect timber posts in the same plane
Philippines: 4) rattan tying to improve the connection between the main structure and the fuse post

- Replacement of the damaged lower posts can be done at minor cost as only a short piece of wood is needed.
- A hard and long-lasting timber is often used for the lower posts to increase their durability.
- Shorter posts are needed for the superstructure.

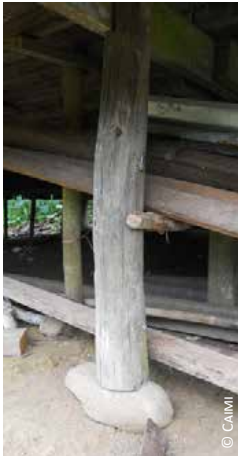
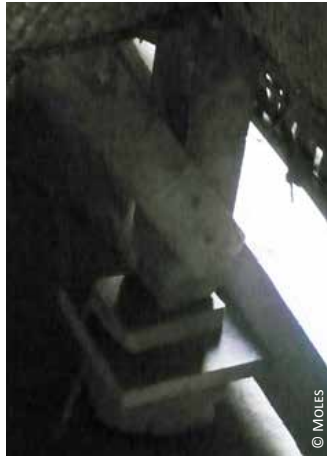
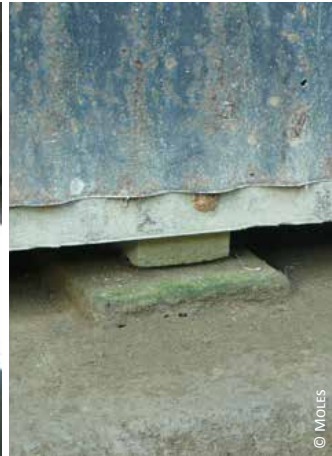
The posts are raised up from the ground so that they are not in contact with soil moisture. This technique increases the structure durability by preventing posts rotting.

Philippines: 1) stone base under a post of a stilt house

- This system is used for both stilt and on-the-ground houses.
- Low-cost locally available materials (such as stones, burnt bricks or small concrete elements) are generally used for waterproofing.
- In cyclone prone areas, the isolation is used mainly for the intermediary posts while the corner posts are driven directly into the ground or provided with foundation to ensure sufficient stability and anchorage of the building.

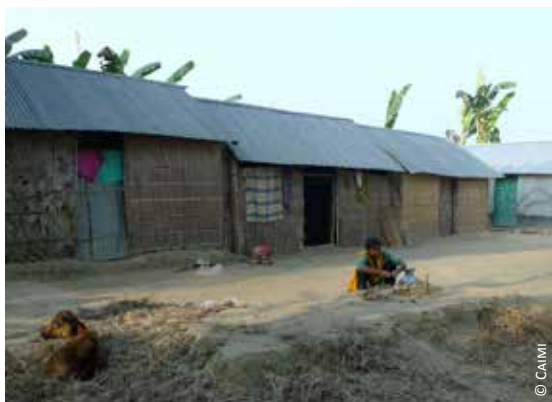
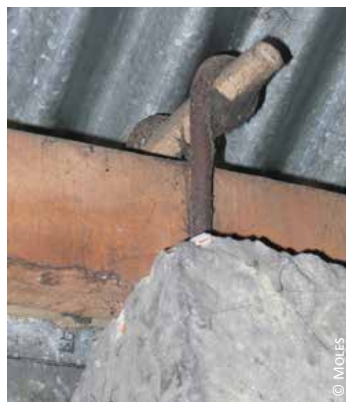
A fast recovery is then possible as the materials of the house are preserved and can be easily reused.

Bangladesh: 1) houses in normal time; 2) connection of the roof structure to the posts, the stick can be quickly removed and replaced so that the joint can be opened and closed several times using the same components

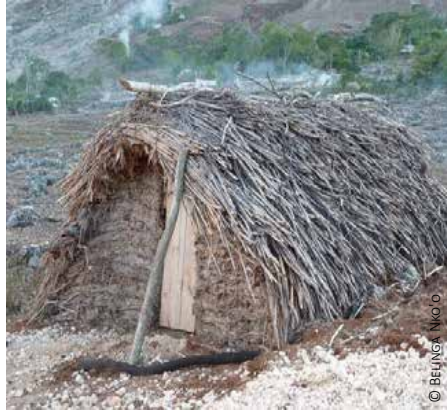
The very low height (in some cases, it is hardly possible to stand inside) and the roof extended to the ground provide improved aerodynamism to the building reducing the impact of strong winds.

Haiti: 2) straw shelter

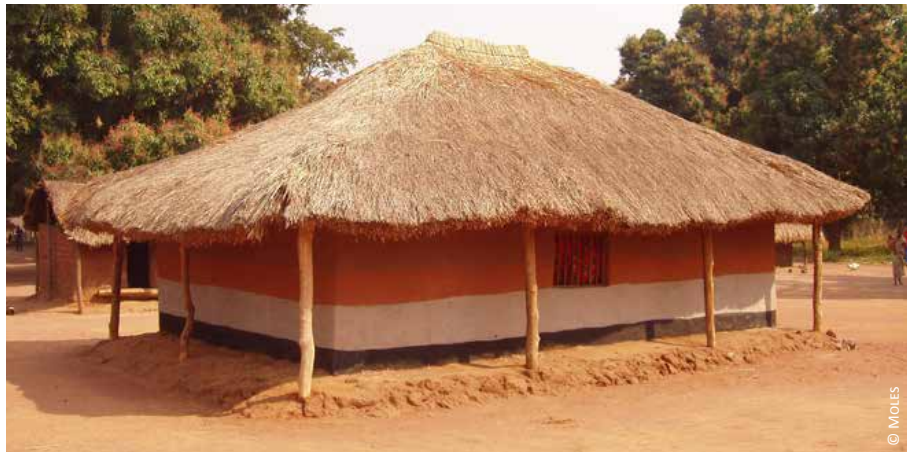
In case of damage to the walls during floods or earthquakes, the risk of a complete collapse of the building is reduced thanks to the structural separation between the roof bearing structure and non-load bearing walls. The frame can withstand autonomously, hence preserving the roof which is often the most expensive part of the construction.

1) Democratic Republic of Congo: outdoor post structure bearing a 4-slope roof

- Repairing works can be easily carried out at minor cost and the space under the withstanding roof can be used as emergency shelter.
- The roof widely covers the walls, ensuring thermal comfort and protection from rainwater.

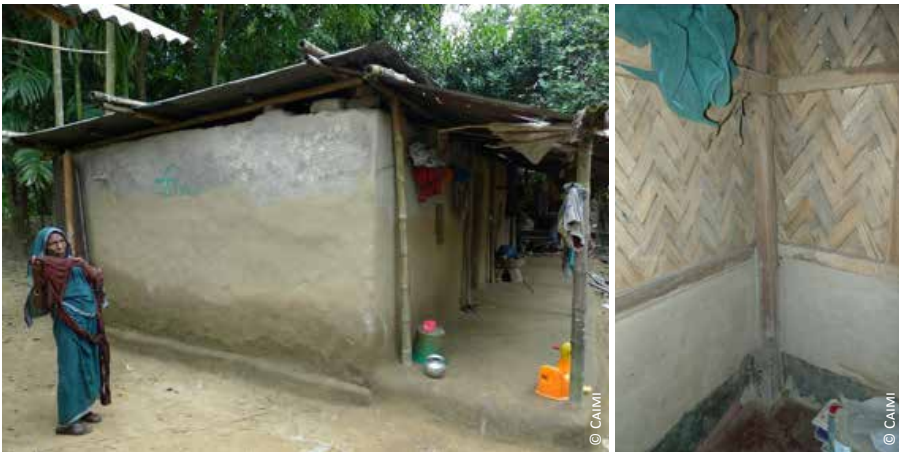
Bangladesh: 2) after flooding, people keep on living inside the house even if the back walls have been damaged;
3) half earthen wall with indoor independent structure for the roof

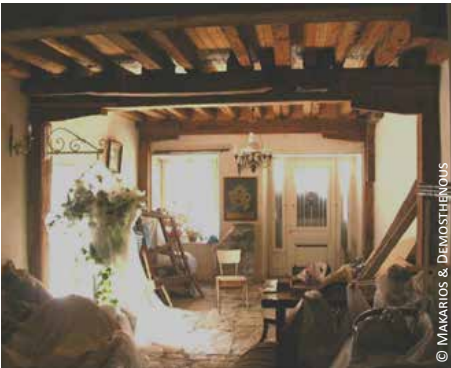
In ordinary situation, the main structural loads are carried by masonry walls. In case of partial or total failure of the masonry walls during an earthquake, the timber frame takes over carrying the load of the upper stories and the roof. The risk of a collapse of the whole building is thus limited. As the floors stand even in case of wall collapse, occupants have more time to escape from the building.

Greece, Lefkada Island: 1) inside timber frame; 2) behaviour of the double load-bearing system a) in ordinary situation and b) in case of an earthquake

- A gap is generally left between the two load-bearing systems to ensure their independent behaviour and to limit damage caused by pounding during earthquakes.
- In some cases, the upper stories are built with a timber frame structure behaving as a light and flexible box during earthquakes.
- In case of wall failures, the frame placed on the inside prevents the inwards collapse of the masonry reducing risk of injuries for the inhabitants.
- After an earthquake, the masonry walls can be rebuilt or repaired reusing the stones from the previous walls and without affecting the stability of the building.
- The building can continue to be used during reconstruction/repair providing on-site shelter.

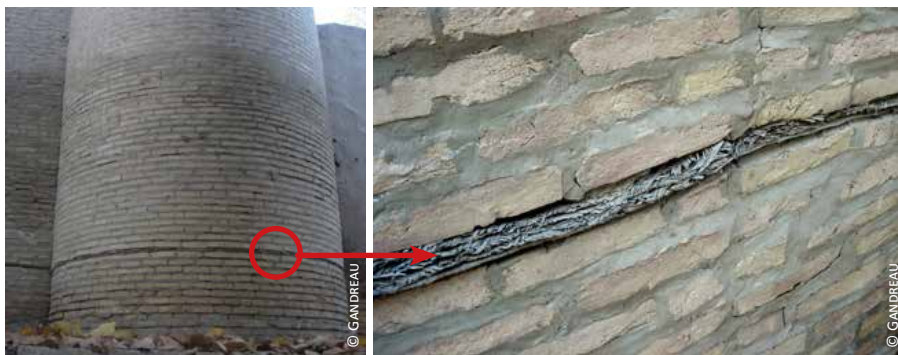
Layers of reeds are placed between the foundations and the masonry superstructure. In some cases, mats of woven straw are used instead of reeds.

Uzbekistan: 1) walled town Itchan Kala; 2) straw woven mats integrated into the masonry wall

The layers of reeds create a disconnection between the building and the ground. The superstructure is free to move as a whole independently from the ground and the foundations while the layers of reeds work as absorber of lateral loads. During earthquakes, slipping may occur between the foundations and the superstructure with small movements reducing stresses inside the masonry walls and dissipating a significant amount of seismic energy. The intensity of lateral forces on the superstructure is then reduced and the effects of the earthquake on the building are limited.

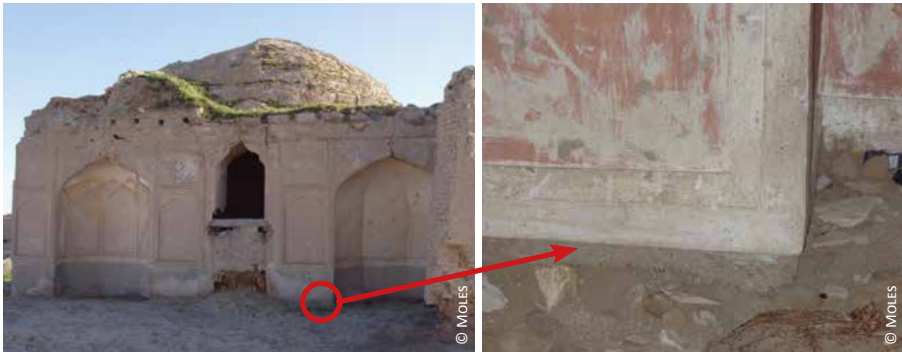
Afghanistan: 4) 15th century Andkhoy mosque; 5) layers of reeds

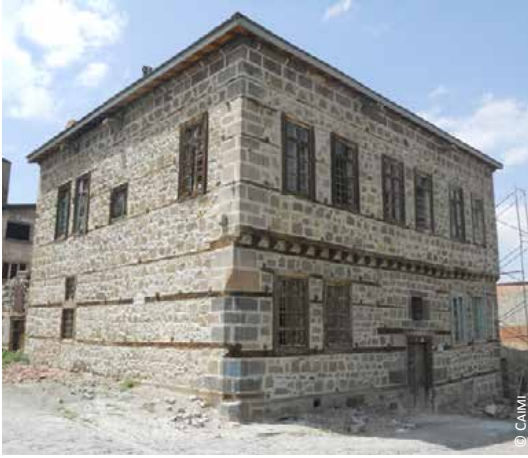
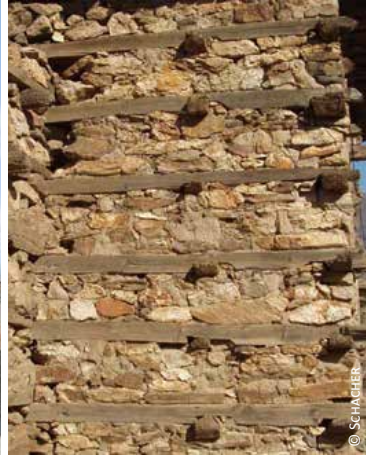
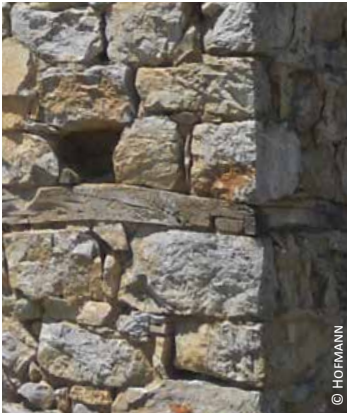
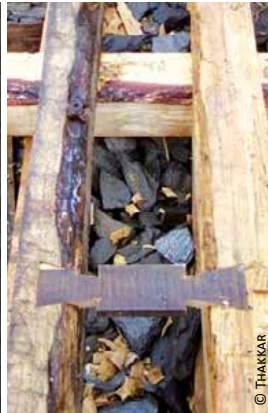
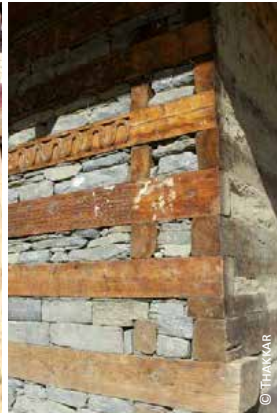
The seismic bands contribute effectively in stopping the extension of localised failures. They prevent diagonal cracks from spreading to large wall sections.

- 1) Turkey, old town of Erzurum
- 2) Pakistan, Besham fort dating from 1750 in a picture taken after the 2005 earthquake: the part of the beam protruding from the perpendicular beam ensures a resistance to tension
- 3) Macedonia: tension resistant corner joint connecting horizontal beams from two perpendicular walls
- India, Himachal Pradesh: 4) ladder shape of horizontal timber bands with cross pieces connected with tension resistant joints on the same level as the main beam; 5) hybrid system with overlapped horizontal timber bands and dry stone masonry

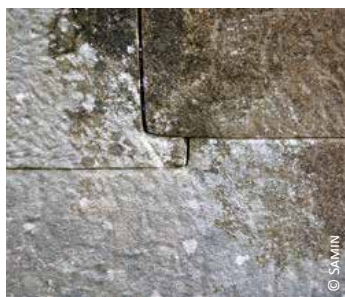
- This type of connection between masonry units requires high skills and very precise work. It is generally found in very ancient buildings and it is not applied anymore.
- In some cases, interlocking is obtained using a connection piece, generally from a flexible material (like wood or lead) inserted into grooves carved in the masonry blocks and working as clips linking them together.

1) Cambodia, Beng Mealea temple; 2) Peru, wall in Cusco; 3) Egypt: grooves to install the pieces to connect blocks of the same row

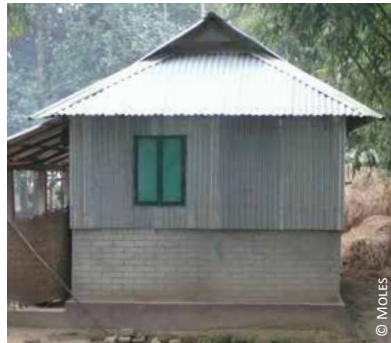
Bangladesh: 1) earthen wall with reed fences; 2) burnt bricks wall with bamboo fences; 3) cement blocks wall with iron sheet fences

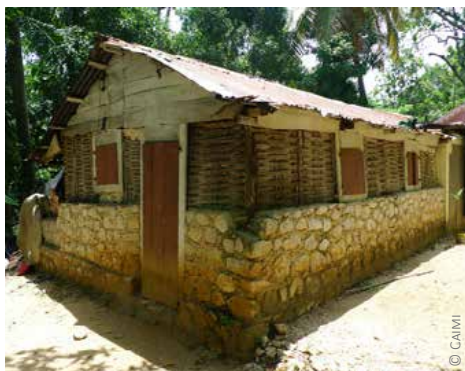
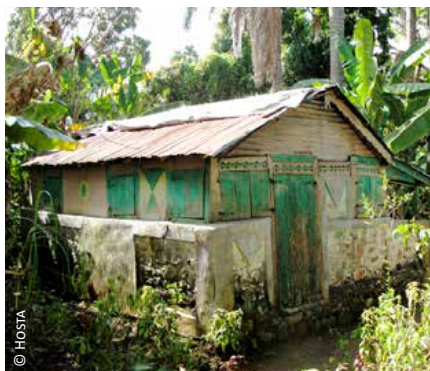
In case of partial collapse of the wall, the risk of serious injuries to the occupants is considerably limited thanks to the reduced weight of the materials used.

Haiti: 1) change in the materials: lower part with masonry walls and upper part with woven coconut sticks; 2) decreasing the thickness of masonry walls

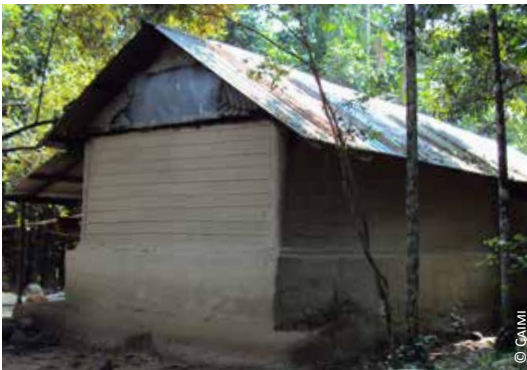
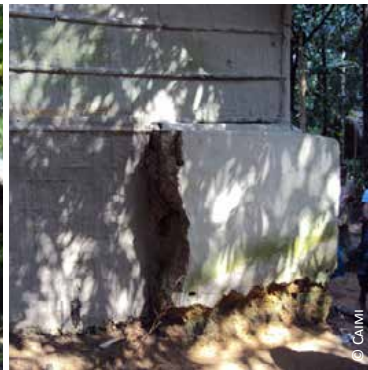
Bangladesh: 3) half earthen wall and upper part with jute stick panels; 4) wall damaged during floods and temporarily repaired with lighter materials

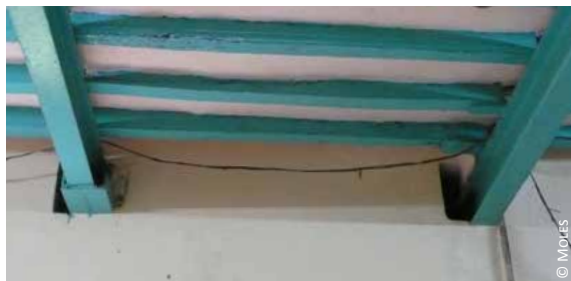
The holes are a little bit bigger than the size of the beams. During earthquakes, the beams are free to move horizontally and independently from the walls without affecting the main masonry structure. It thus prevents cracks and failures due to punching.

Bangladesh: 1) upper floor beams free to move; 2) behaviour under lateral forces

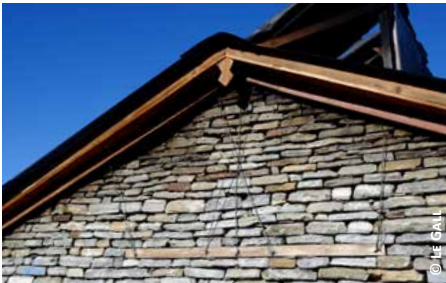
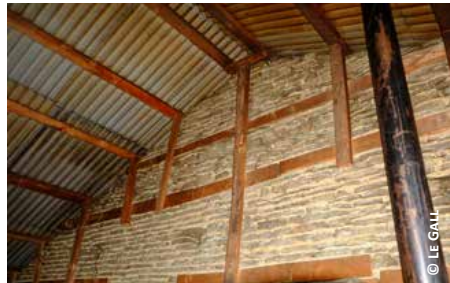
In case of an earthquake, the cables and the studs prevent the gable wall from tilting. It thereby limits damage and reduces the risk of injuries for the inhabitants.

Nepal, light roof with confined gable walls using 1) steel cables and 2) timber studs

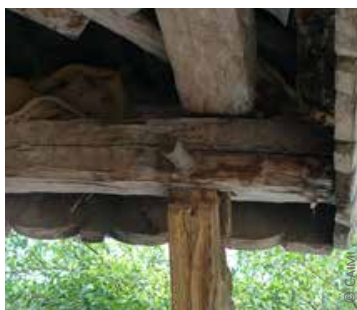
The whole frame can swing and deform without the risk of a sudden collapse due to the break of structural elements caused by stiff points at the connections. In case very important deformations occur, inhabitants have time to leave the building and move in a safer place.

Haiti: 1) beam-post connection with long peg; 2) double pegged joint connecting the post to the beam and the roof structure to the beam; 3) pegged joint for connecting two parts of the top beam

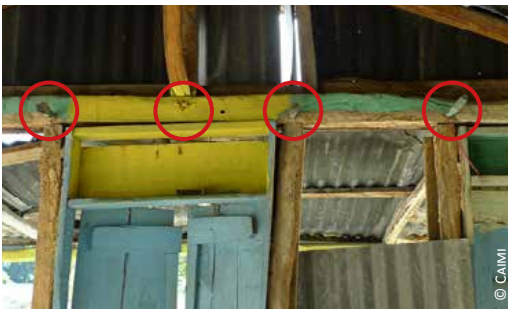
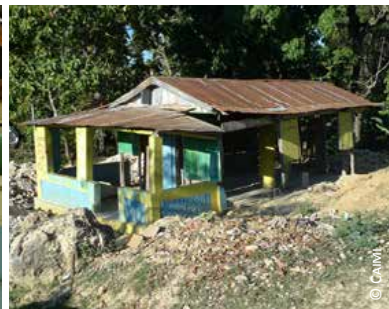
Haiti: 4) pegged tenon and mortise joints are used for each connection between structural elements, including for the roof structure; 5) during 2010 earthquake the building was damaged but the main structure was able to withstand

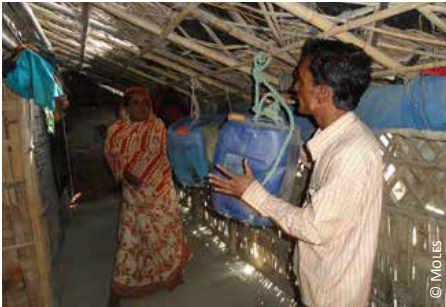
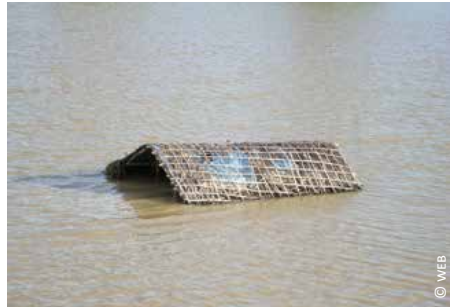
During high floods, the jerrycans work as floats avoiding a complete sinking of the roof. Damage to the roof is significantly reduced as the whole roof will be kept above the water level.

Bangladesh: 1) empty jerrycans suspended to the roof structure; 2) a floating roof during a flood

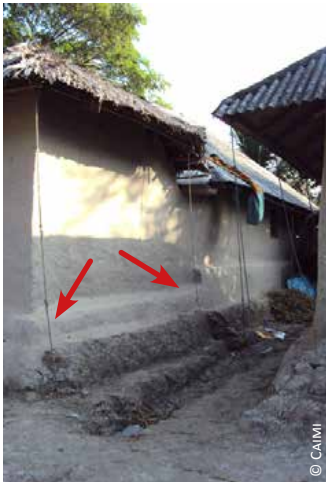
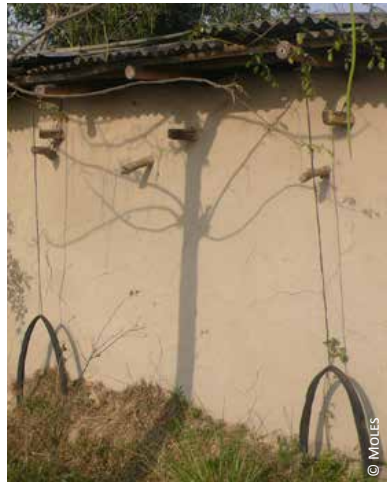
Fastening the roof structure provides an additional connexion thus preventing the roof from being entirely blown off under wind pressure. The roof structure can slightly move but it is kept in place avoiding wrenching and severe damage.

Bangladesh: anchoring using 1) ropes and wood stakes, 2) existing roots and 3) used tyres

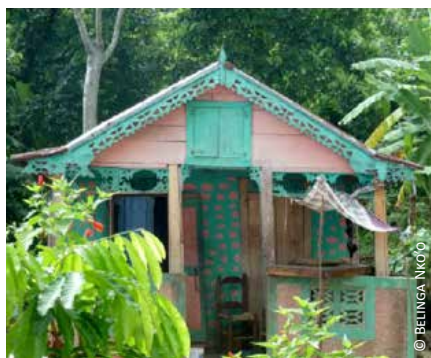
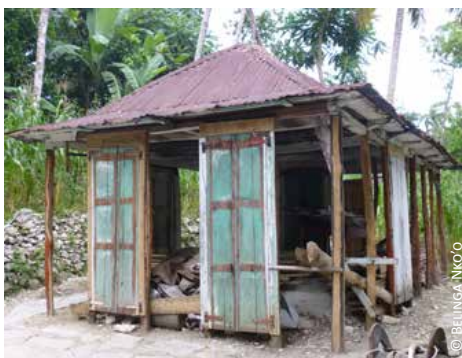
This device improves the protection of the wall while limiting the extension of the overhangs, vulnerable to strong winds.

Haiti: double slope on 1) gable roof and 2) 4-slope roof

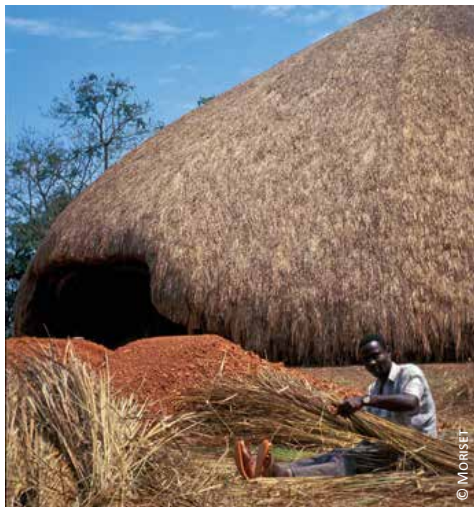
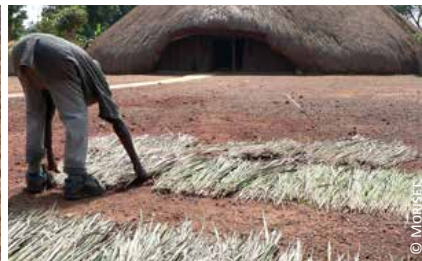
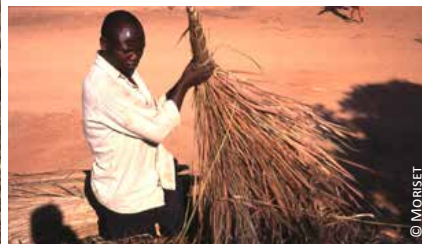
When one bundle is rotten, it can be easily pulled out and replaced by driving another bundle at its place. This practice facilitates maintenance allowing for a fast and a very localized replacement of damaged parts.

Uganda: 1, 2 & 3) preparation of conical bundles

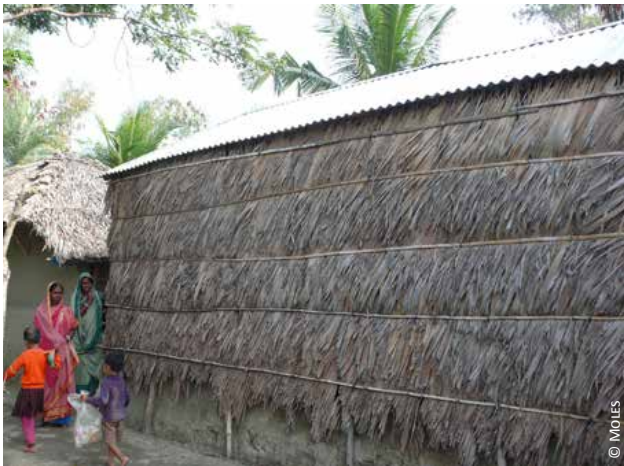
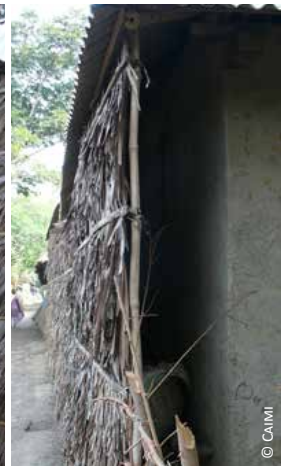
The panels protect the earthen walls from erosion and degradation due to direct exposure to rain and strong winds. Maintenance cost and work are thus reduced as the lifespan of the wall is increased and the panels can be easily replaced using freely available materials.

Bangladesh, vegetable double-skin: 1) covering the whole façade; 2) gap ensuring the ventilation of the wall

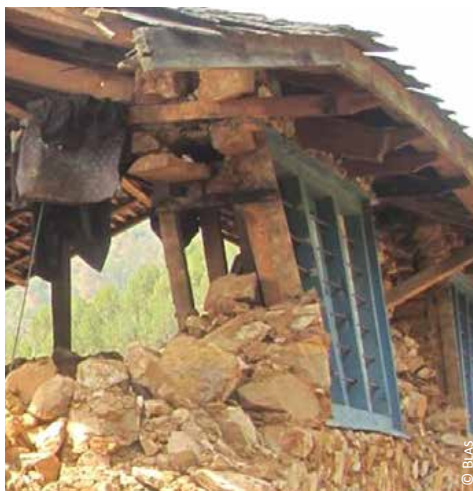
The connected double frame acts as a box providing an additional support for the above portions of the wall as well as for the upper stories or the roof in case of structural weakening of the masonry walls during earthquakes.

Nepal: 1) a window with a double timber frame; 2) the double frame of a window supporting the roof after the failure of a masonry wall during 2015 Gorkha earthquake
