# RECONSTRUCTION OF THE 3D CRACK PROFILE IN WOOD BASED STRUCTURES BY X-RAY COMPUTED MICROTOMOGRAPHY

Hamdi Seif Eddine, Rostand Moutou Pitti, Eric Badel, Joseph Gril

Hamdi Seif Eddine, Rostand Moutou Pitti, Eric Badel, Joseph Gril. RECONSTRUCTION OF THE 3D CRACK PROFILE IN WOOD BASED STRUCTURES BY X-RAY COMPUTED MICROTOMOGRAPHY. Jet 2018, May 2018, Marrakech, Maroc. hal-01909285

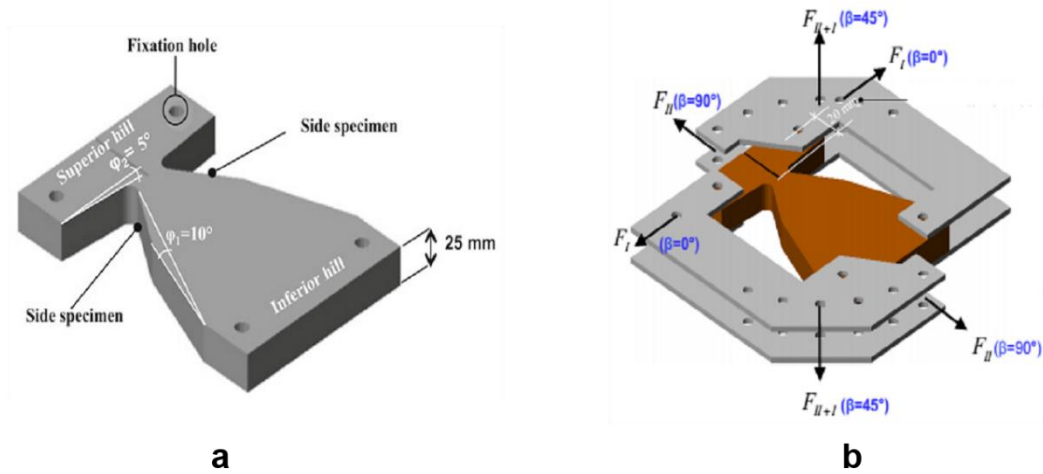
Figure 1. MMCG Padouk wood sample (a), Experimental ARCAN setup (b).

This section presents the experimental setup considered in this study. The tests were carried out on a tropical specie known as Padouk. Figure.1 (a) shows the dimensions of wood specimen, with an overall size 210 x 140 x 25 mm<sup>3</sup>. The side of the specimen has inclinations with angles of 5° and 10° from the edge and the inferior hill, respectively, as shown in Figure. 1 (b). On both hills, four holes were perforated in order to fix the steel Arcans. The distance between the hole's centers is 110 mm. The steel Arcans, were performed to allow for mixed-mode configurations. An initial crack of 20 mm is machined in the wood specimen in the direction of the fibers.

The MMCG specimen, shown in Figure 1 (b), is defined by the combination of a modified DCB specimen, and CTS specimen, on the one hand, and the observation of stability range of energy release rate versus crack length computed numerically with M $\theta$  [8], on the other hand. The main objective of this specimen is to allow for the decrease in the energy release rate during the tests. The wood specimen presented in Figure. 3 (a), is fixed in a framed structure with Arc-formed handles containing symmetrical holes for load application according to various crack mode ratios  $\beta$ . The application of symmetric loads FI with angle  $\beta = 0^\circ$  is equivalent to the opening mode, and the application of FII, with angle  $\beta = 90^\circ$  corresponds to the shear mode as shown in Figure 1 (b).

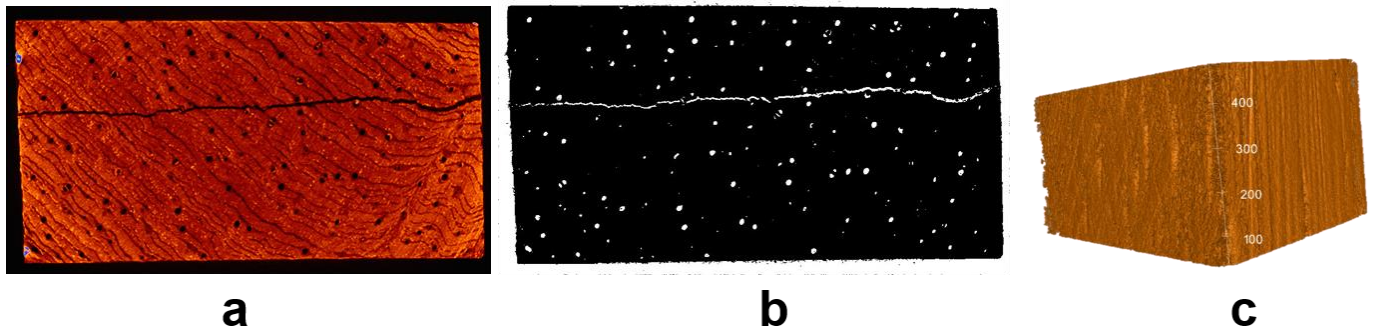
Figure 2. Internal evolution of the crack growth (a), Extraction of porosities by image analysis (b), 3D volume of the cracked Padouk sample (c).

After reconstruction, a 3D volume was obtained in consecutive slices from the 2D cross-sectional images of the investigated sample, as shown in Figure 2(a-c). The entire acquisition process took approximately 120-160 min, with an exposure time of 3 500 ms per projection. Once the region of interest (ROI) of the Padouk sample was chosen (Figure 2 (a)), the fibre elements were then segmented and binary images were obtained (Figure 2 (b)). Three-dimensional rendering of the wood sample, as shown in Figure 2 (c), was used to obtain information regarding the crack orientation, wood porosity, density and size distribution. All the 3D volume-rendered images of the Padouk, carried out along this study, had a fixed size of 900 x 800 x 750 voxels for a specimen with a volume of 33  $\text{mm}^3$  and a voxel size of 6.9  $\mu\text{m}^3$ .

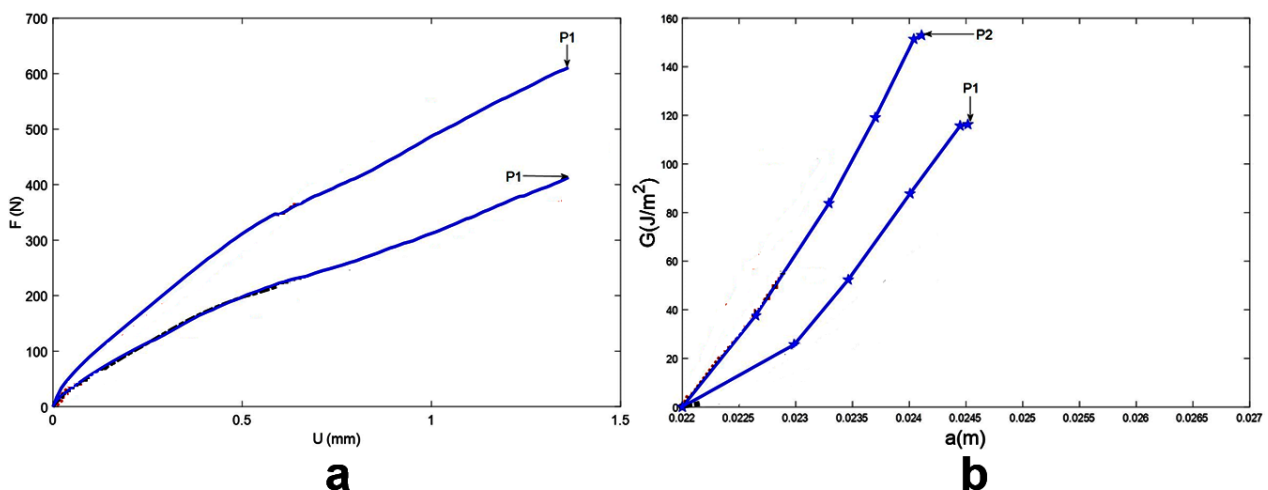
Figure 3. Force versus crack opening evolution (a), Energy release rate evolution according to crack tip advance (b)

In this section, mechanical testing was conducted on two MMCG Padouk (P1 and P2) specimen. Figure .3 (a) present the applied force versus crack opening evolution. Figure .3 (b) illustrate the viscoelastic energy release rate evolution versus crack growth process for mixed mode configuration. The crack growth process can be interpreted as brittle or ductile. If for all cases, the crack growth or damage evolutions in the process zone induce a rigidity decrease, we can note an energy release rate increase during the crack growth advance. With these considerations, for mixed mode configurations, Figure .3 (b) shows a progressive growing of the process zone (phase of energy release rate increasing) and, in the other hand, Figure .3 (a) a stationary phase with a stabilization of its evolution. More precisely, we can observe, for the second Padouk (P2) specimen, a greater energy release rate then the first Padouk (P1) specimen, which correspond on brittle crack tip advance with an approximately peaks values around 120 J/m<sup>2</sup> for P1 and 157 J/m<sup>2</sup> for P22. Energy steady state evolution after these peaks illustrate crack growth stabilities for mixed mode.

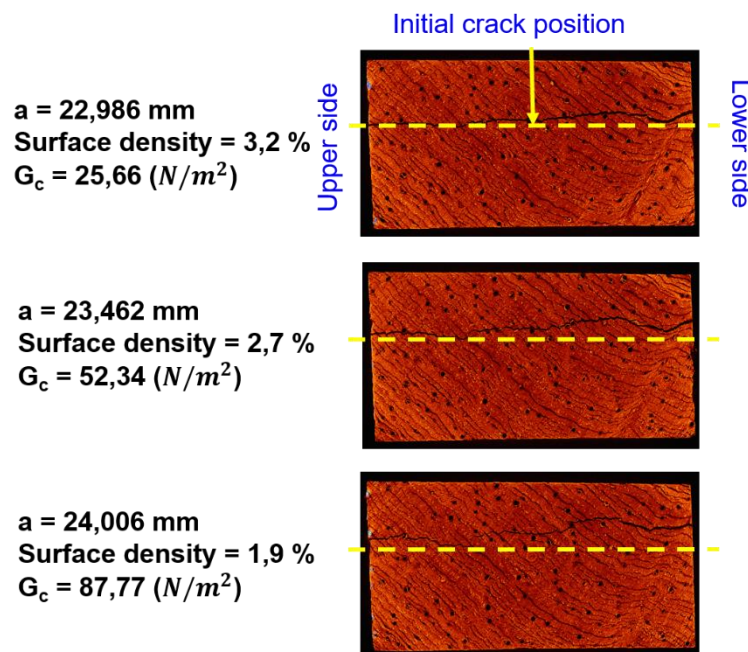
Figure 4. Crack growth path according to surface density of Padouk sample: 2D Cross sectional images extracted from 3D volume of Padouk P1 sample.

Although crack length comparison performed by the experimental method and 3D image analysis cannot be directly related to the specific features of the applied methods with regard to the analyzed crack length distribution, it provides some useful information. In fact, the mean length of the crack evolution is a good indicator of the damage level on MMCG wood samples, which is suitable for comparing the values obtained using different methods. Comparison of individual crack-based measurements is possible by relying on segmented images correlated by the surface density of the analyzed samples, as shown in Figure 4.

The volume-weighted crack length distribution of the analyzed tropical wood samples is calculated from 2D cross images (see Fig. 4). The results showed that crack progress continues inside the MMCG wood samples most likely after this progress ends in the surface of the specimens. In addition, we notice in first hand, that the surface density distribution inside a specific Padouk sample is not homogenous, which tends to accelerate the crack growth speed. In the other hand, X-ray CT showed that Padouk wood presents a high surface density. This can be explained by, the fact that Padouk wood fibers and particles diameters, estimated using the X-ray CT method (Figure 2b), showed a dispersion smaller than  $60\ \mu\text{m}$  and larger than  $800\ \mu\text{m}$ . Indeed, the conditions of fiber repartition inside the wood material affects the crack growth speed and direction as depicted in Figure. 4. The observation using the 3D scanning method showed that the crack tip progress tends to move towards larger fibers porosity all along crack path.
