RECONSTRUCTION OF THE 3D CRACK PROFILE IN WOOD BASED STRUCTURES BY X-RAY COMPUTED MICROTOMOGRAPHY

Hamdi Seif Eddine, Rostand Moutou Pitti, Eric Badel, Joseph Gril

Hamdi Seif Eddine, Rostand Moutou Pitti, Eric Badel, Joseph Gril. RECONSTRUCTION OF THE 3D CRACK PROFILE IN WOOD BASED STRUCTURES BY X-RAY COMPUTED MICROTOMOGRAPHY. Jet 2018, May 2018, Marrakech, Maroc. hal-01909285

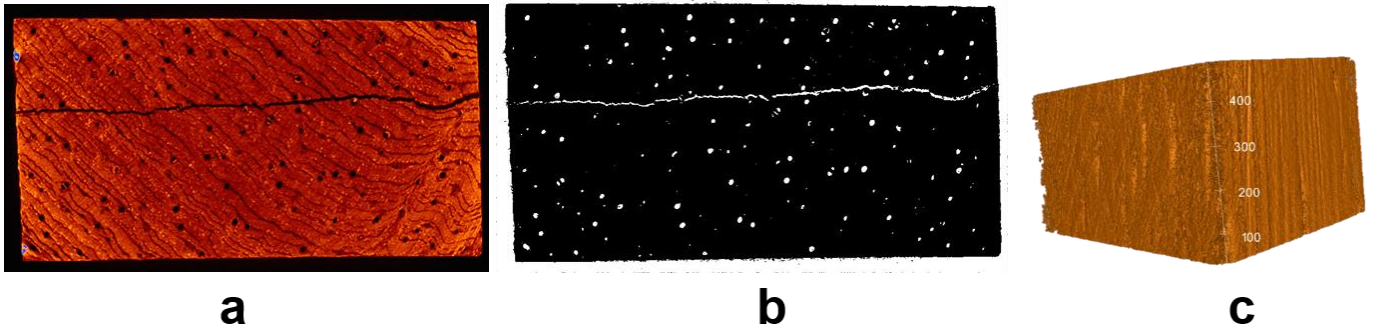
Figure 2. Internal evolution of the crack growth (a), Extraction of porosities by image analysis (b), 3D volume of the cracked Padouk sample (c).

After reconstruction, a 3D volume was obtained in consecutive slices from the 2D cross-sectional images of the investigated sample, as shown in Figure 2(a-c). The entire acquisition process took approximately 120-160 min, with an exposure time of 3 500 ms per projection. Once the region of interest (ROI) of the Padouk sample was chosen (Figure 2 (a)), the fibre elements were then segmented and binary images were obtained (Figure 2 (b)). Three-dimensional rendering of the wood sample, as shown in Figure 2 (c), was used to obtain information regarding the crack orientation, wood porosity, density and size distribution. All the 3D volume-rendered images of the Padouk, carried out along this study, had a fixed size of 900 x 800 x 750 voxels for a specimen with a volume of 33 mm^3 and a voxel size of 6.9 μm^3 .

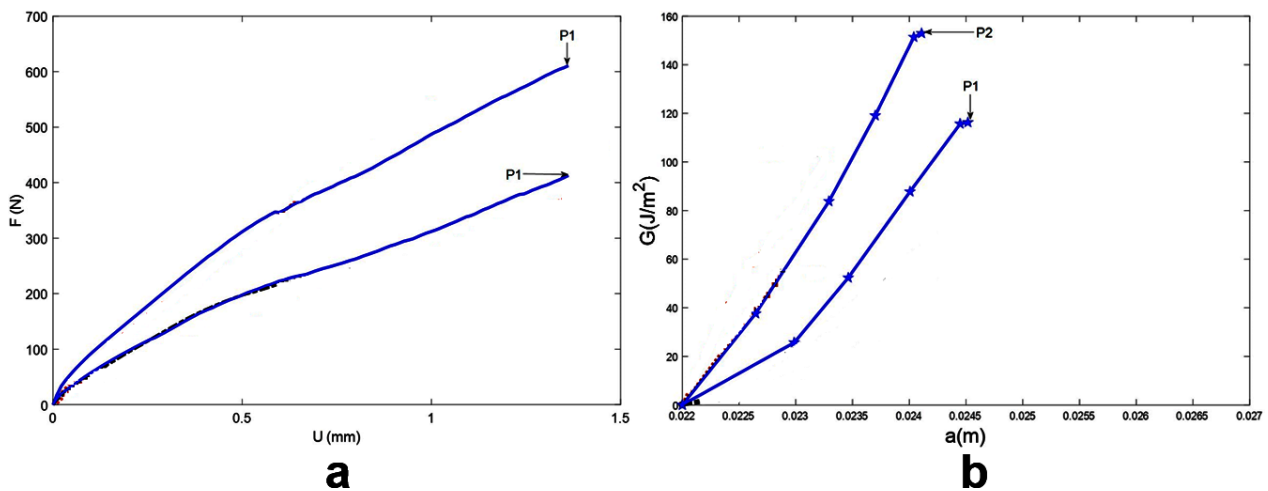
Figure 3. Force versus crack opening evolution (a), Energy release rate evolution according to crack tip advance (b)

In this section, mechanical testing was conducted on two MMCG Padouk (P1 and P2) specimen. Figure .3 (a) present the applied force versus crack opening evolution. Figure .3 (b) illustrate the viscoelastic energy release rate evolution versus crack growth process for mixed mode configuration. The crack growth process can be interpreted as brittle or ductile. If for all cases, the crack growth or damage evolutions in the process zone induce a rigidity decrease, we can note an energy release rate increase during the crack growth advance. With these considerations, for mixed mode configurations, Figure .3 (b) shows a progressive growing of the process zone (phase of energy release rate increasing) and, in the other hand, Figure .3 (a) a stationary phase with a stabilization of its evolution. More precisely, we can observe, for the second Padouk (P2) specimen, a greater energy release rate then the first Padouk (P1) specimen, which correspond on brittle crack tip advance with an approximately peaks values around 120 J/m² for P1 and 157 J/m² for P22. Energy steady state evolution after these peaks illustrate crack growth stabilities for mixed mode.
