## Measurement of fracture toughness of metallic materials produced by additive manufacturing

**MEASUREMENT OF FRACTURE TOUGHNESS OF METALLIC MATERIALS**  
**PRODUCED BY ADDITIVE MANUFACTURING**

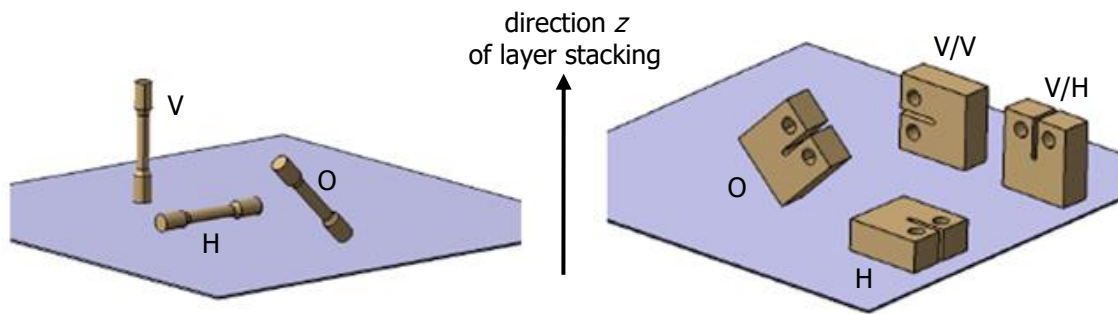
**Figure 1: Orientations of the samples for tensile and toughness tests**

The ALM process consists in melting the part layer by layer, favouring the anisotropy of direction  $z$  of the "stacking". Consequently, three particular orientations of the samples were identified for the tensile specimens, as shown in Figure 1. Note that for tensile specimens, this direction corresponds to the loading axis: vertical (denoted by "V"), horizontal ("H"), slanted at  $45^\circ$  ("O"). Note that in-plane directions  $x$  and  $y$  were not distinguished since the laser advance direction is turning of  $30^\circ$  when changing for the next layer. For the toughness specimens however, one needs to report both the building plane and the loading axis due to multiple crack orientations. Consequently four different orientations were identified: horizontal (resp. oblique) specimens gave only horizontal (resp. oblique) loading direction denoted by "H" (resp. "O"), whereas vertical specimens could lead to both a vertical

notch and horizontal loading direction (denoted by "V/H"), and a horizontal notch and vertical direction ("V/V").

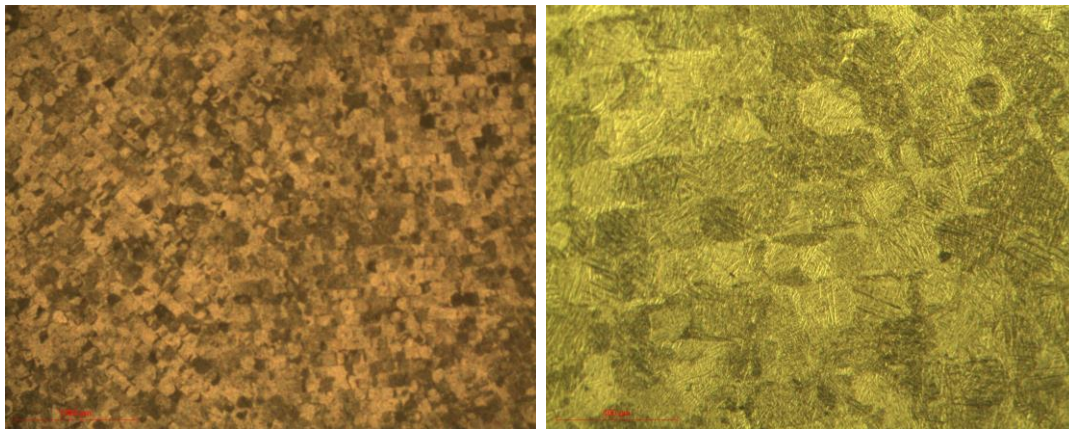
**Figure 2: Microstructure observed for the Ti-6Al-4V sample at low magnifications**

**Horizontal:** At low magnification, each layer is composed of lines parallel one to each other, each of them showing a succession of more or less regular squares (see Figure 2). This typical microstructure reflects the successive scanning orientations of the laser beam during the manufacturing. Indeed, for each layer, the laser beam produced a melted bead and, after recrystallization, a line of solid material (the width of which is ranging between 100 and 120  $\mu\text{m}$ ) aligned to the direction of the laser beam displacement. The direction of the beam changing from layer to layer, and the induced fusion affecting not only the concerned layer but also the 2-3 lower layers, the recrystallization produced square grains detectable along each line. Observing several orientations of the lines indicates that the polishing affected several successive layers.

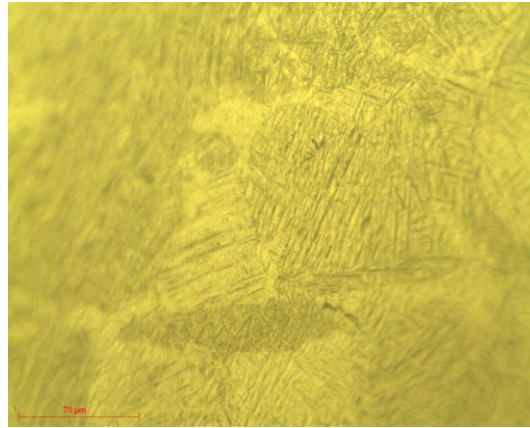
**Figure 3: Martensitic microstructure of the Ti-6Al-4V sample**

Higher magnification allows observing the martensitic structure (see Figure 3) of each square of the Ti-6Al-4V sample. This microstructure indicates that the cooling rate during the manufacturing process was fast enough to lead to the  $\alpha'$  metastable phase.

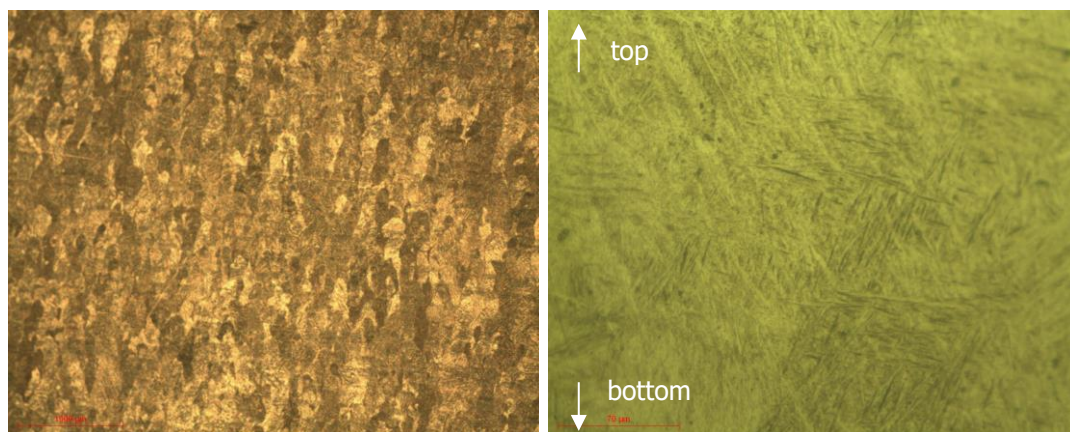
**Figure 4: Microstructure along the height of the Ti-6Al-4V sample at low (left) and high (right) magnification**

**Vertical:** Observations of the Ti-6Al-4V sample along its height revealed that, if the microstructure is composed of layers, the obtained grains after recrystallization have a columnar structure (see Figure 4), the orientation of which is perpendicular to the layers. This microstructure is only possible by fusion of the lower layers, leading to a melted bead with a “keyhole” section when scanning the laser beam [29, 30]. Figure 4 confirmed that the grains are made of  $\alpha'$  martensitic phase.

As a result, it appears that the microstructure of the Ti-6Al-4V samples obtained by LBM is quite homogeneous, even if it does not seem to be isotropic, nor in the layer plane, nor in the height plane.

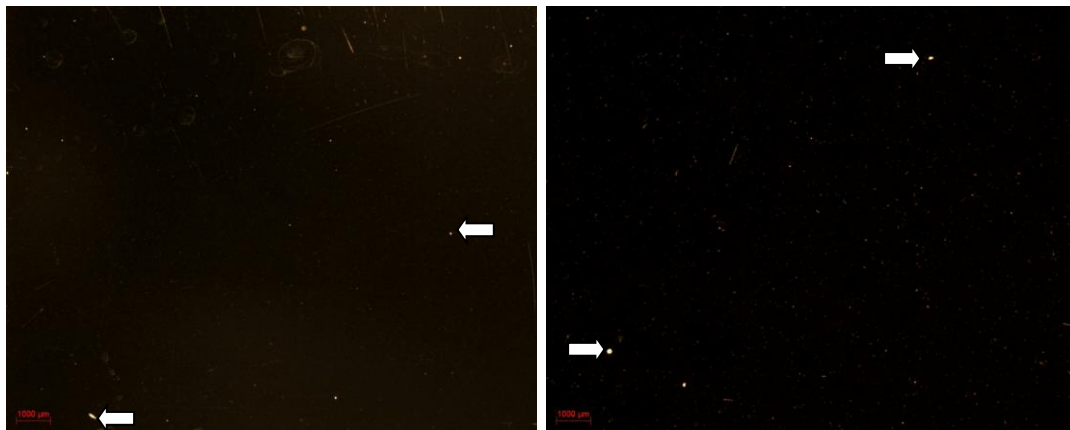
**Figure 5. Porosity (white dots) detected in the Ti-6Al-4V sample before (left) and after (right) the HIP treatment**

The HIP treatment was expected to eliminate, or at least reduce, the porosity rate in the obtained samples. Among all the potential techniques, we estimated the porosity rate by observing the polished surface of the sample and detect the porosity by difference of colour. The surface of the sample appears dark while porosity appears as white dots (see Figure 5). As a first result, we can say that the HIP finally did not reduce the porosity rate, maybe due to the very low proportion of porosity (lower than 0.2%) in the initial material.

Then, it appeared that there was no porosity detected on the fracture surface, proving that if there was residual porosity in the whole sample (as noted in Figure 5), it had no influence on the mechanical performances of the HIPed sample. The thermal treatment seems to be very efficient to increase the plastic deformation of LBM manufactured Ti-6Al-4V.

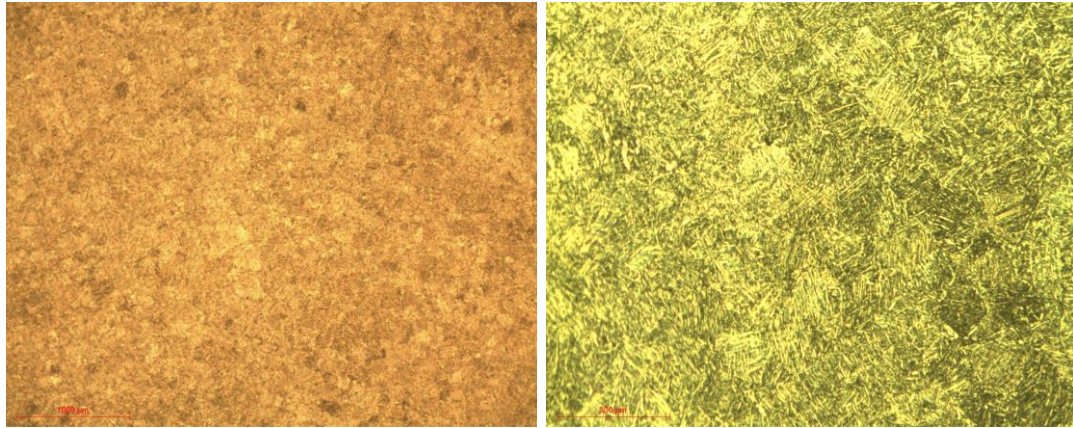
**Figure 6. Microstructure observed for the Ti-6Al-4V sample after HIP at low magnifications**

**Horizontal:** The HIP treatment clearly blurred the anisotropic microstructure of the Ti-6Al-4V sample (see Figure 6), even if some residual anisotropy can be detected. The lines and squares largely vanished.

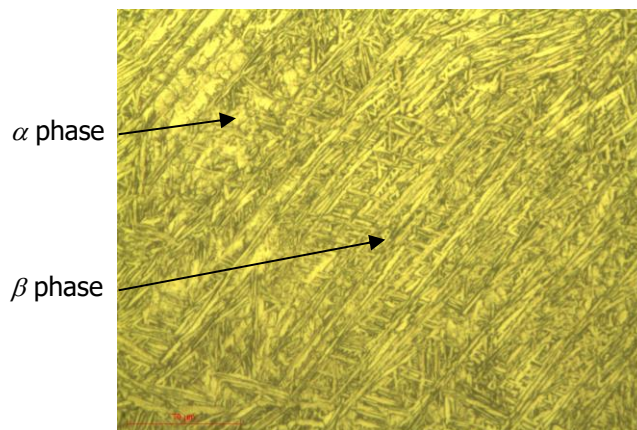
**Figure 7. Microstructure observed for the Ti-6Al-4V sample after HIP at high magnification**

At higher magnification (see Figure 7), observations showed that the martensitic structure disappeared; the sample is now constituted by a  $\alpha/\beta$  structure. The proportion of obtained  $\alpha$  phase is low due to a thermal treatment either at too low temperature or with a too short duration.

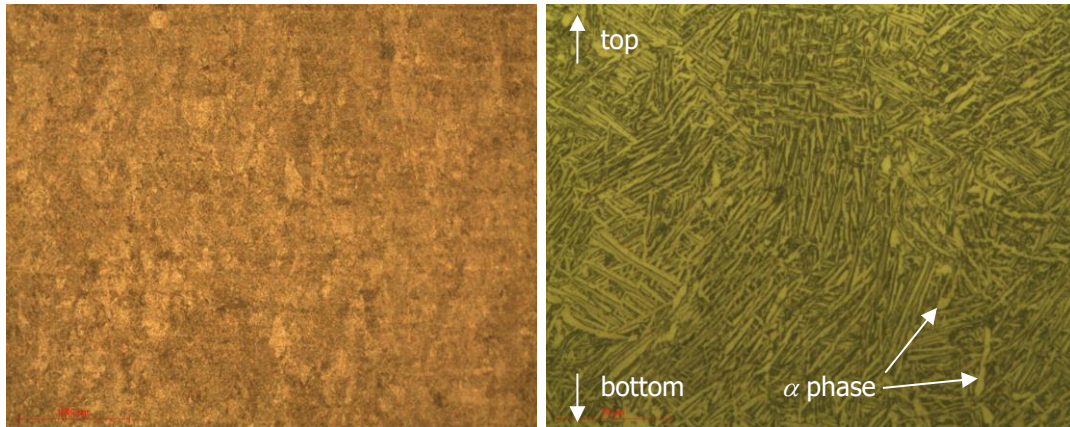
**Figure 8. Microstructure along the height of the Ti-6Al-4V sample after HIP at low (left) and high (right) magnification**

**Vertical:** One can note at low magnification (Figure 8, left) that the anisotropy is not fully blurred, as layers are still slightly visible, as well as some residual columnar grains. We could then estimate that the anisotropy is more strongly present in the vertical plane than in the horizontal one. Higher magnification (Figure 8, right) allows to conclude that the  $\beta$  phase appears along the grain boundaries between the columnar grains, as expected.

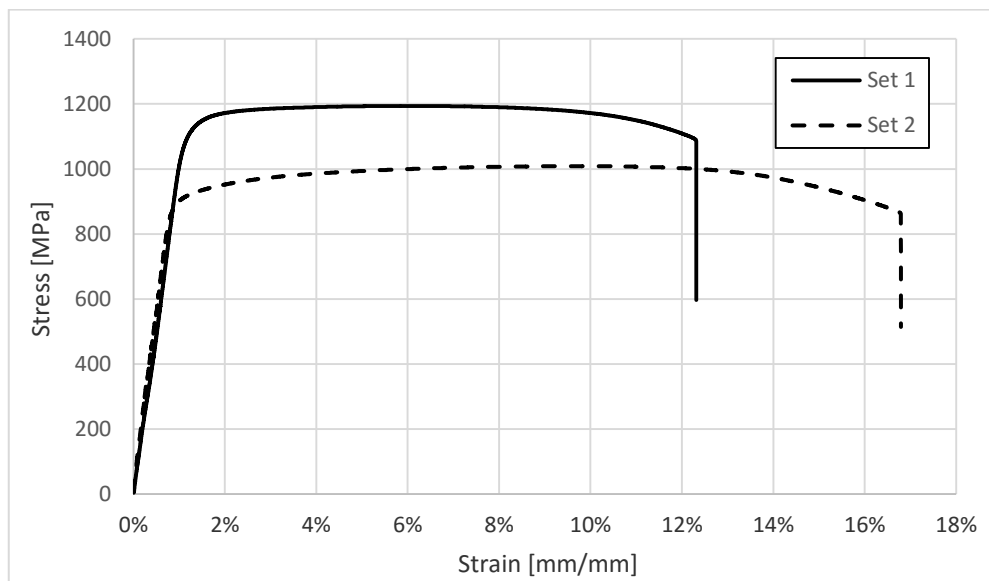
**Figure 9 - Typical stress-strain results for titanium specimen**

Two typical stress-strain curves obtained for samples of batches #1 and #2 are shown in Figure 9. Detailed results including Young's modulus (E), tensile yield stress (YS), ultimate tensile stress (UTS) and elongation (A%) for batches #1 and #2 are reported in Table 2 and Table 3 respectively. Unlike toughness specimen, tensile specimens did not experience cracking during the ALM process thank to more slender shape, and all specimens manufactured could be tested.

Except for elongation, results for batch #1 were rather repeatable. For Young’s modulus, yield stress and ultimate stress, the slight differences between the various orientations are hardly significant and the material can be considered as quasi-isotropic for those properties. However a moderate 16% increase in the elongation tends to appear for the vertical direction (building direction), although low repeatability maintains doubt about this.

Samples of batch #2 were found to provide very repeatable results including the elongation. Again the material looks almost isotropic including the elongation. This tends to confirm that the HIP treatment removed the slight z-anisotropy noted in the elongation in batch #1.

Comparisons between batch #1 and batch #2 lead to the most interesting conclusions. Young’s modulus seemed to have slightly decreased (by 4.6%) after the HIP treatment, but the difference is not high enough to be sure that it is relevant. Important drops were noticed concerning the yield stress (-19.2%) and the ultimate stress (-14.7%). On the opposite elongation increased by 59%. As a conclusion, the HIP treatment did not lead to any improvement in the tensile characteristics, except the large 59% increase in the inelastic deformation of the material.

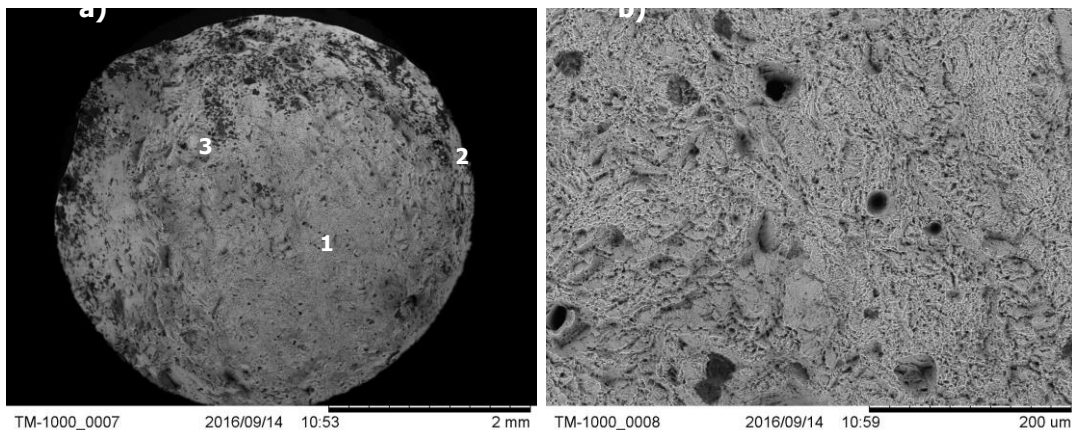
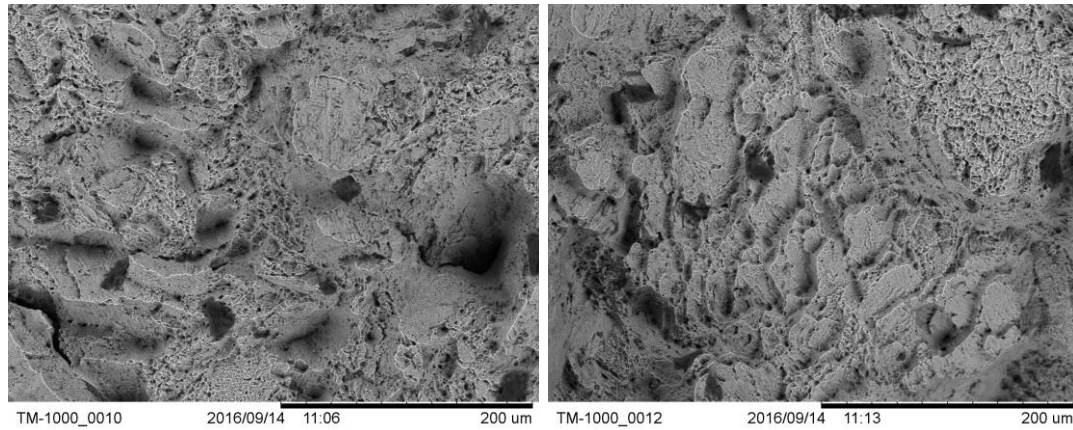
**Figure 10. Fracture tensile surface of the vertical stress-relieved sample. (a): overall view of the fracture surface. (b): defects detected in location 1 in (a). (c): microcracks detected in location 2 in (a). (d): brittle fracture surface in location 3 in (a).**

The overall view of the tensile fracture surface of the vertical as built samples is presented in Figure 10a. It appears that failure mechanism was mostly ductile as a transgranular fracture surface with a network of dimples can be largely observed (see Figure 10b).

Some defects can also be observed, such as porosity (resulting from microvoid coalescence during the manufacturing process), mostly located in the center part of the section of the sample (see Figure 10b), even if this porosity does not seem to have a strong influence on the mechanical properties, at least for tensile tests. One could assume that the porosity could be the main cause of the fracture [13].

Nevertheless, another defect seems to have much more influence on the mechanical behaviour of the sample: the micro-cracks. They were mostly detected in the external part of the section of the sample (see Figure 10c), even if few of them can be observed in the centre of the section. These micro-cracks were attributed in our case to the residual stress in the sample after the laser manufacturing, which was not erased after the stress relieving treatment. The large number of such micro-cracks at the fracture surface should underline their strong influence on the mechanical performance of the stress-relieved Ti-6Al-4V sample. This conclusion was confirmed by the brittle surfaces detected around most of these micro-cracks, leading to cleavage facets and a layered profile (see Figure 10c-d). These brittle surfaces were attributed to cleavage within layers of the material, joining two ductile surfaces, which were the interface between two successive layers. Nevertheless, in such a mixed ductile-brittle behaviour, the ductility was largely dominating.

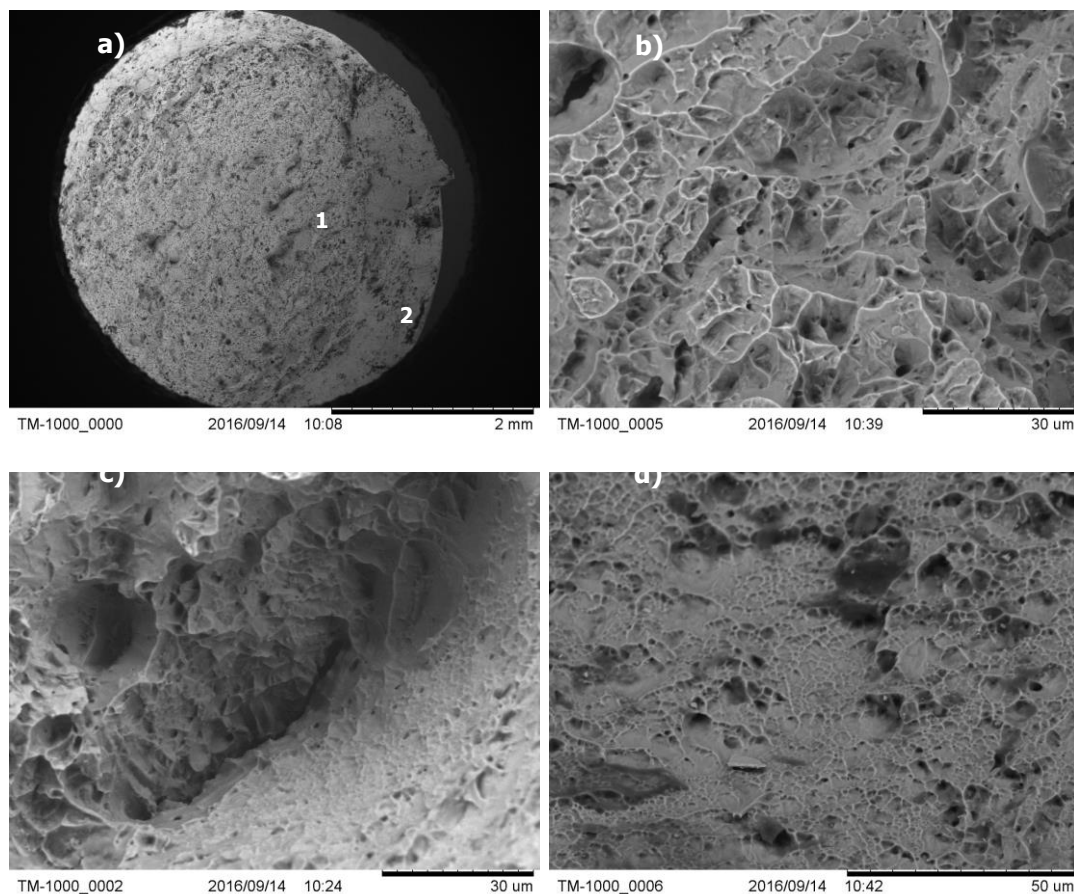
**Figure 11. Fracture tensile surface of the vertical sample after HIP treatment. (a): overall view of the fracture surface. (b): observed ductile behaviour. (c): microcrack detected in location 1 in (a). (d): magnification in location 2 in (a).**

As a first result, one must note that at the lowest magnification (x40), the whole fracture surface of the vertical sample after HIP could be observed (see Figure 11a), what was not possible for the

Increasing magnification during the observation allowed revealing a pure ductile behaviour of the sample, characterized by the dimples network (see Figure 11b). Such a behaviour could be confirmed by both a larger necking of the sample and a "cup and cone" aspect (typical of ductile material).

Some few micro-cracks were still remaining (see Figure 11c), but they did not give rise to cleavage facets attributed to brittle behaviour. The final overloaded surface (see Figure 11d) also presented a ductile aspect, but the size of the dimples is much smaller. This result can be explained as the duration of final fracture was too short to allow large plastic deformation of the corresponding area, and then to lead to larger dimples.
